DESIGNED - DAB	EXAMINED - Timothy A. Daulton ACTING ENGINEER OF STRUCTURAL SERVICES	DATE - NOVEMBER 15, 2013	STATE OF ILLINOIS DEPARTMENT OF TRANSPORTATION		STRAIGHTENING DETAILS FOR GIRDERS 2 & 3 SN 016-2050		F.A. RTE.	SECTION	COUNTY	TOTAL SHEETS	SHEET NO.
CHECKED - SMR	PASSED - [Signature]						VAR	2013-044BR	COOK	35	19
DRAWN - Kyle M. Steffan	ACTING ENGINEER OF BRIDGES AND STRUCTURES						CONTRACT NO. 60W94				
CHECKED - DAB SMR					SHEET NO. 2 OF 4 SHEETS		ILLINOIS FED. AID PROJECT

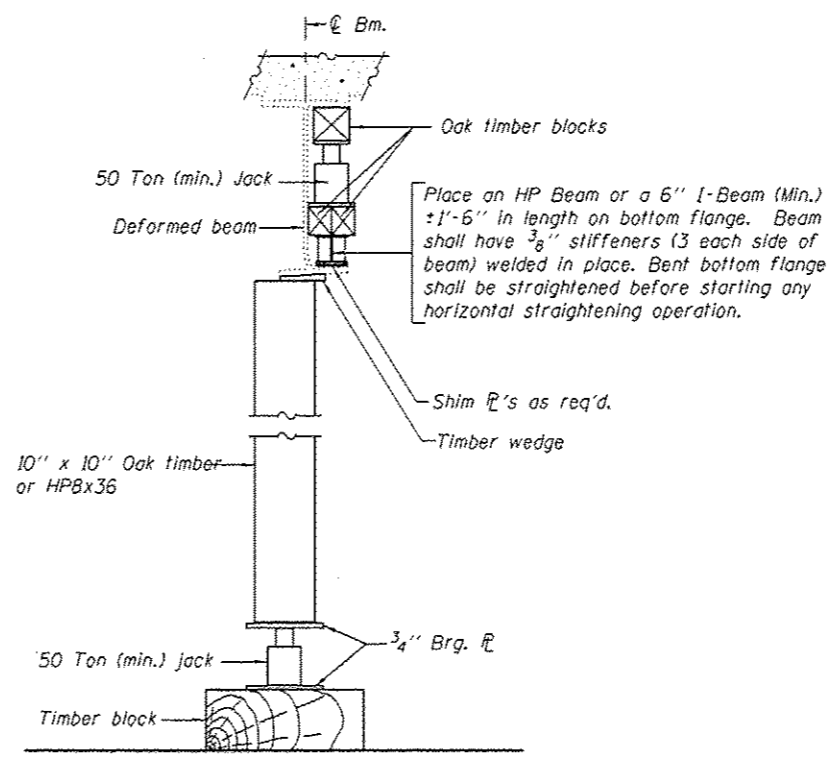
**SUGGESTED VERTICAL STRAIGHTENING DETAIL**  
 (To correct flange rotation.)

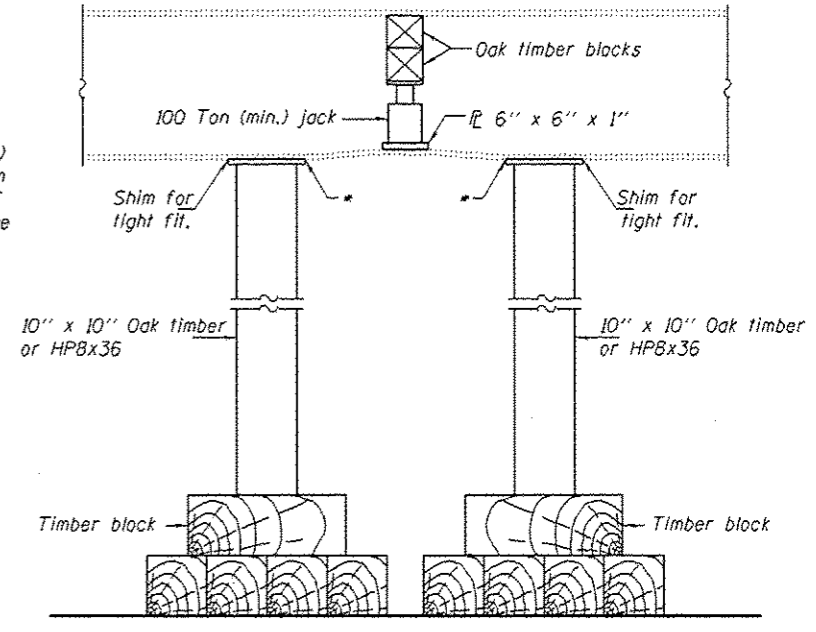
**SUGGESTED VERTICAL STRAIGHTENING DETAIL**  
 (To correct localized vertical flange deformations.)

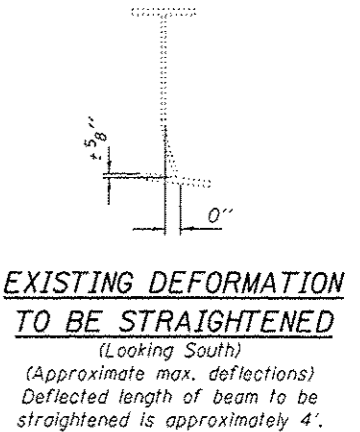
**EXISTING DEFORMATION TO BE STRAIGHTENED**  
 (Looking South)  
 (Approximate max. deflections)  
 Deflected length of beam to be straightened is approximately 4'.

Note:  
 Braces and jack assembly shall be placed on same side of web.  
 Bent bottom flange shall be straightened before starting any horizontal straightening operations.
