East River Road
Stephenson County, IL
Sampling Report

East River Road; Stephenson Co, IL - Sampling Report Summary

- Per request of Stephenson County, East River Road was sampled on November 7th, 2023, from Rock City Road to IL-75. The roadway was sampled to explore existing material, as well as evaluate the roadway's candidacy for a Cold In-Place Recycling (CIR) treatment utilizing engineered emulsion.
- The total project length is approximately 5.1 miles, averaging 20.9 feet wide, with a total existing pavement area of approximately 62,500 square yards.
- A total of 12 locations were sampled throughout the roadway to measure material thickness and examine material type.

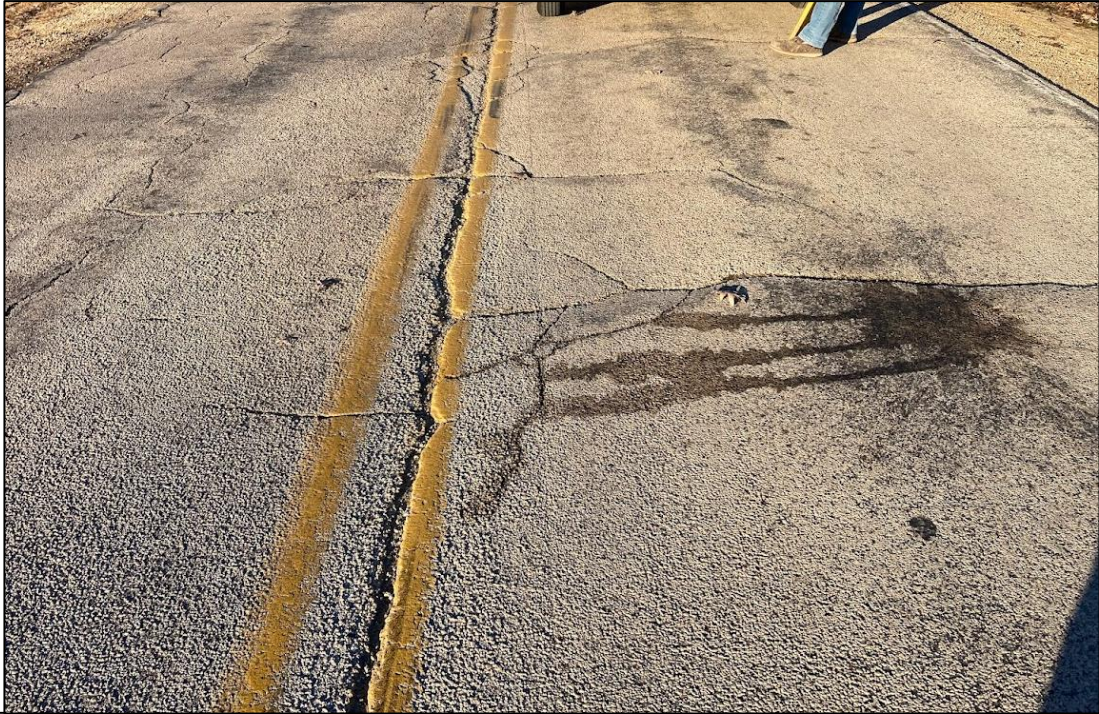
Location 1: Westbound Lane

- Longitudinal and transverse cracking was observed
- An average of 6.0 inches of bituminous material was observed at this location
- Top-down cracking was observed to a depth of 5.3 inches in core #3
- Full depth sample was not pictured of core #3
- A crushed aggregate base was observed directly below the bituminous material past a depth of 6.5 inches

- Per conversations with Stephenson County, a 4.0-inch CIR is planned for East River Road. Full-depth cracking and stripping similar to that observed at locations #1, 3, 4, 5, and 8 cannot be addressed with a 4.0-inch CIR treatment. Based on the findings during sampling, it is recommended to alter the treatment depth to 5.0-inches in order to address distressed deeper in the pavement structure.

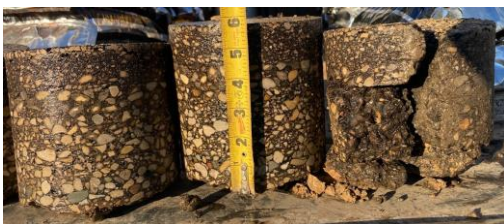
#1-5.5" #2-6.0" #3-5.5"

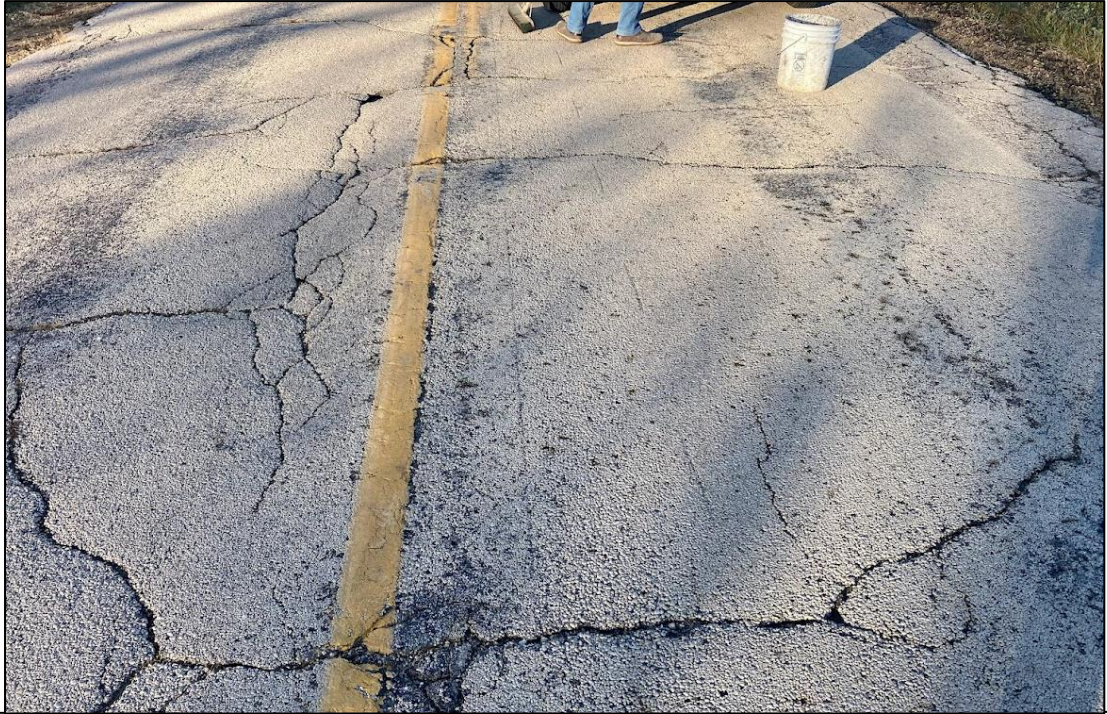
Location 2: Westbound Lane

- Longitudinal and transverse cracking was observed
- A total of 5.0 inches of bituminous material was observed at this location
- Top-down cracking was observed to 2.5 inches in core #3
- A crushed aggregate base was observed directly below the bituminous material

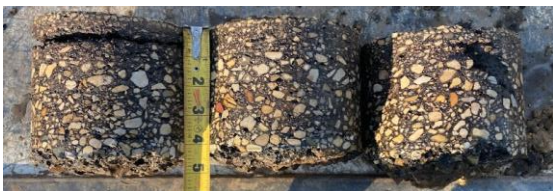
#1-5.0" #2-5.0" #3-5.0"

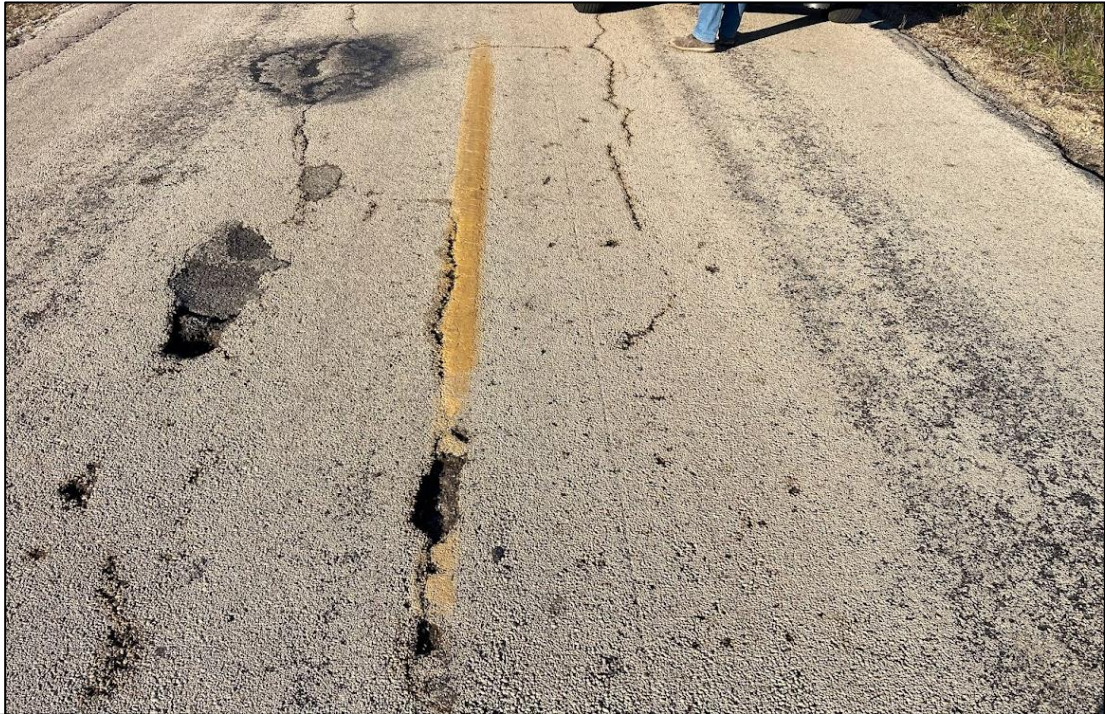
Location 3: Westbound Lane

- Loss of surface material was observed
- Loss of edge material was observed
- An average of 6.7 inches of bituminous material was observed at this location
- Full depth samples not pictured of cores #2 and 3
- A crushed aggregate base was observed directly below the bituminous material past a depth of 8.0 inches

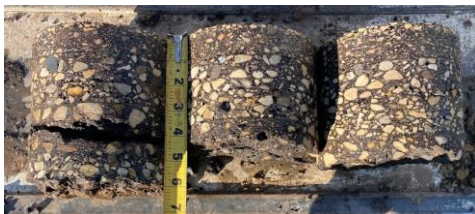
#1-6.0" #2-4.5" #3-5.0"

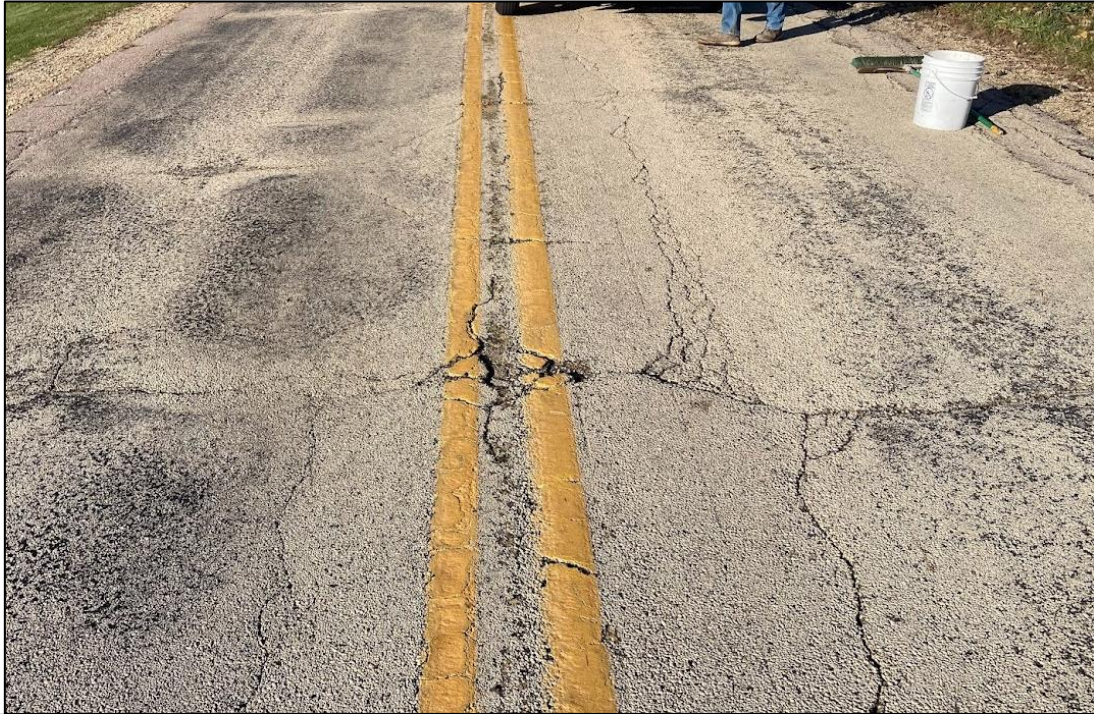
Location 4: Westbound Lane

- Longitudinal and transverse cracking was observed
- An average of 6.0 inches of bituminous material was observed at this location
- Full depth samples unable to be extracted intact due to stripping was observed between 5.5 and 6.5 inches
- A crushed aggregate base was observed below the bituminous material

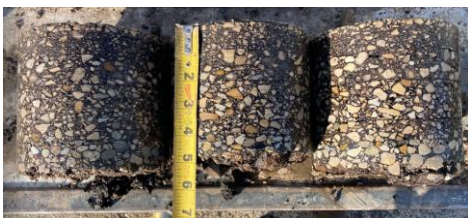
#1-5.5" #2-5.0" #3-6.0"

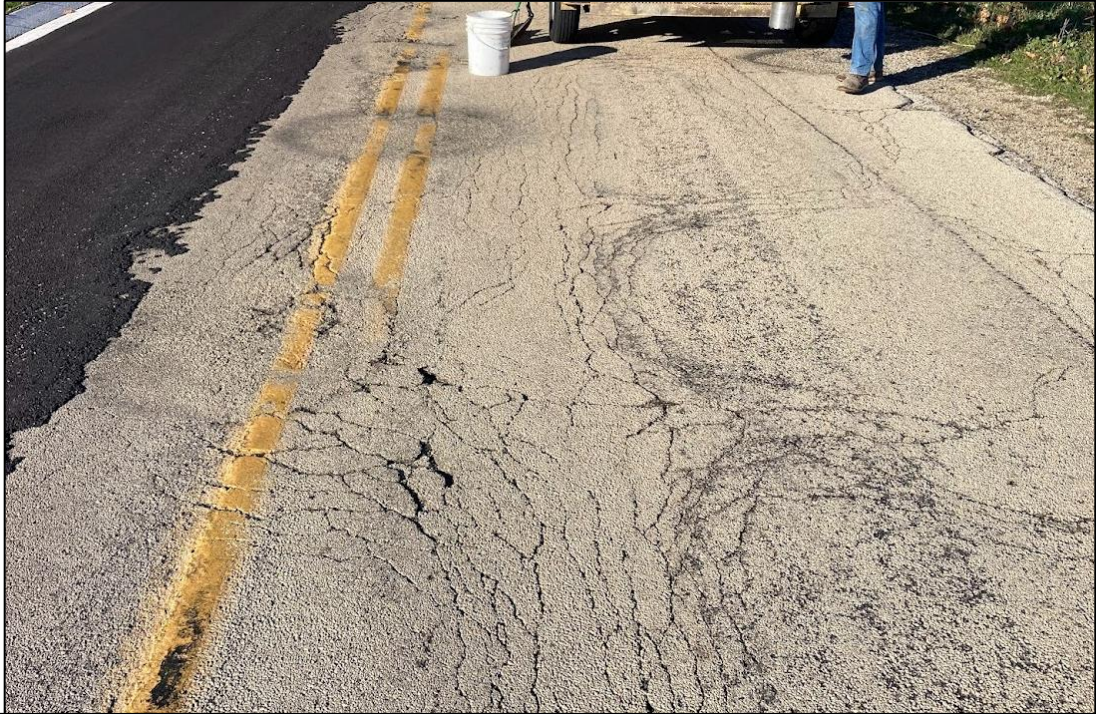
Location 5: Westbound Lane

- Alligator cracking was observed
- Surface patching was observed in the eastbound lane
- A total of 6.0 inches of bituminous material was observed at this location
- Stripping was observed past a depth of 3.0 inches in core #1
- A crushed aggregate base was observed below the bituminous material

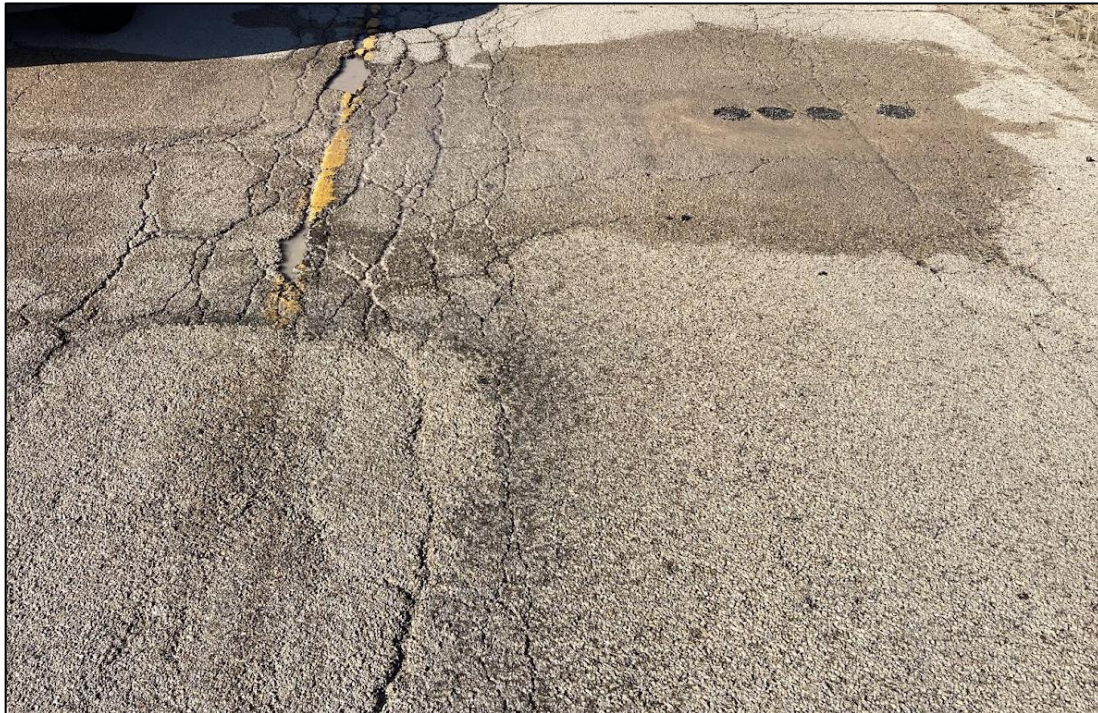
Location 6: Westbound Lane

- Alligator cracking was observed
- Loss of surface material was observed
- A total of 5.0 inches bituminous material was observed at this location
- A crushed aggregate base was observed directly below the bituminous material

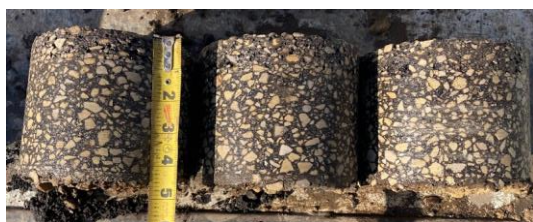
#1-5.0" #2-5.0" #3-5.0"

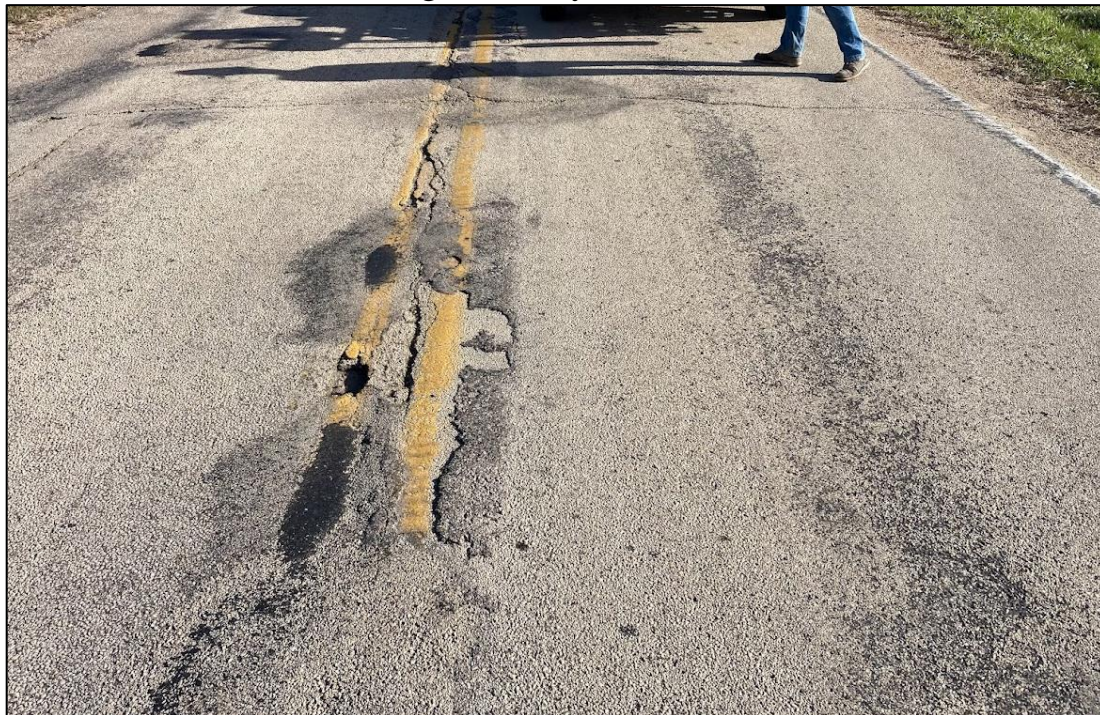
Location 7: Eastbound Lane

- Longitudinal and transverse cracking was observed
- Loss of surface material was observed
- A total of 6.5 inches of bituminous material was observed at this location
- A crushed aggregate base was observed below the bituminous material

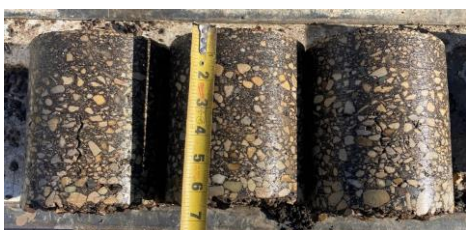
#1-6.5" #2-6.5" #3-6.5"

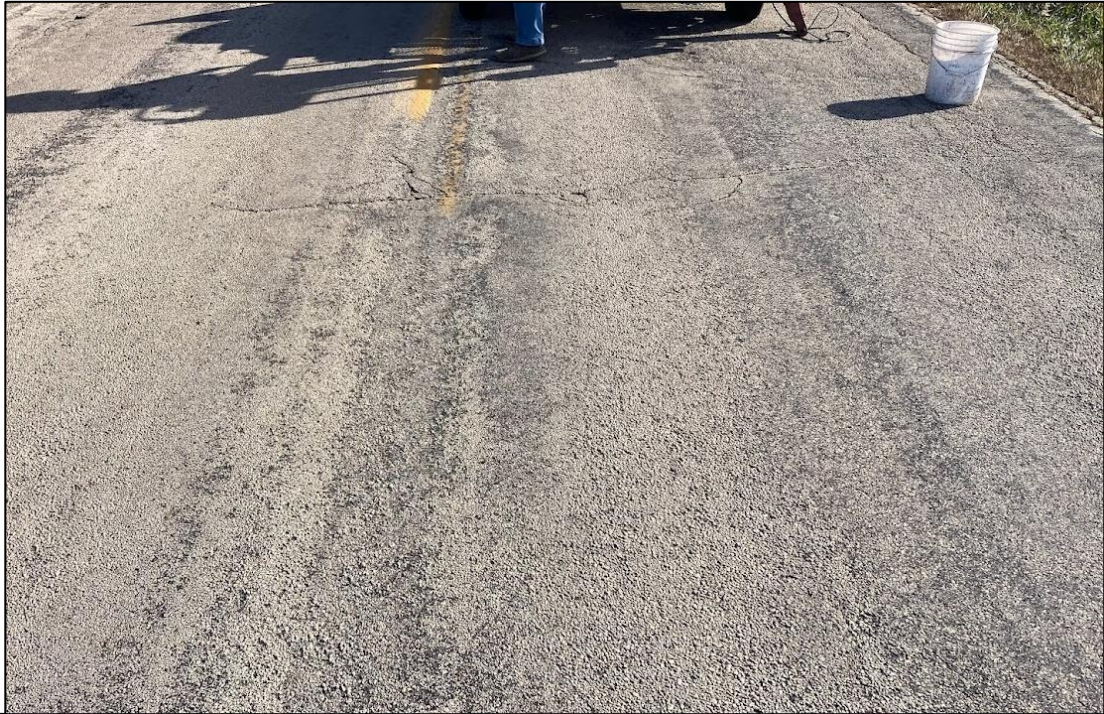
Location 8: Eastbound Lane

- Transverse cracking was observed
- Alligator cracking was observed in the shoulders
- A total of 4.0 inches of bituminous material was observed at this location
- Full depth cracking was observed in core #2 and 3
- A crushed aggregate base was observed directly below the bituminous material past a depth of 8.0 inches

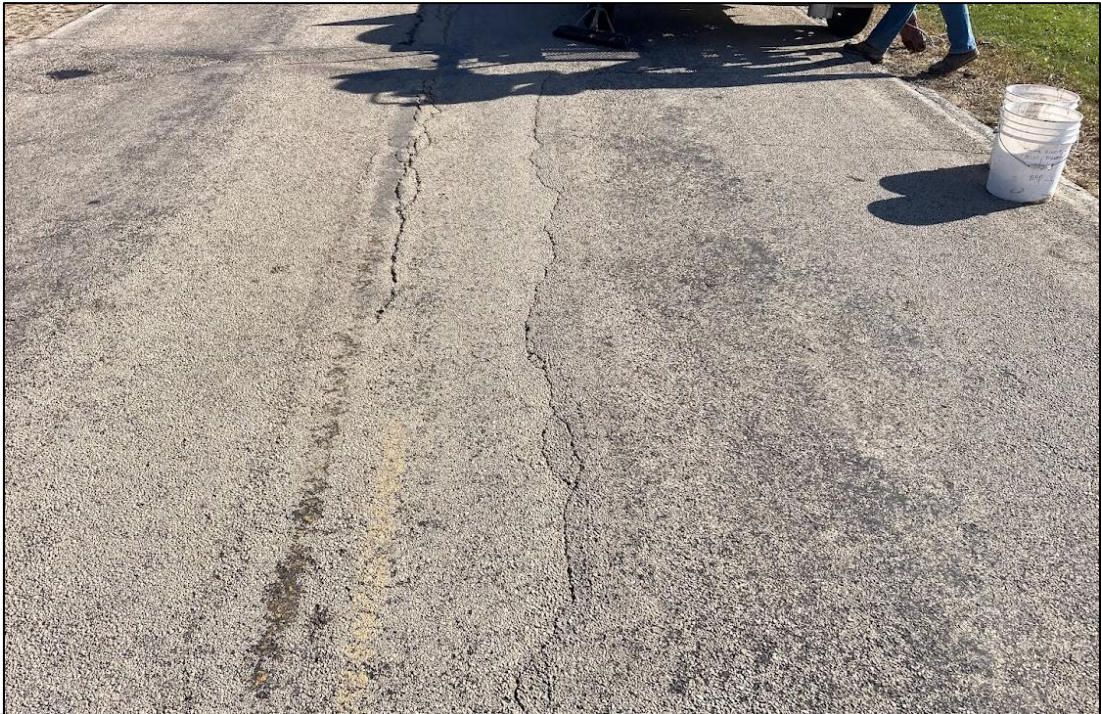
Location 9: Eastbound Lane

- Longitudinal and transverse cracking was observed
- Transverse cracking was observed to be 4.0 inches in depth
- An average of 5.7 inches of bituminous material was observed at this location
- A crushed aggregate base was observed directly below the bituminous material past a depth of 8.0 inches

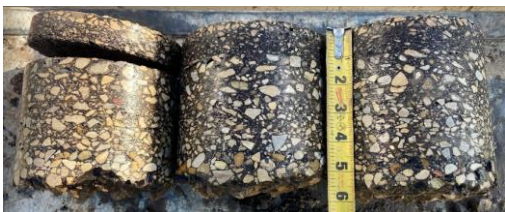
#1-5.5" #2-5.5" #3-6.0"

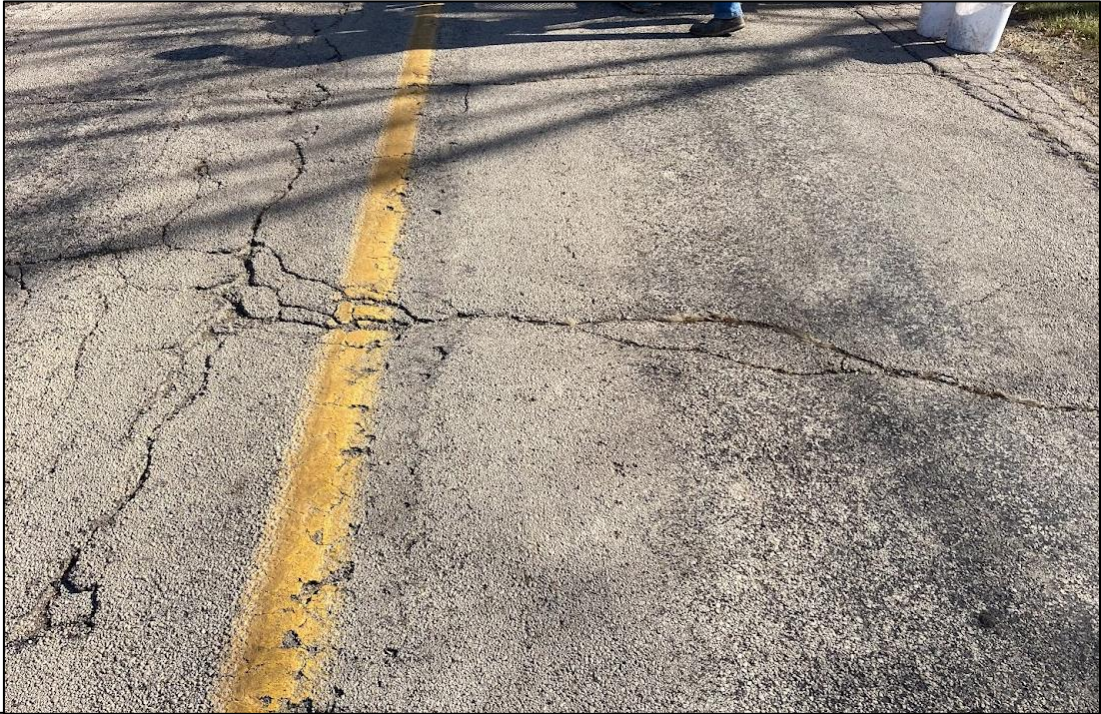
Location 10: Eastbound Lane

- Longitudinal and transverse cracking was observed
- Alligator cracking was observed
- An average of 4.7 inches of HMA was observed at this location
- A crushed aggregate base was observed below the bituminous material past a depth of 7.5 inches

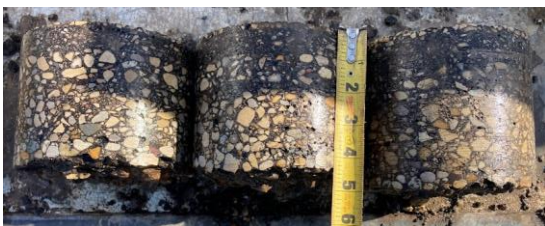
#1-4.5" #2-4.5" #3-5.0"

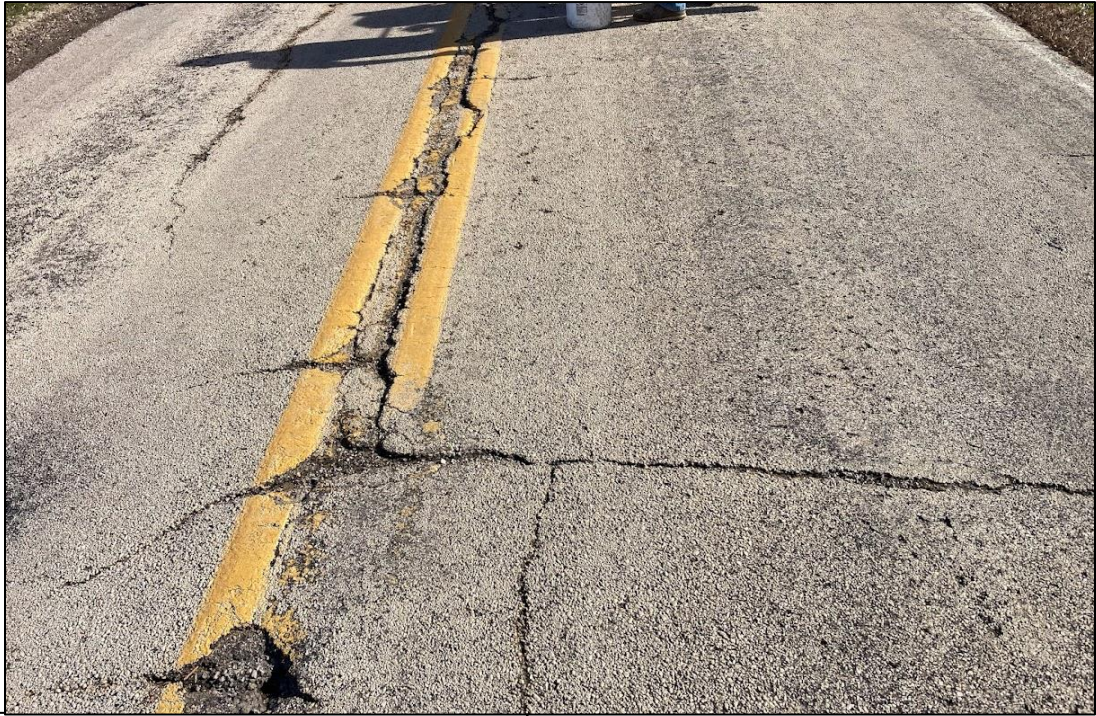
Location 11: Eastbound Lane

- Longitudinal and transverse cracking was observed
- Loss of edge material was observed in the westbound lane
- A total of 6.8 inches of bituminous material was observed at this location
- A crushed aggregate base was observed directly below the bituminous material past a depth of 9.3 inches

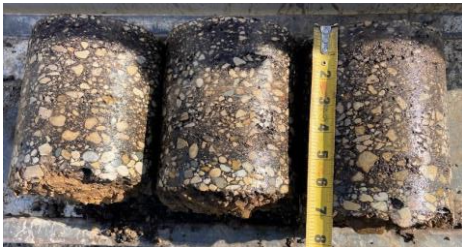
#1-6.5" #2-6.5" #3-7.0"

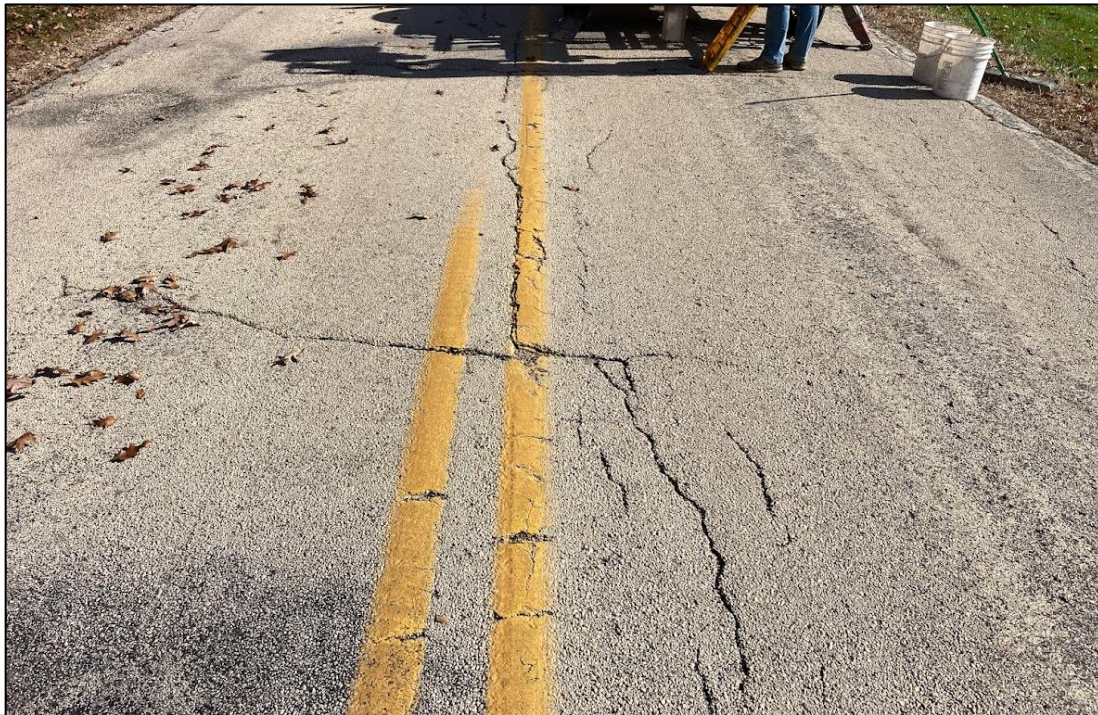
Location 12: Eastbound Lane

- Longitudinal and transverse cracking was observed
- An average of 4.8 inches of bituminous material was observed at this location
- A crushed aggregate was observed directly below the bituminous material past a depth of 8.0 inches

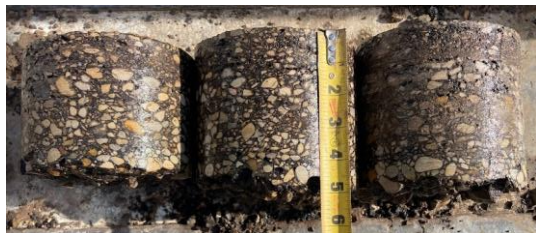
#1-4.5" #2-5.0" #3-5.0"
