ROUTE NO.	SECTION	COUNTY	TOTAL SHEETS	SHEET NO.
FAP 315		McLEAN	44	23
STA.	TO STA.			
FED. ROAD DIST. NO.	ILLINOIS	FED. AID PROJECT-		
*102X-BR-2		DWG. NO.	11	OF 17
CONTRACT NO. 66584

**EAST ABUTMENT**  
**US 136 OVER BRANCH OF SALT CREEK**  
**FAP ROUTE 315 - SECTION 102X-BR-2**  
**McLEAN COUNTY**  
**STATION 616+99.00**  
**STRUCTURE NO. 057-0185**

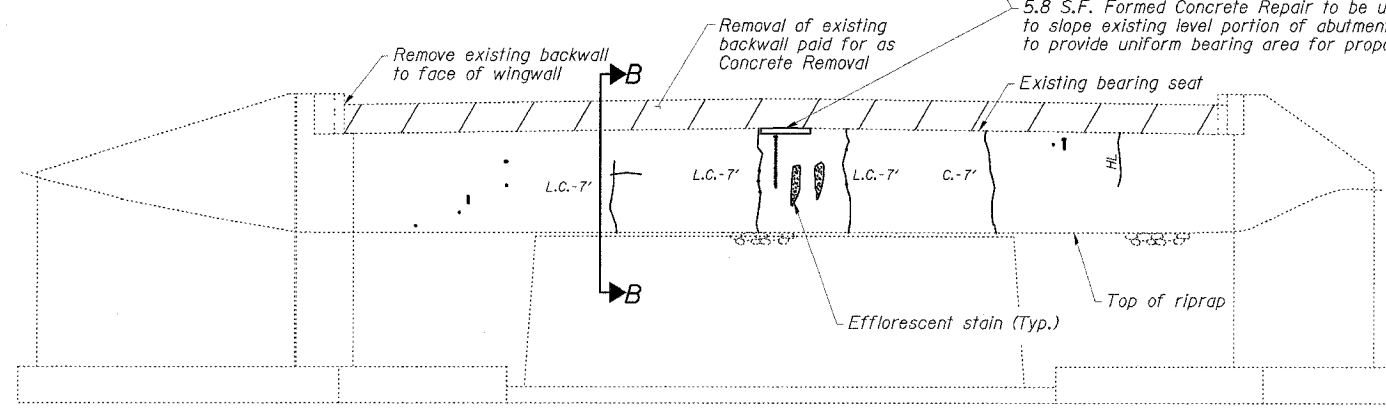
**ELEVATION**  
Abutment and Wingwall Repairs

NOTE: ABUTMENT CRACK REPAIR LENGTHS AND FORMED CONCRETE REPAIR AREAS ARE ESTIMATED FROM 11-15-01 SURVEY WORK. ACTUAL LOCATIONS AND QUANTITIES OF REPAIRS SHALL BE SHOWN BY THE ENGINEER ON THE AS-BUILT PLANS FOR THIS SECTION.

- Inspection Date: 11-15-01
- ▮ Rust Stained Area
  - (W/L) Moisture Stained or Leached Area
  - {HL} Hairline Crack - Not to be Sealed
  - {c.-6"} Crack (> 1/16" Width) — EPOXY CRACK SEALING
  - {L.C.-6"} Leached Crack (> 1/16" Width) — EPOXY CRACK SEALING
  - S.F. (diagonal lines) Delaminated Area — FORMED CONC. REPAIR
  - S.F. (cross-hatched) Spalled Area (Depth ≤ 5") — FORMED CONC. REPAIR
