ILLINOIS DEPARTMENT OF TRANSPORTATION

I-64 OVER
WABASH RIVER
STRUCTURE NUMBER: 097-0003
EASTBOUND PIER 3

Drawn By: PRH/DR		Date: JULY, 2005
Checked By: JEO		Scale: 1"=20'
Code: 419503-04		Figure No.: 14

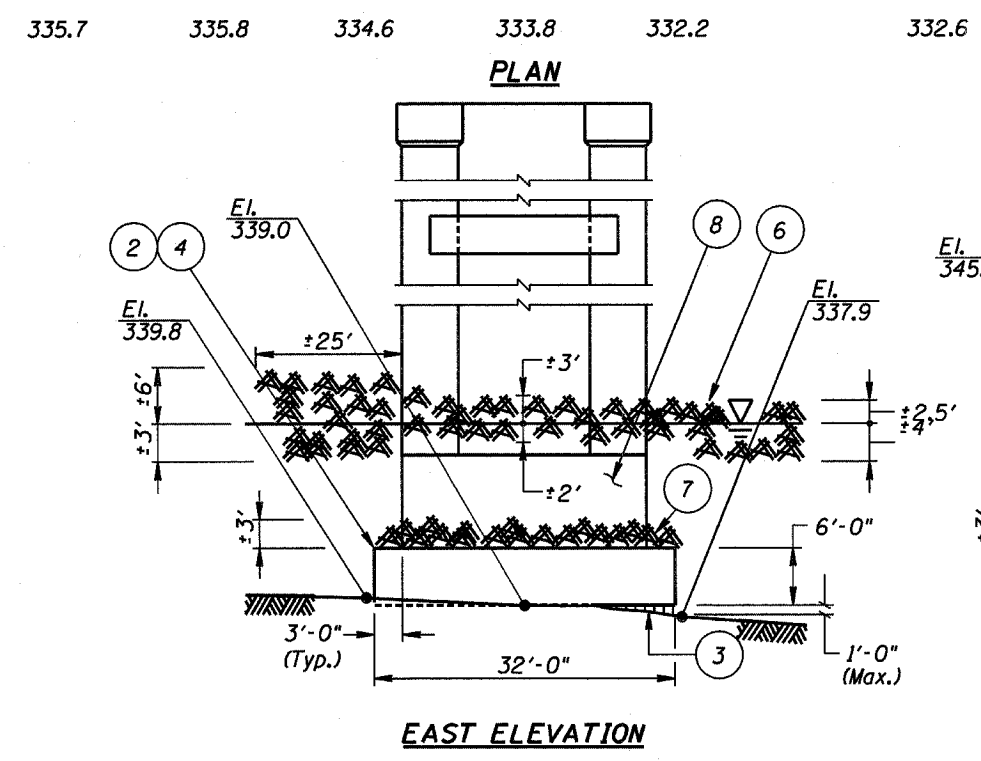
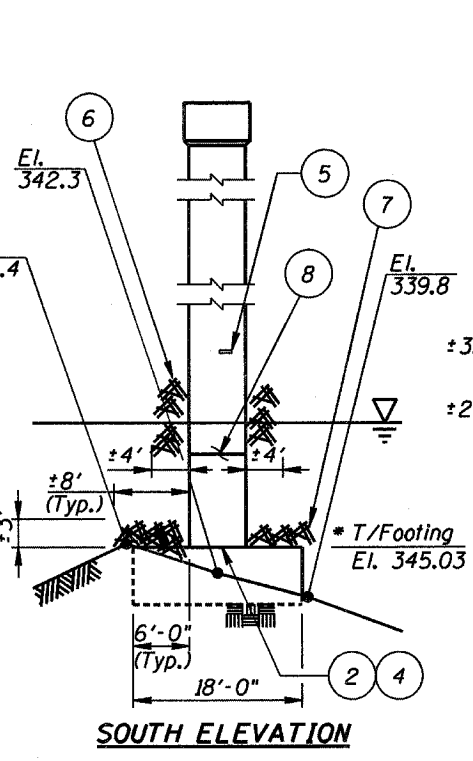
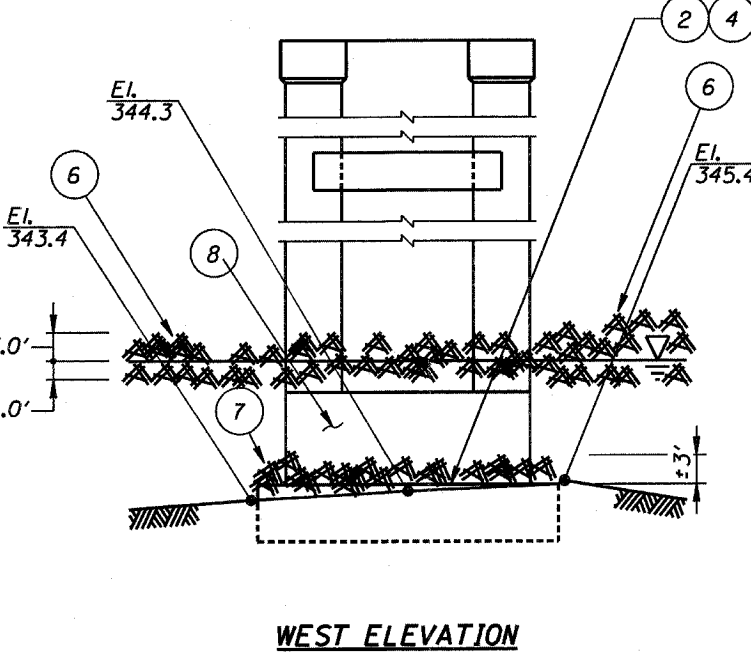
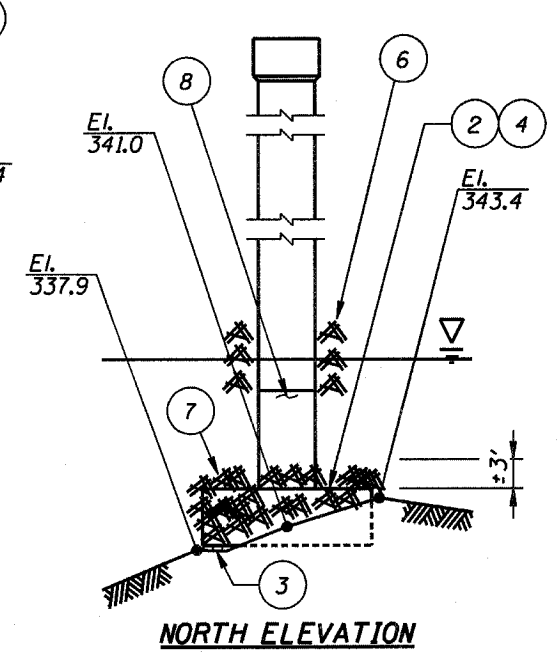
- ① The channel bottom material typically consisted of sandstone, which was fragmented along the upstream nose of the pier.
- ② Footing exposure, with vertical limits as shown.
- ③ Footing undermined, creating a 1-foot vertical cavity with up to 4 feet of penetration.
- ④ Timber formwork covered approximately 90 percent of the vertical concrete footing surface.
- ⑤ Minor area of concrete section loss located 6 feet above the waterline. The area measured 16 inches wide and 4 inches high, with up to 4 inches of penetration.
- ⑥ Heavy accumulation of timber debris, consisting of trees measuring up to 3 feet in diameter with associated branches.
- ⑦ Heavy accumulation of timber debris, consisting of trees measuring up to 1.5 feet in diameter with associated branches.
- ⑧ No damage below waterline.

1. At the time of the inspection, the waterline was located approximately 14.4 feet below the bottom of the pier beam at Eastbound Pier 3. This corresponds to a waterline elevation of 358.1 feet, based on the 1966 design plans.
2. Soundings indicate the channel bottom elevation at the time of inspection and are measured in feet.
