F.A.I. RTE.	SECTION	COUNTY	TOTAL SHEETS	SHEET NO.
64	97-3B-1-2	WHITE	15	8
STA.		TO STA.		
FED. ROAD DIST. NO.	ILLINOIS	FED. AID PROJECT

I-64 OVER
WABASH RIVER
STRUCTURE NUMBER: 097-0004
WESTBOUND PIER 3

Drawn By: PRH/DR	COLLINS ENGINEERS <small>123 North Wacker Drive Suite 300 Chicago, IL 60606 (312) 704-9300 www.collinsengr.com</small>	Date: JULY, 2005
Checked By: JEO		Scale: 1"=20'
Code: 419503-04		Figure No.: 15

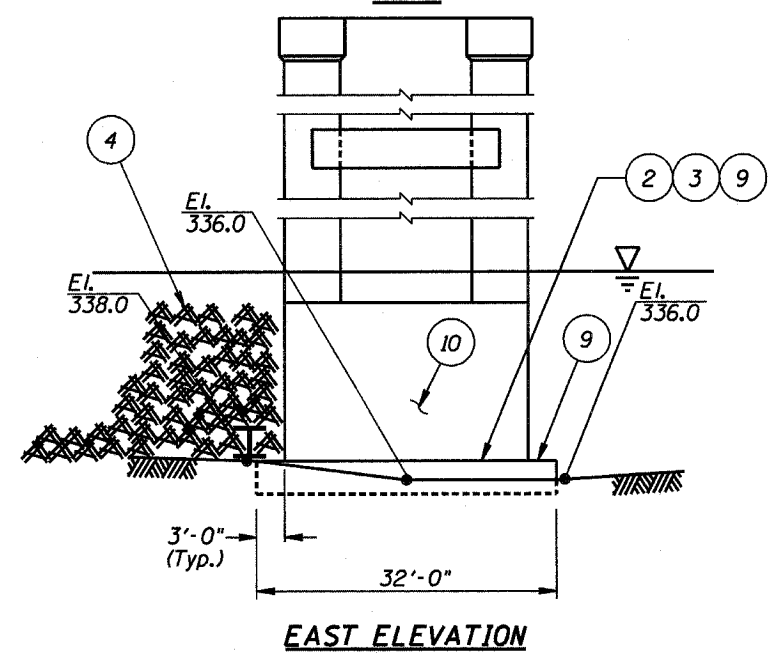
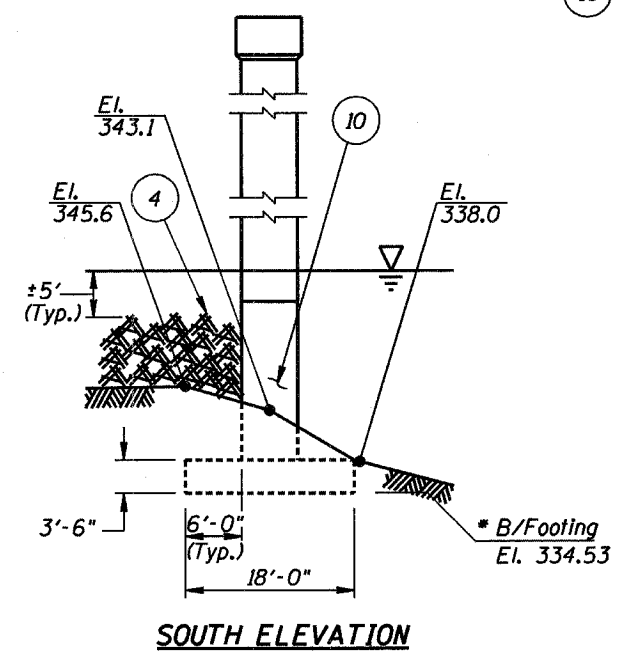
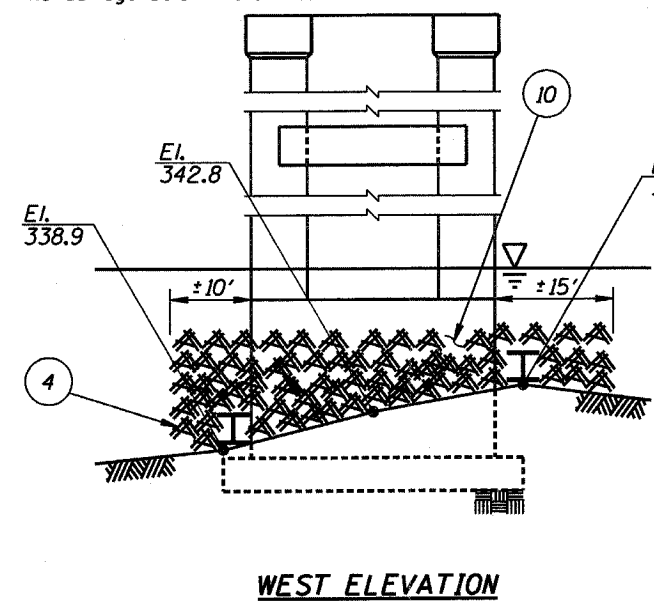
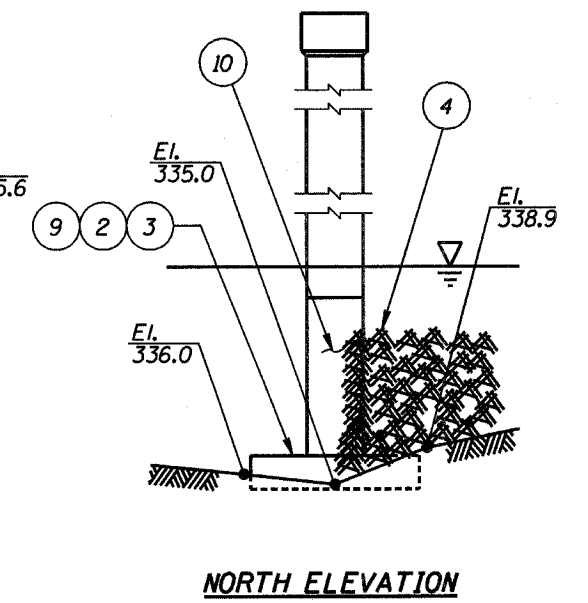
- Inspection Notes:**
- 1 The channel bottom material typically consisted of fragmented sandstone.
 - 2 Footing exposure, with vertical limits as shown. Due to heavy timber and steel debris accumulations, the footing could not be detected along the west fascia or western half of the upstream nose. In the area where the footing was exposed, no undermining was detected.

- 3 Timber formwork covered approximately 90 percent of the vertical concrete footing surface.
 - 4 Heavy accumulation of timber debris, consisting of trees measuring up to 3 feet in diameter and random railroad ties.

- 5 Steel debris, consisting of two steel beams connected by a gusset plate. The beams measured 15 feet and 20 feet in length, and were approximately 1 foot deep. Small circular ribs were noted along the steel beams, indicating riveted fasteners consistent with railroad truss construction. Due to the heavy accumulations of timber debris covering portions of these beams, exact measurements could not be obtained. While the locations of the observed beams were noted, additional steel debris may intermixed below the large drift accumulation.

- 6 Steel debris, consisting of two steel beams connected by a gusset plate. The beams measured 10 feet and 30 feet in length, and were approximately 2 feet deep. Small circular ribs were noted along the steel beams, indicating riveted fasteners consistent with railroad truss construction. Due to the heavy accumulations of timber debris covering portions of these beams, exact measurements could not be obtained. While the locations of the observed beams were noted, additional steel debris may intermixed below the large drift accumulation.

- 7 Steel debris, consisting of an 8-foot long steel beam measuring approximately 1 foot in depth.
 - 8 Steel debris, consisting of a 55-gallon drum located along the channel bottom.

- 9 No change in exposure condition from June 2005 inspection.
 - 10 No damage below waterline.
