**ILLINOIS  
DEPARTMENT OF TRANSPORTATION**

I-64 OVER  
WABASH RIVER  
STRUCTURE NUMBER: 097-0003  
**EASTBOUND PIER 4**

Drawn By: PRH/DR	<b>COLLINS ENGINEERS</b> <small>123 North Wacker Drive Suite 300 Chicago, IL 60606 (312) 704-9300 www.collinseng.com</small>	Date: JULY, 2005
Checked By: JEO		Scale: 1"=20'
Code: 419503-04		Figure No.: 16

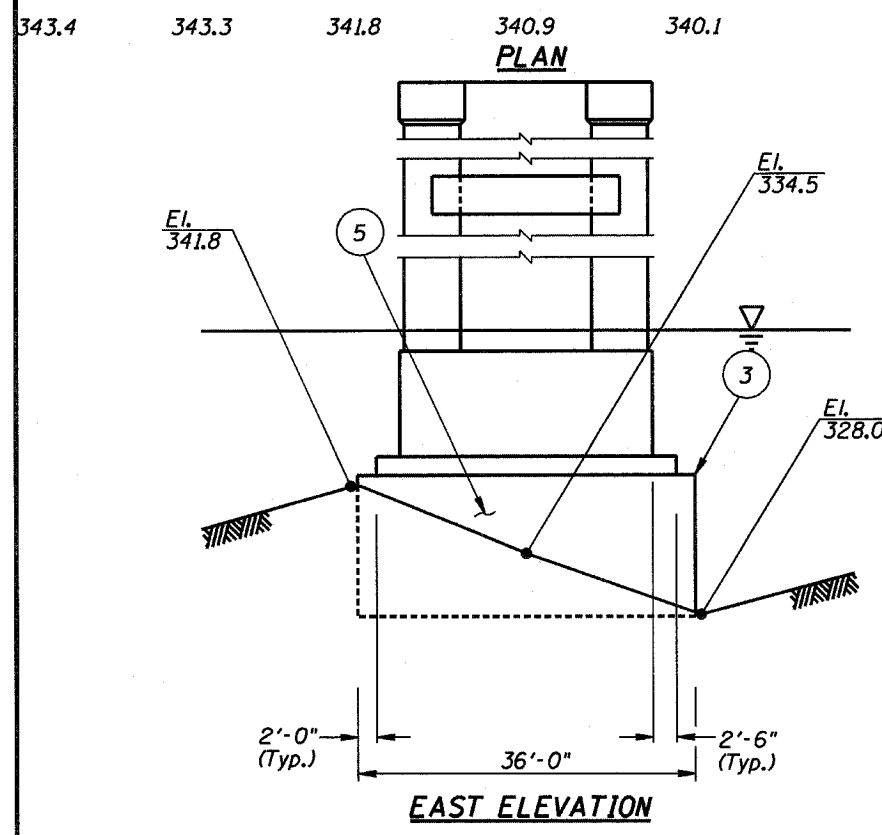
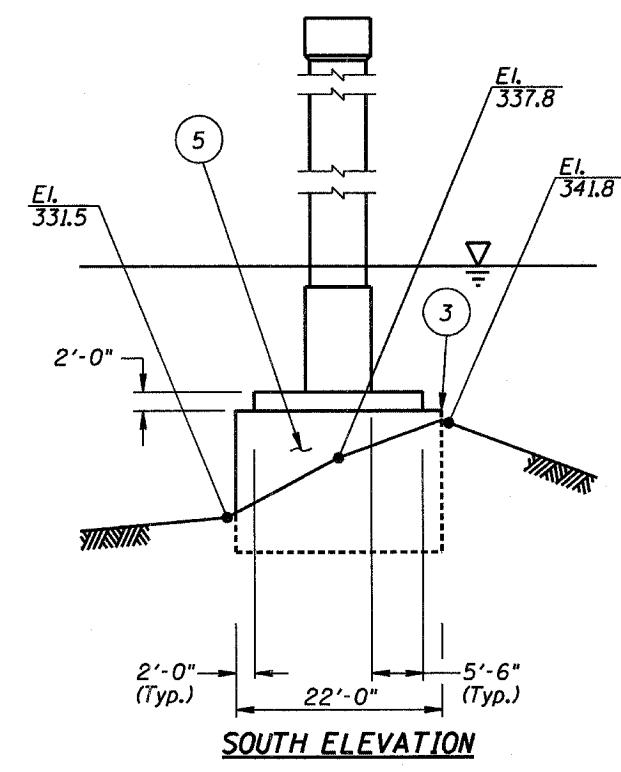
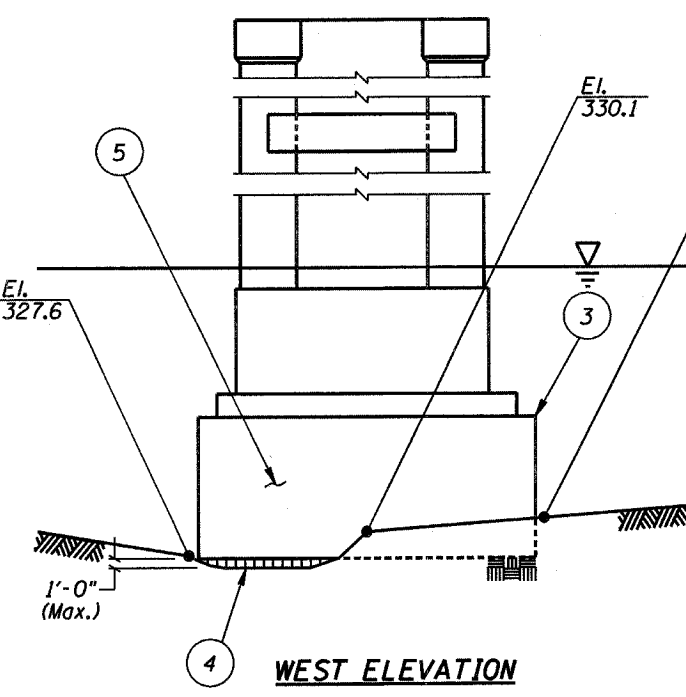
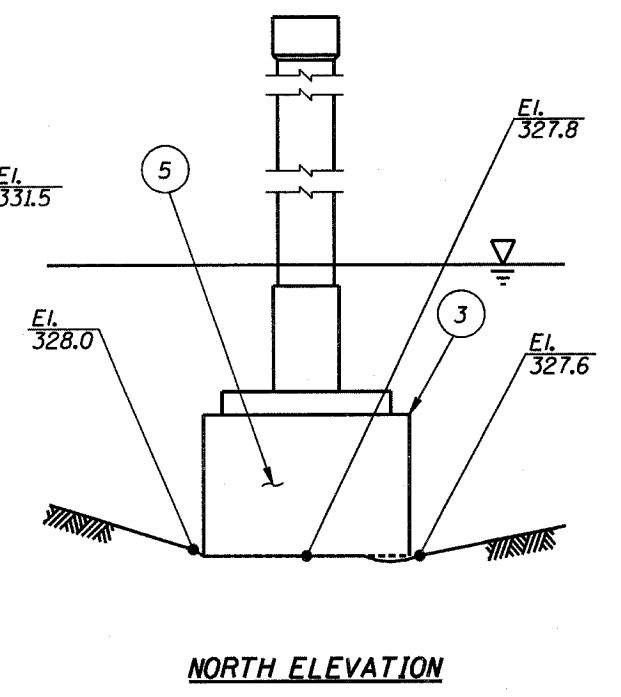
- 1 The channel bottom material typically consisted of fragmented sandstone.
- 2 The channel bottom material typically consisted of loose sand, with up to 1.5 feet of probe rod penetration.
- 3 Seal exposure, with vertical limits as shown.
- 4 Seal undermined, creating a 1-foot vertical cavity with up to 4 feet of penetration. The bottom concrete surface of the undermined seal was typically rough and loose.
- 5 No damage below waterline.

1. At the time of the inspection, the waterline was located approximately 14.4 feet below the bottom of the pier beam at Eastbound Pier 3. This corresponds to a waterline elevation of 358.1 feet, based on the 1966 design plans.
2. Soundings indicate the channel bottom elevation at the time of inspection and are measured in feet.
