F.A.I. RTE.	SECTION	COUNTY	TOTAL SHEETS	SHEET NO.
64	97-3B-I-2	WHITE	15	10
STA.		TO STA.		
FED. ROAD DIST. NO.		ILLINOIS	FED. AID PROJECT

<b>ILLINOIS DEPARTMENT OF TRANSPORTATION</b>		
I-64 OVER WABASH RIVER STRUCTURE NUMBER: 097-0004 <b>WESTBOUND PIER 4</b>		
Drawn By: PRH/DR	<b>COLLINS ENGINEERS</b> <small>123 North Wacker Drive Suite 300 Chicago, IL 60606 (312) 704-9300 www.collinsengr.com</small>	Date: JULY, 2005
Checked By: JEO		Scale: 1"=20'
Code: 419503-04		Figure No.: 17

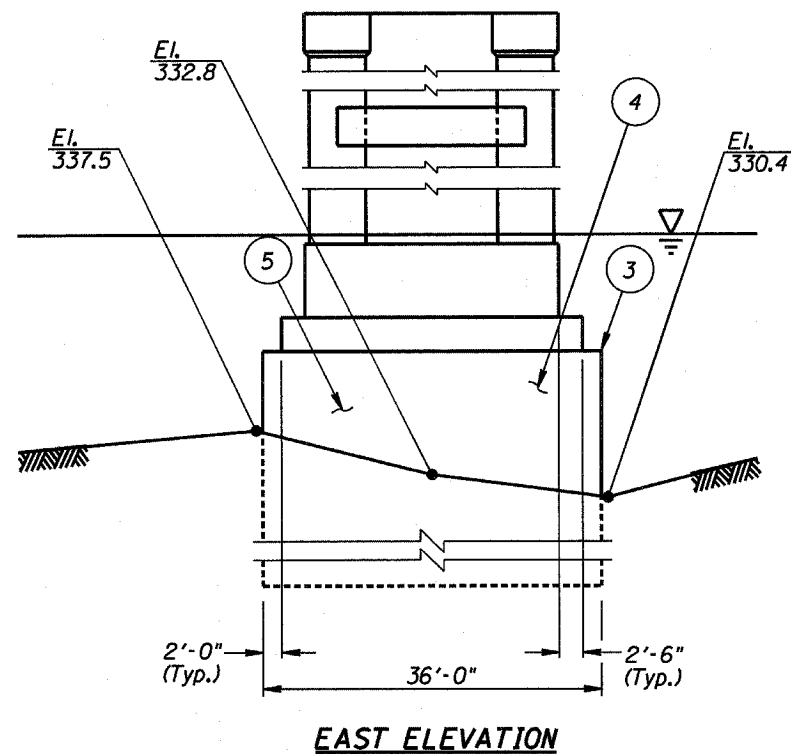
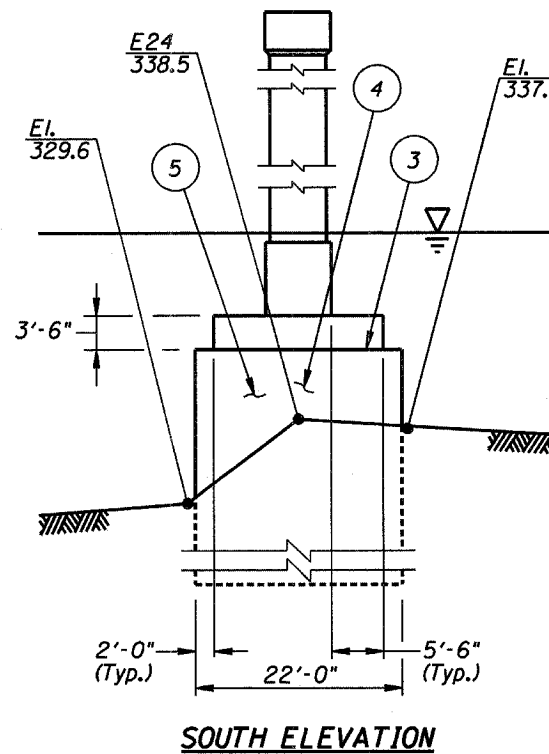
**WEST ELEVATION**

- ① The channel bottom material typically consisted of loose sand and gravel, with up to 2 feet of probe rod penetration.
- ② The channel bottom material typically consisted of loose gravel, with up to 1 foot of probe rod penetration.
- ③ Seal exposure, with vertical limits as shown. No seal undermining detected.
- ④ Band of heavy concrete scale around pier perimeter, measuring 8 inches wide, located 4 feet below the top of the seal. The scale had a typical penetration of 6 inches and a maximum penetration of 1 foot.
- ⑤ No damage below waterline.
