June 9 Inspection Notes:

**ILLINOIS  
DEPARTMENT OF TRANSPORTATION**

I-64 OVER  
WABASH RIVER  
STRUCTURE NUMBER: 097-0004  
**WESTBOUND PIER 5**

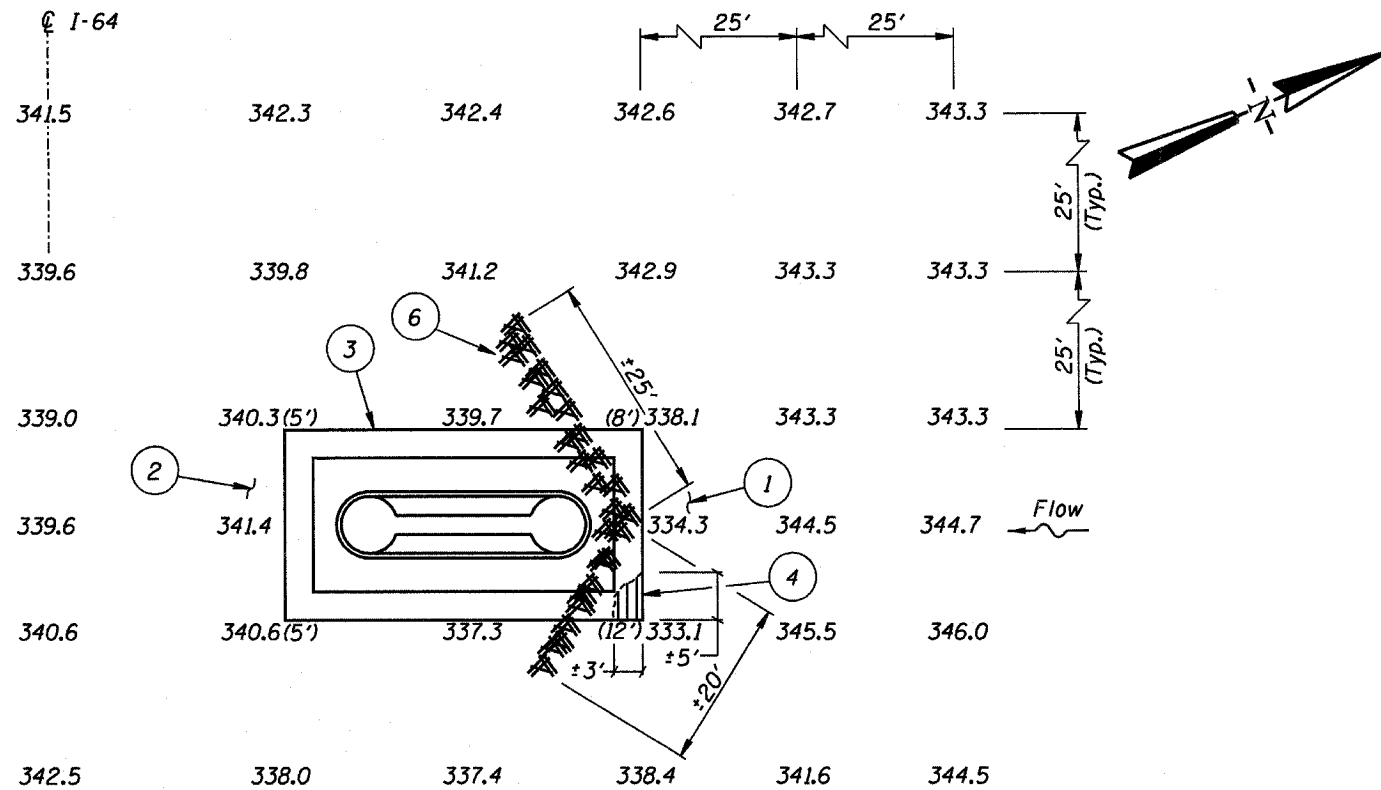
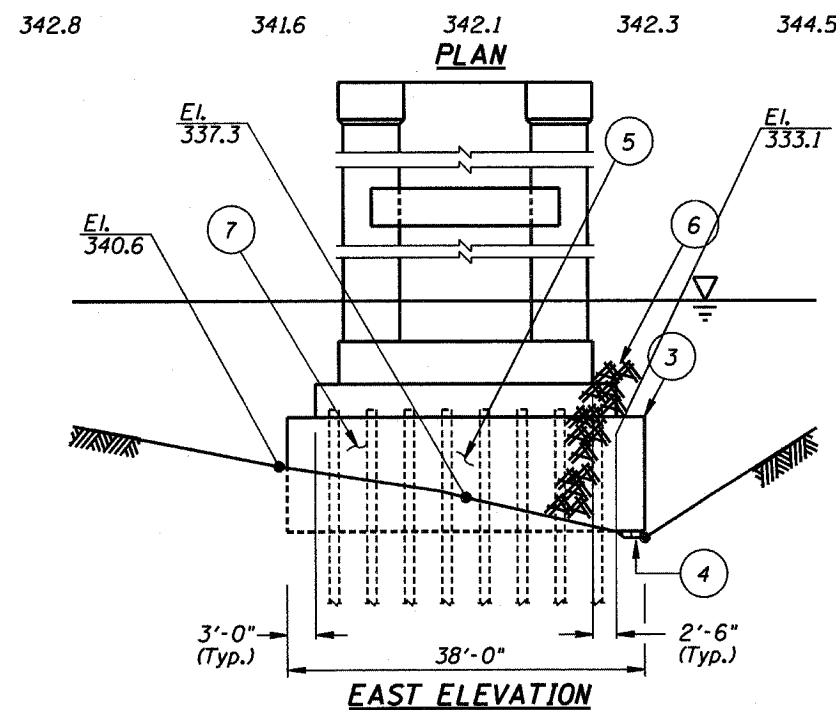
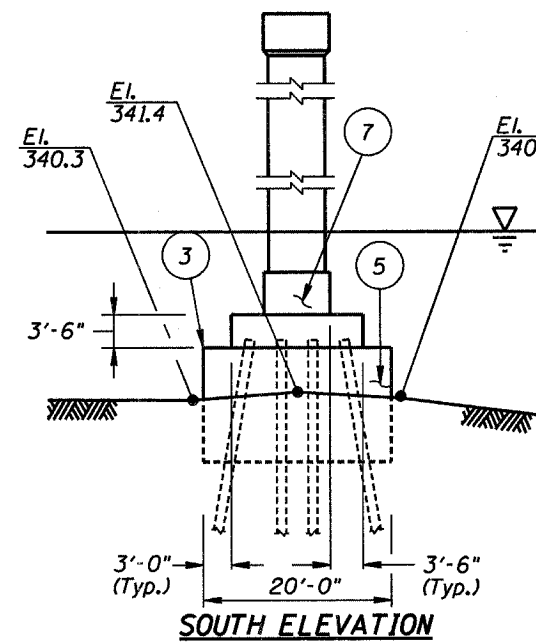
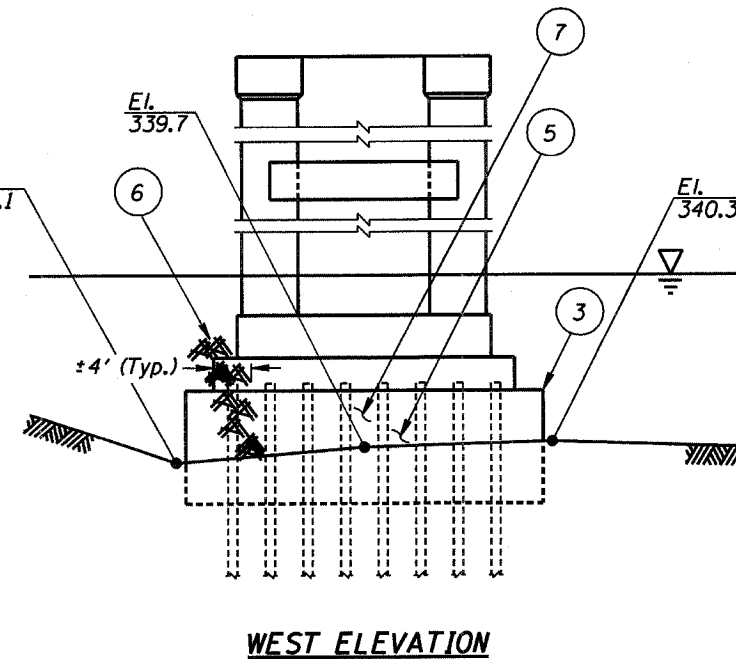
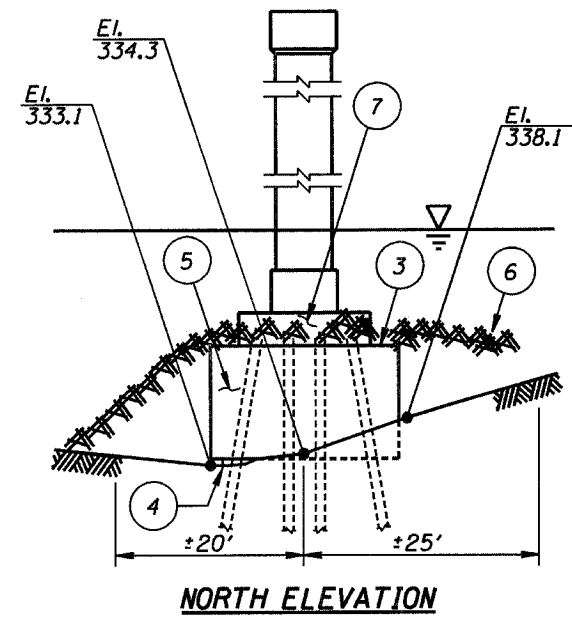
- ① The channel bottom material typically consisted of loose sand and gravel, with up to 1 foot of probe rod penetration.
- ② The channel bottom material typically consisted of loose sand and gravel, with up to 2 feet of probe rod penetration.
- ③ Seal exposure, with vertical limits as shown.
- ④ Seal undermined, creating a 1-foot vertical cavity with up to 4 feet of penetration. The bottom concrete surface of the undermined seal was typically rough and loose.
- ⑤ Band of heavy concrete scale around pier perimeter, measuring 8 inches wide, located 5 feet below the top of the seal. The scale had a typical penetration of 6 inches and a maximum penetration of 1 foot.
- ⑥ Moderate accumulation of timber debris, consisting of a tree measuring up to 3 feet in diameter with associated branches.
- ⑦ No damage below waterline.

1. At the time of the inspection, the waterline was located approximately 14.4 feet below the bottom of the pier beam at Eastbound Pier 3. This corresponds to a waterline elevation of 358.1 feet, based on the 1966 design plans.
2. Soundings indicate the channel bottom elevation at the time of inspection and are measured in feet.
