June 9 Inspection Notes:

ILLINOIS DEPARTMENT OF TRANSPORTATION		
I-64 OVER WABASH RIVER STRUCTURE NUMBER: 097-0004 WESTBOUND PIER 6		
Drawn By: PRH/DR	COLLINS ENGINEERS <small>123 North Wacker Drive Suite 300 Chicago, IL 60606 (312) 704-9300 www.collinsengr.com ILLINOIS PROFESSIONAL DESIGN FIRM LICENSE NO. 184-000993</small>	Date: JULY, 2005
Checked By: JEO		Scale: 1"=20'
Code: 419503-04		Figure No.: 21

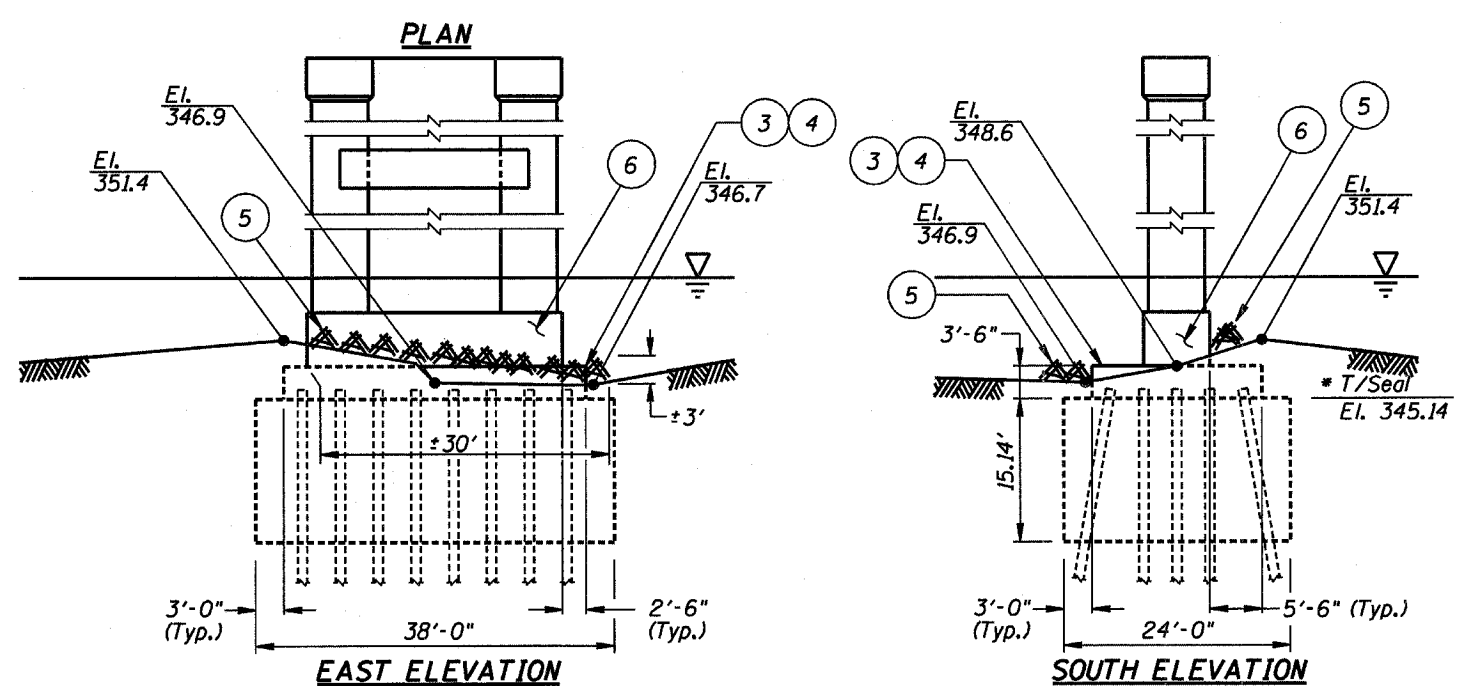
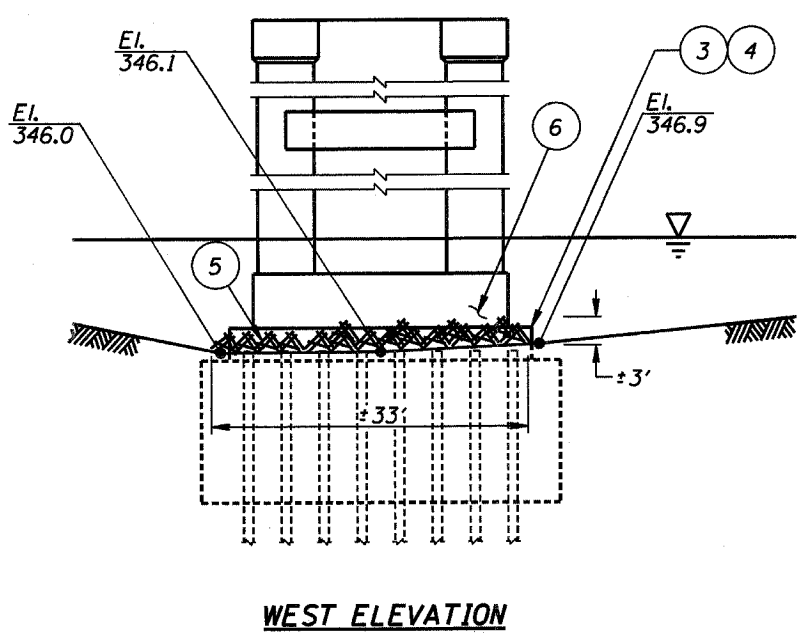
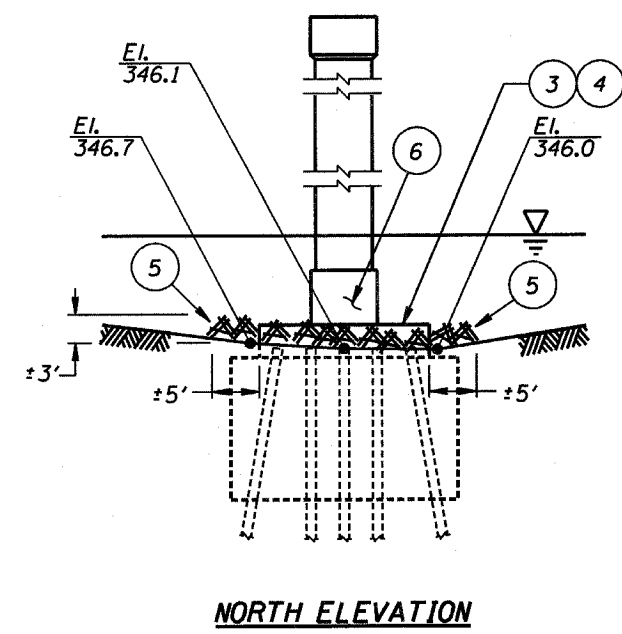
- ① The channel bottom material typically consisted of loose sandy silt, with up to 1.5 feet of probe rod penetration.
- ② The channel bottom material typically consisted of soft silt, with up to 3 feet of probe rod penetration.
- ③ Footing exposure, with vertical limits as shown. In the area where the footing was exposed, no undermining was detected.
- ④ Timber formwork covered approximately 90 percent of the vertical concrete footing surface.
- ⑤ Heavy accumulation of timber debris, consisting of trees measuring up to 2 feet in diameter with associated branches.
- ⑥ No damage below waterline.
