## DRAINAGE STRUCTURE IMPROVEMENT DETAIL LOCATION #1 STA. 789 + 00

STATE OI	ILLINOIS
DEPARTMENT OF	TRANSPORTATION

F.A.I. RTE.	SECTION	COUNTY	TOTAL SHEETS	SHEET NO.	
					74	(57-20(1),21,22)RS-3	McLean	150	51	
LOUNTION #1 OIA. 705 T 00								CONTRACT	NO. 7	0550
	SHEET NO.	OF	SHEETS	STA.	TO STA.		TILLINOIS FED. AID PROJECT

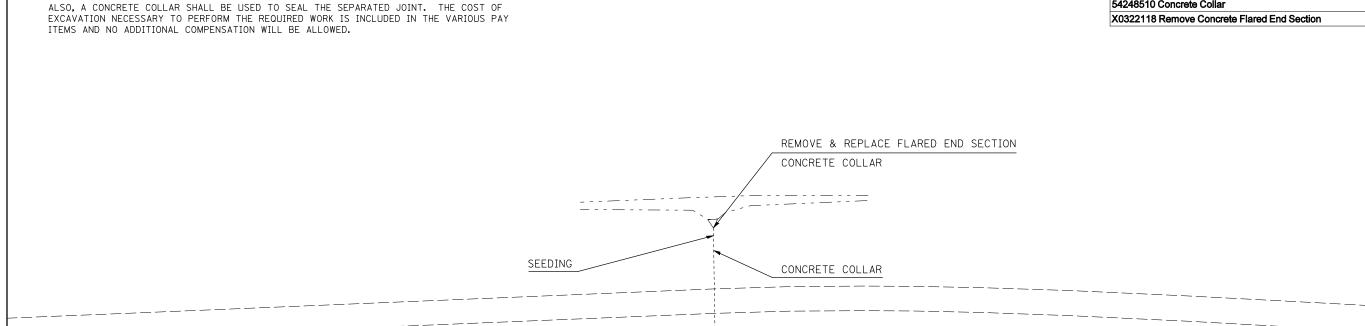
THE EXISTING STRUCTURE AT STATION 789+00 LT. CONSISTS OF A 24" R.C.C.P. WITH A MEDIAN INLET AND A PRECAST DOWNSTREAM END SECTION. THE STRUCTURE IS IN GOOD CONDITION BUT HAS THE FOLLOWING DEFICIENCIES. WHILE THE JOINT BETWEEN THE DOWNSTREAM END SECTION AND THE FIRST SECTION OF PIPE IS INTACT, THE NEXT JOINT UPSTREAM HAS SEPARATED ALLOWING SOIL TO ENTER THE STRUCTURE AND IS CAUSING A SINKHOLE IN THE FORESLOPE. ALSO, THE DOWNSTREAM END SECTION IS BROKEN.

THE PROPOSED SCOPE OF WORK IS TO REPLACE THE DOWNSTREAM END SECTION WITH A NEW PRECAST END SECTION. THE EXISTING SAFETY GRATE SHALL BE REUSED. A CONCRETE COLLAR SHALL BE USED TO CONNECT THE PROPOSED END SECTION TO THE STRUCTURE. ALSO, A CONCRETE COLLAR SHALL BE USED TO SEAL THE SEPARATED JOINT. THE COST OF EXCAVATION NECESSARY TO PERFORM THE REQUIRED WORK IS INCLUDED IN THE VARIOUS PAY ITEMS AND NO ADDITIONAL COMPENSATION WILL BE ALLOWED.
