# DRAINAGE STRUCTURE IMPROVEMENT DETAIL

## LOCATION #5 STA. 847 + 44

**STATE OF ILLINOIS**  
**DEPARTMENT OF TRANSPORTATION**

| F.A.I. RTE. | SECTION | COUNTY | TOTAL SHEETS | SHEET NO. |
|---|---|---|---|---|
| 74 | (57-20(1),21,22)RS-3 | McLean | 150 | 55 |

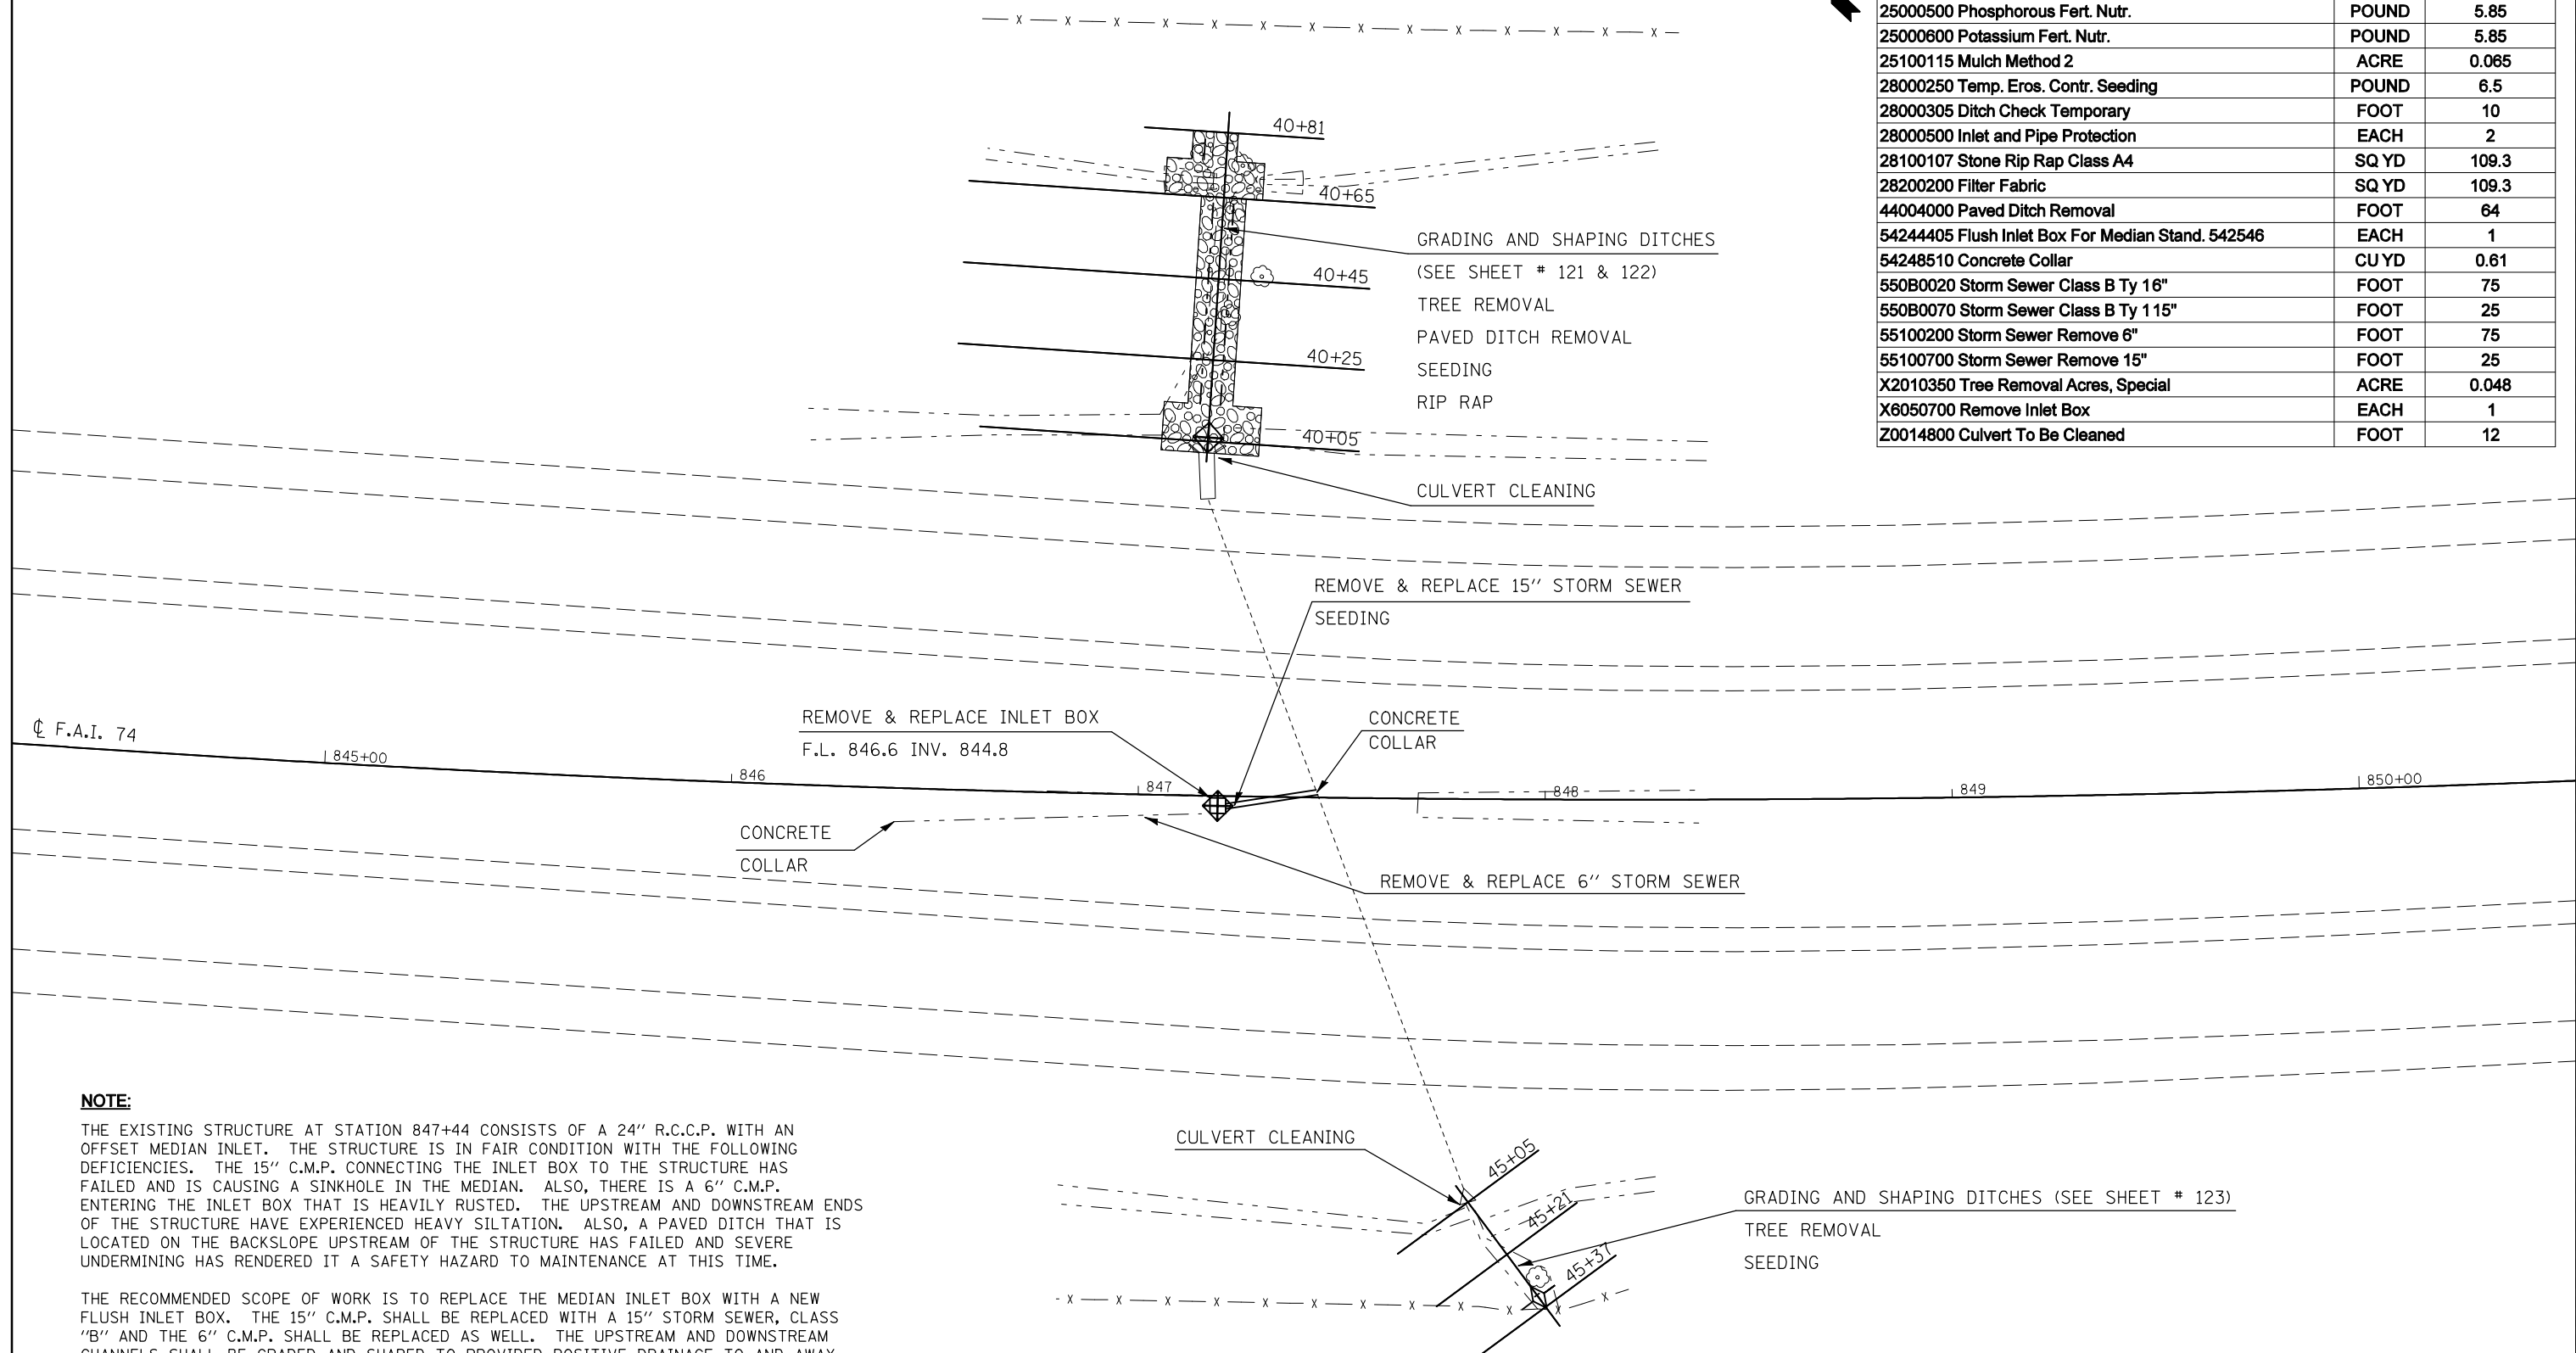
LOC. #5 STA.847+44

THE EXISTING STRUCTURE AT STATION 847+44 CONSISTS OF A 24" R.C.C.P. WITH AN OFFSET MEDIAN INLET. THE STRUCTURE IS IN FAIR CONDITION WITH THE FOLLOWING DEFICIENCIES. THE 15" C.M.P. CONNECTING THE INLET BOX TO THE STRUCTURE HAS FAILED AND IS CAUSING A SINKHOLE IN THE MEDIAN. ALSO, THERE IS A 6" C.M.P. ENTERING THE INLET BOX THAT IS HEAVILY RUSTED. THE UPSTREAM AND DOWNSTREAM ENDS OF THE STRUCTURE HAVE EXPERIENCED HEAVY SILTATION. ALSO, A PAVED DITCH THAT IS LOCATED ON THE BACKSLOPE UPSTREAM OF THE STRUCTURE HAS FAILED AND SEVERE UNDERMINING HAS RENDERED IT A SAFETY HAZARD TO MAINTENANCE AT THIS TIME.

THE RECOMMENDED SCOPE OF WORK IS TO REPLACE THE MEDIAN INLET BOX WITH A NEW FLUSH INLET BOX. THE 15" C.M.P. SHALL BE REPLACED WITH A 15" STORM SEWER, CLASS "B" AND THE 6" C.M.P. SHALL BE REPLACED AS WELL. THE UPSTREAM AND DOWNSTREAM CHANNELS SHALL BE GRADED AND SHAPED TO PROVIDED POSITIVE DRAINAGE TO AND AWAY FROM THE STRUCTURE, AND THE PAVED DITCH SHALL BE REMOVED AND REPLACED WITH A RIPRAP DITCH. TREES SHALL BE REMOVED AT EACH END OF THE STRUCTURE. FINALLY, THE CULVERT SHALL BE CLEANED OUT TO REMOVE SILTATION FROM BOTH ENDS.
