STATE OF ILLINOIS
DEPARTMENT OF TRANSPORTATION

REPAIR DETAILS
SN 016-0545

SHEET NO. 2 OF 2 SHEETS

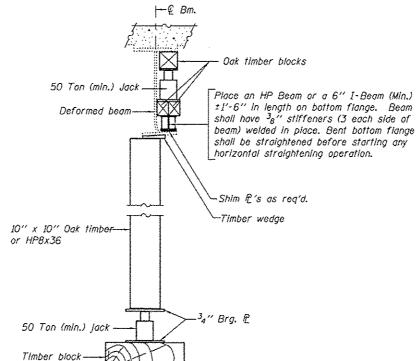
SUGGESTED VERTICAL STRAIGHTENING DETAIL

(To correct flange rotation.)

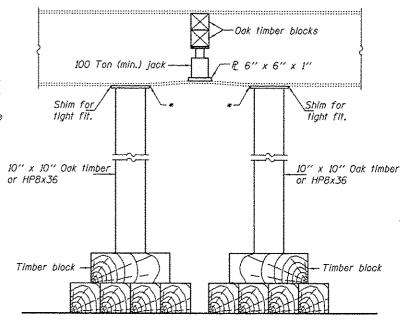
SUGGESTED VERTICAL STRAIGHTENING DETAIL

(To correct localized vertical flange deformations.)

* Edge of plate shall line up with edge of deformation.

Braces and jack assembly shall be placed on same side of web. Bent bottom flange shall be straightened before starting any horizontal straightening operations.
