STATE OF ILLINOIS  
 DEPARTMENT OF TRANSPORTATION

REPAIR DETAILS  
 SN 049-0050

F.A.U. RTE. 1225	SECTION 2012-0258R	COUNTY LAKE	TOTAL SHEETS 21	SHEET NO. 10
				CONTRACT NO. 60T66
ILLINOIS FED. AID PROJECT

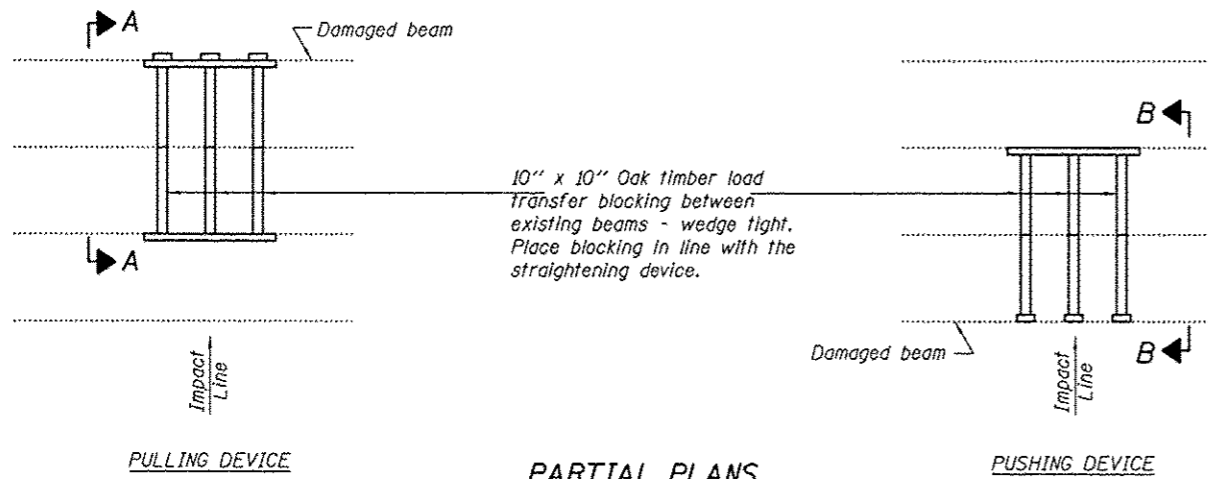
**PARTIAL PLANS**  
**SUGGESTED BEAM STRAIGHTENING METHODS**  
 Straightening force shall be maintained on all load transfer blocking during beam straightening.

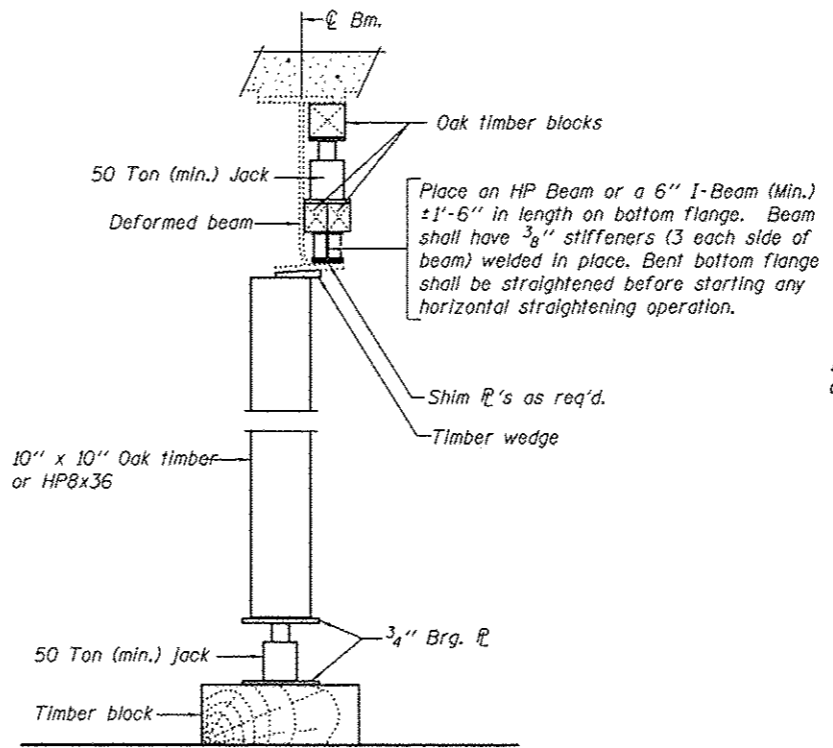
**SUGGESTED VERTICAL STRAIGHTENING DETAIL**  
 (To correct flange rotation.)

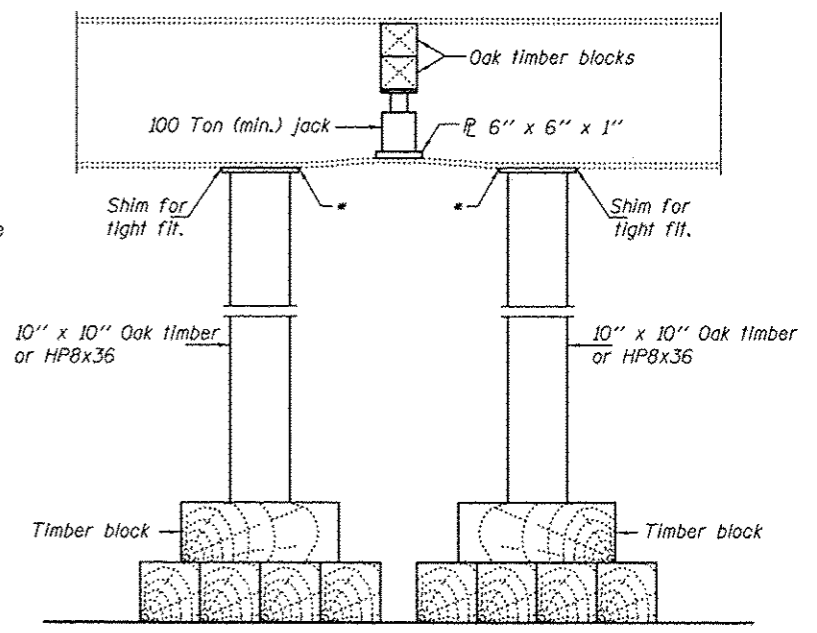
**SUGGESTED VERTICAL STRAIGHTENING DETAIL**  
 (To correct localized vertical flange deformations.)

\* Edge of plate shall line up with edge of deformation.  
 Note:  
 Braces and jack assembly shall be placed on same side of web.  
 Bent bottom flange shall be straightened before starting any horizontal straightening operations.

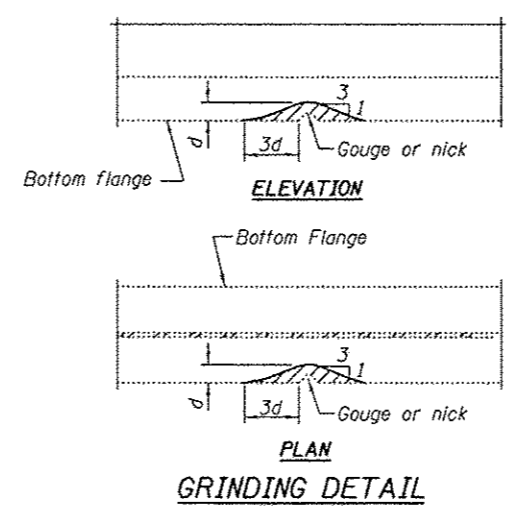
**GRINDING DETAIL**

Grind existing nicks, gouges and shallow cracks in the damaged beams as detailed. Ground surfaces shall be inspected for cracks using magnetic particle testing prior to initiating any beam straightening operations. Any cracks that cannot be removed by grinding approximately 1/4\"/>
