STATE OF ILLINOIS  
DEPARTMENT OF TRANSPORTATION

PHOTOSHEET 4 OF 5

LONGHOLLOW SCENIC OVERLOOK REST AREA  
TOWER REPAIRS  
FAP RT. 301 (U.S. RT. 20), SECTION 28-SO-M-1  
JODAVIESS COUNTY

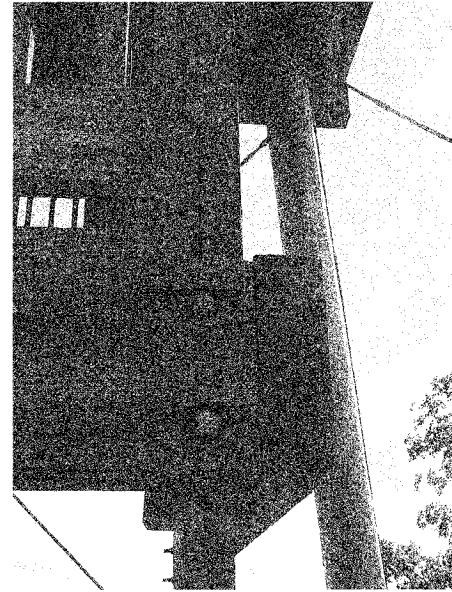
Photo 19 - Vertical Crack at the Middle of the Hanger Section to some distance away from the Support.

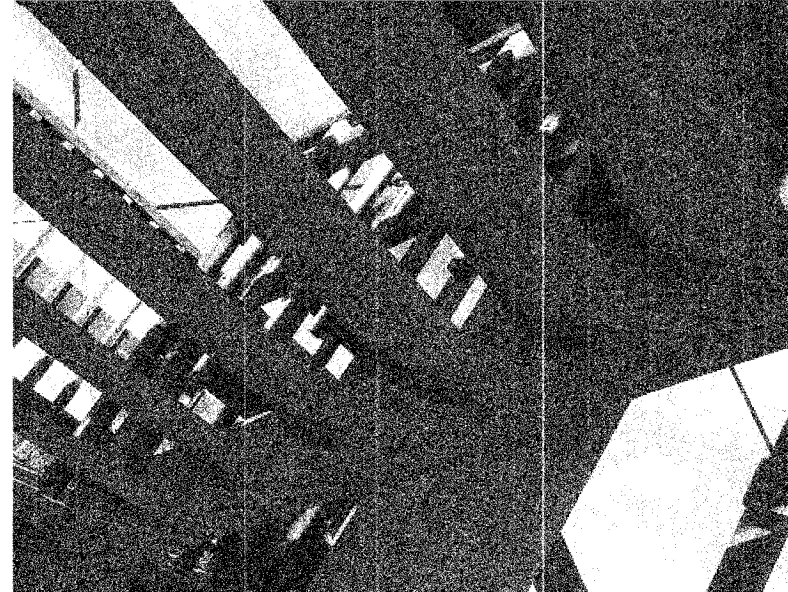
Photo 21 - Stair Stringer (Typical)

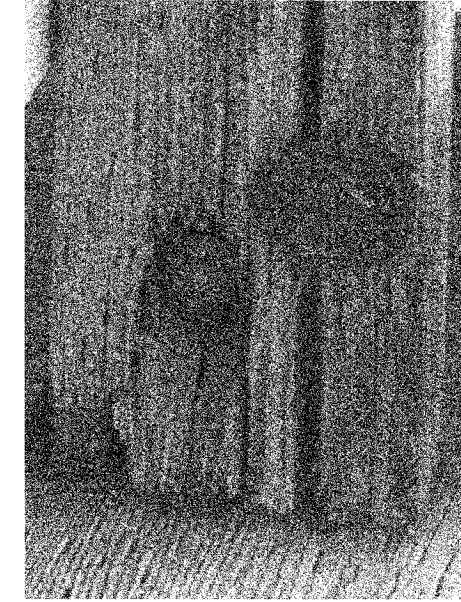
Photo 23 - Deteriorated member-to-member end connection with missing washers.

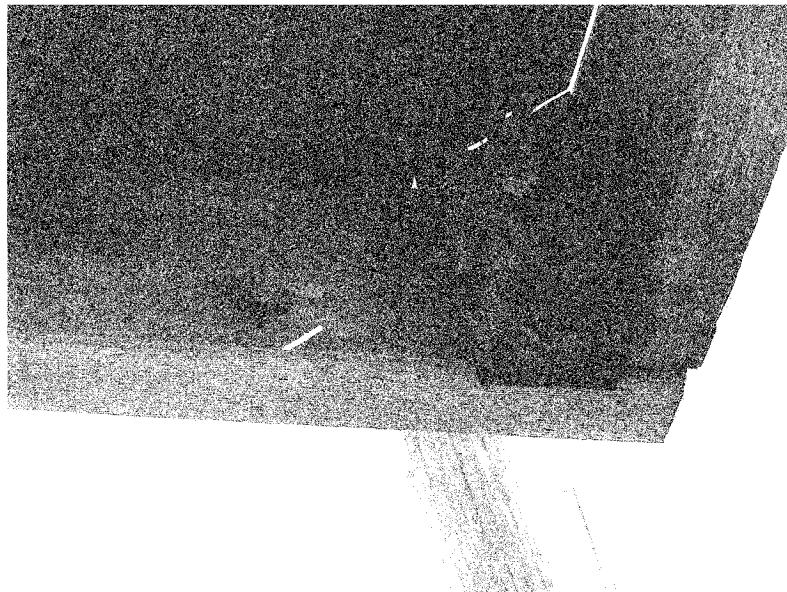
Photo 20 - Hanger Detail Connection at landing showing split wood and Rusted Washers.

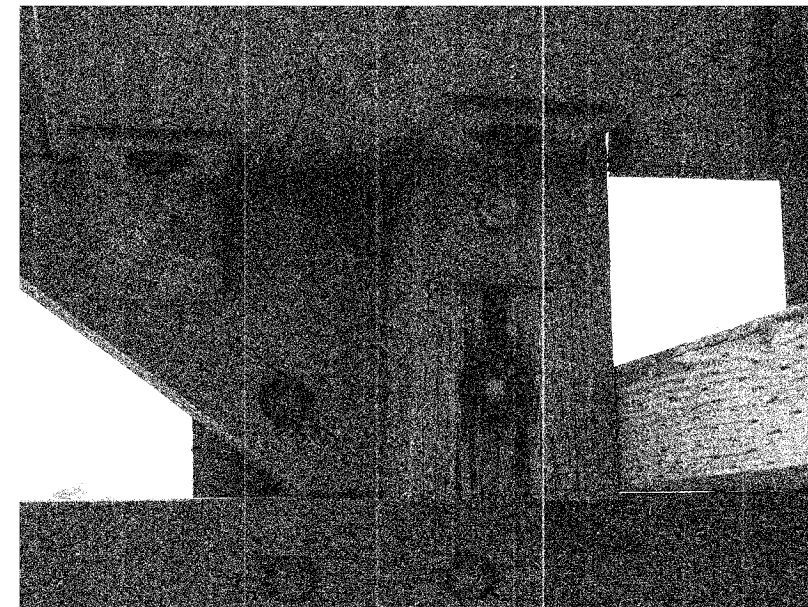
Photo 22 - Stair Railing Posts with cracks at Connection location (Typical)

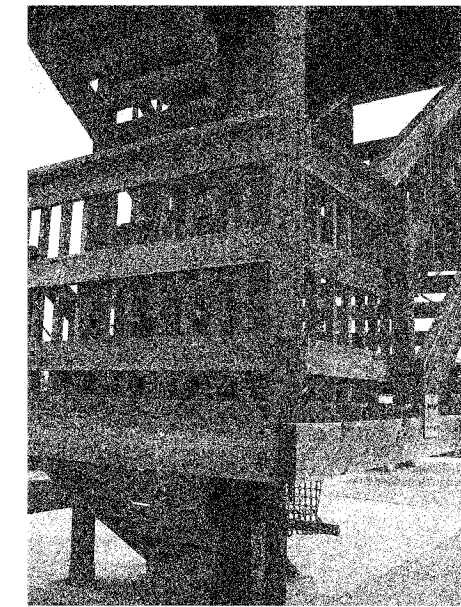
Photo 24 - Deterioration in Member-to-Member Connection with missing Washers.
