**PLANS FOR REPAIRS TO  
THE LONGHOLLOW SCENIC  
OVERLOOK REST AREA TOWER**  
LOCATED ALONG US 20, 1 MILE WEST OF IL 84 (S)

**FAP 301 (U.S. 20)  
SECTION 28-S0-M-1  
JODAVIESS COUNTY  
D-92-036-07 / C-92-039-07**

**LONGHOLLOW SCENIC  
OVERLOOK TOWER REPAIR**

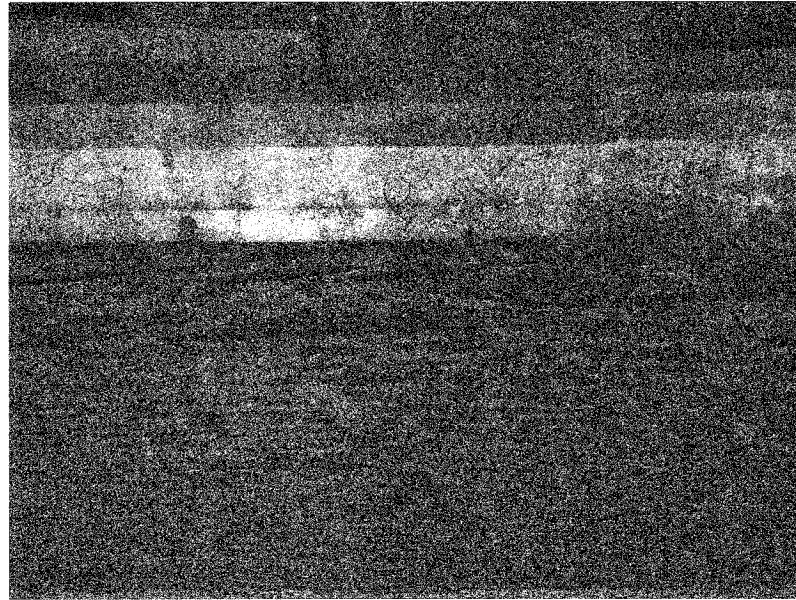
Photo 01- (Roof) Horizontal Crack in 8"x14" Main Supporting Beam

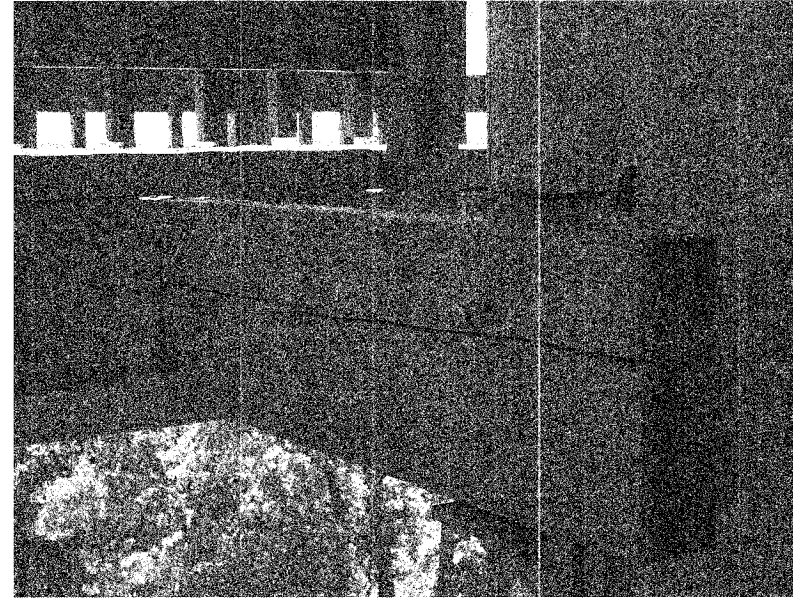
Photo 03- (Third Level) 4"x12" Beam at North of Center Pole Showing Horizontal Cracks at Mid Depth for the Full Length

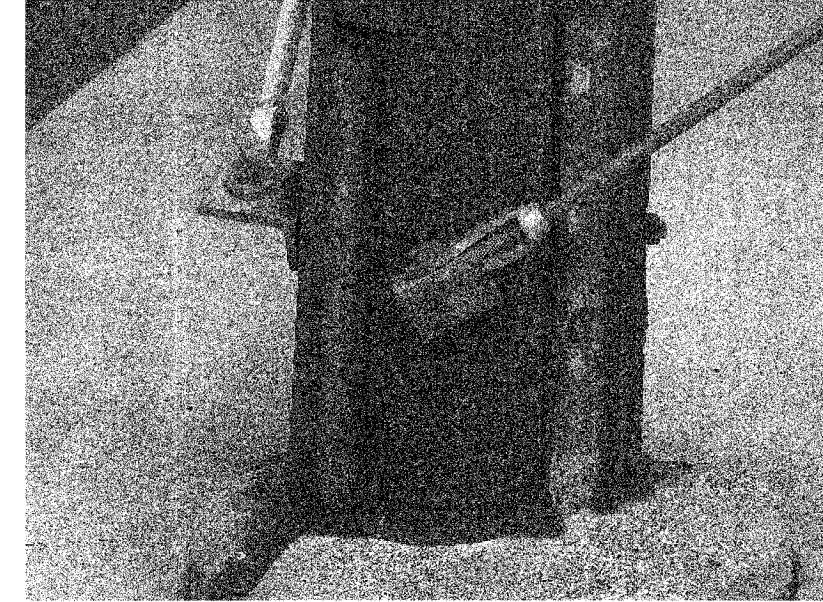
Photo 05- Wood Treatment leaching out of the Tower Structure and accumulating at Pole Base.

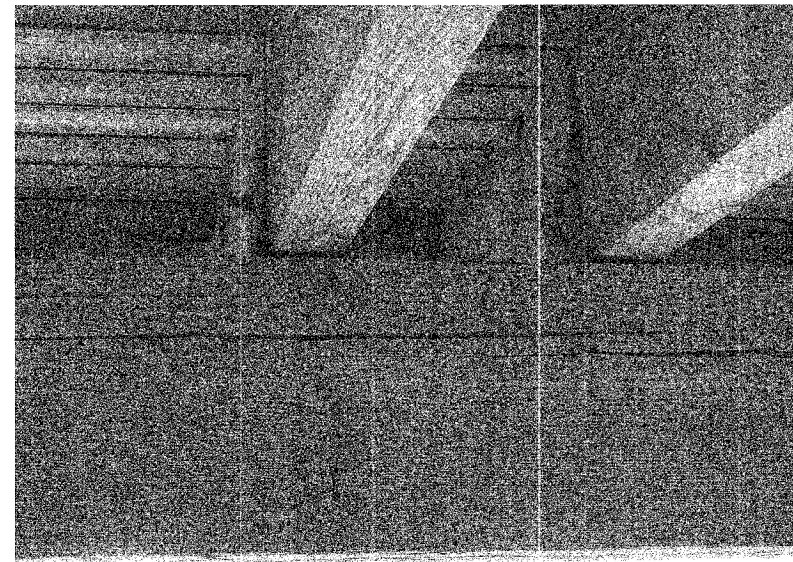
Photo 04- (Third Level) 8"x12" Beam at East and West Side showing Horizontal Cracks at Mid Depth for the Full Length

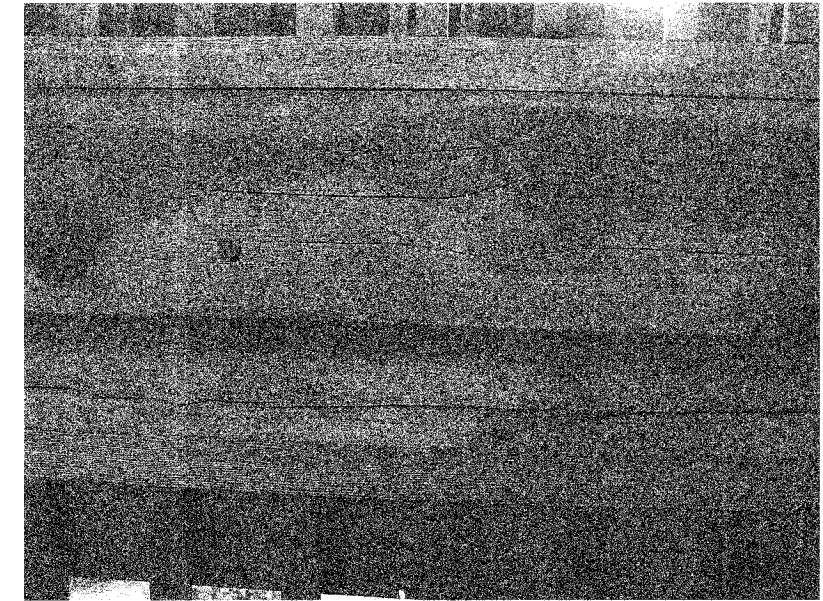
Photo 06- (Third Level) 8"x12" Beam at West side showing Horizontal Cracks at Mid Depth for the Full Length.

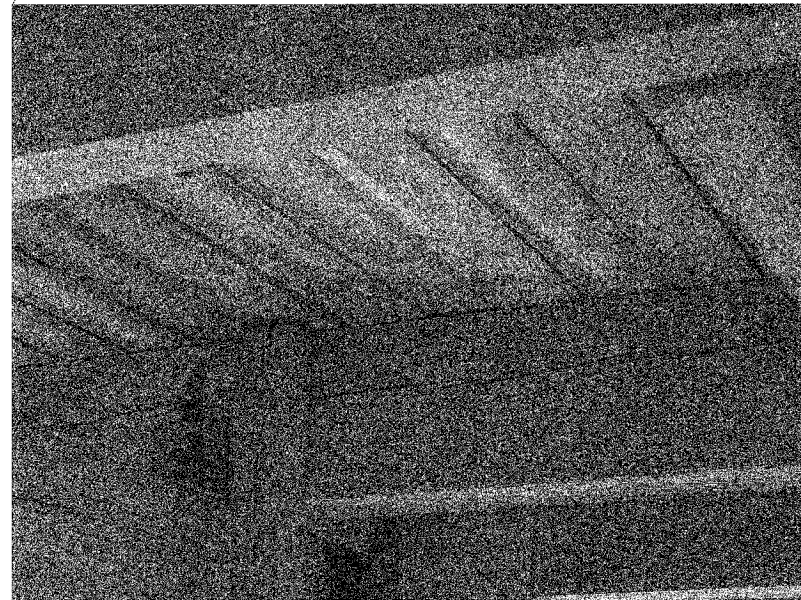
Photo 07 - (Third Level) 8"x12" Beam at South Side showing Horizontal Cracks at Mid Depth for the Full Length.

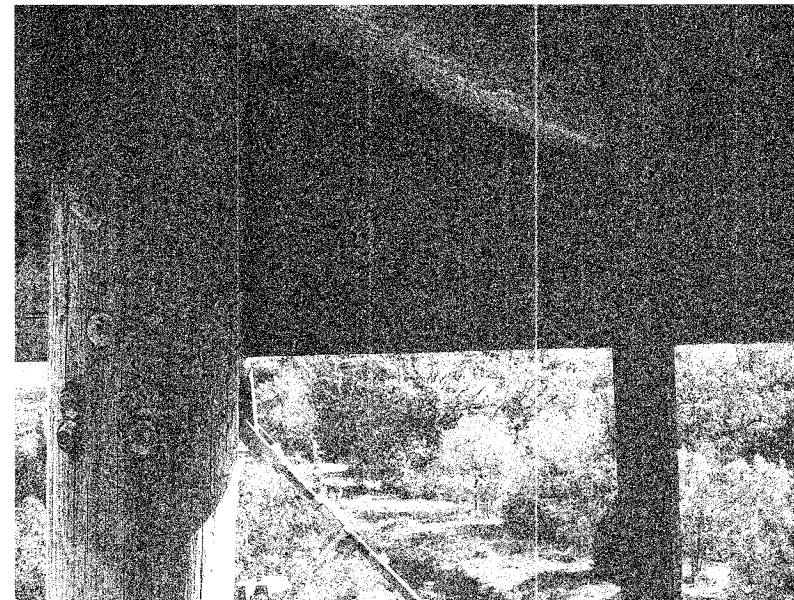
Photo 09- (Second Level) 8"x16" Beam at East Side showing Horizontal cracks at Mid Depth for the Full Length

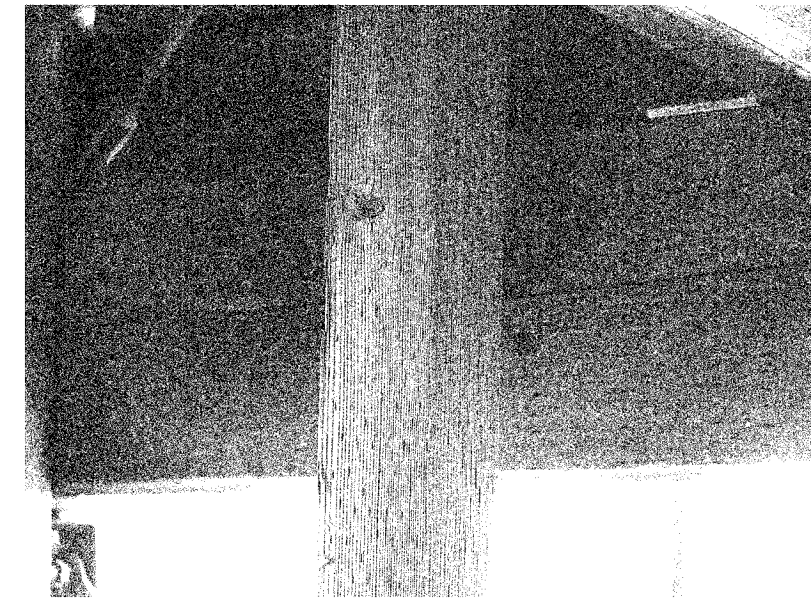
Photo 11 - (Second Level) 8" x 16" Beam at East Side Showing Horizontal Cracks at Mid Depth for the Full Length

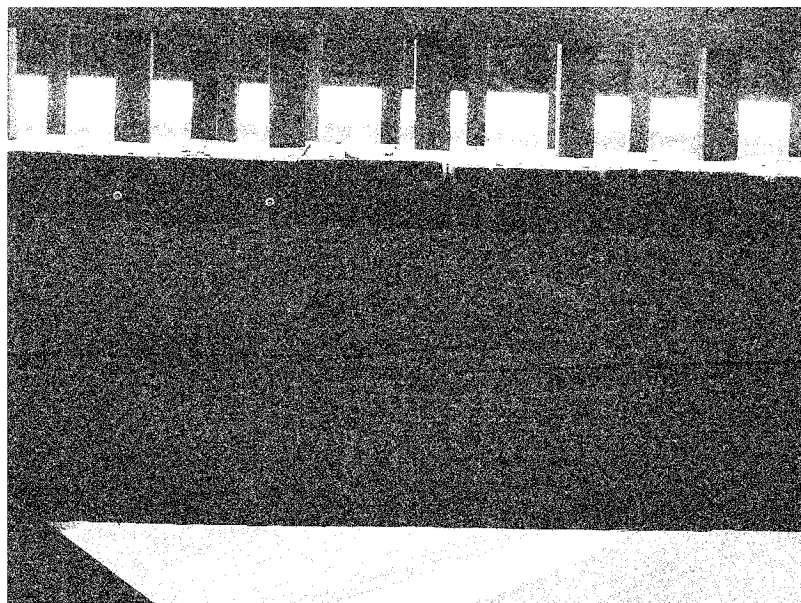
Photo 08- (Third Level) 8" x 12" Beam at South side Showing Horizontal Cracks at Mid Depth for the Full Length.

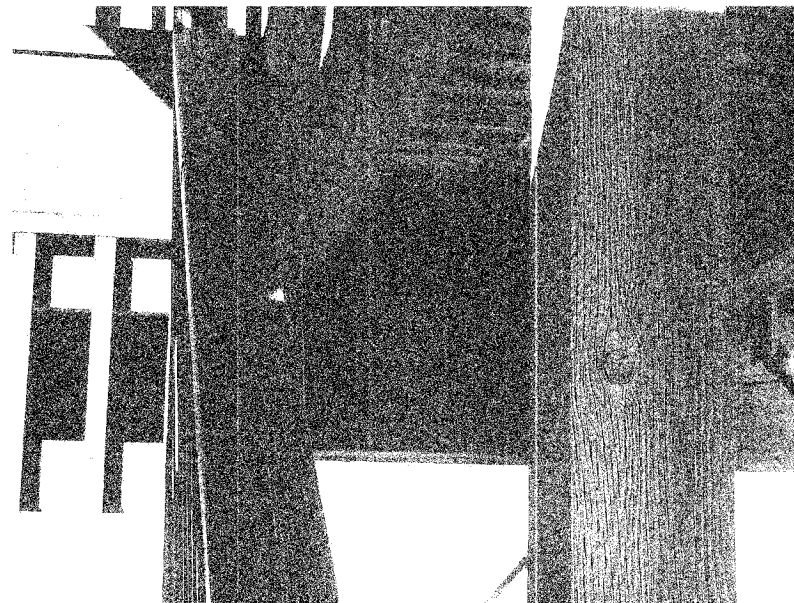
Photo 10 - (Second Level) 8"x16" Beam at East and West Side showing Horizontal Cracks at Mid Depth for the Full Length

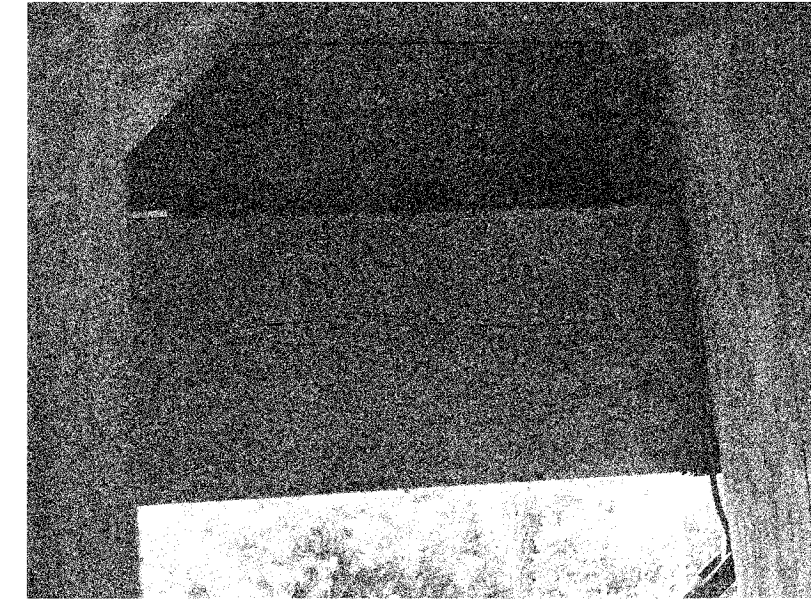
Photo 12 - (Second Level) 8"x16" Beam at West side showing Horizontal Craks at Mid Depth for the Full Length.

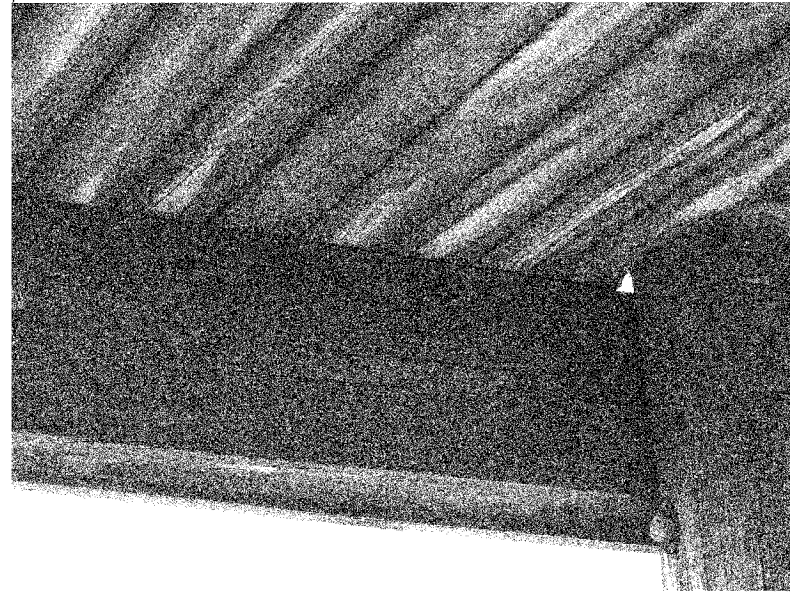
Photo 13 - (First Level) 8"x14" Edge Beam at North Side showing Horizontal Cracks at Mid Depth for the Full Length.

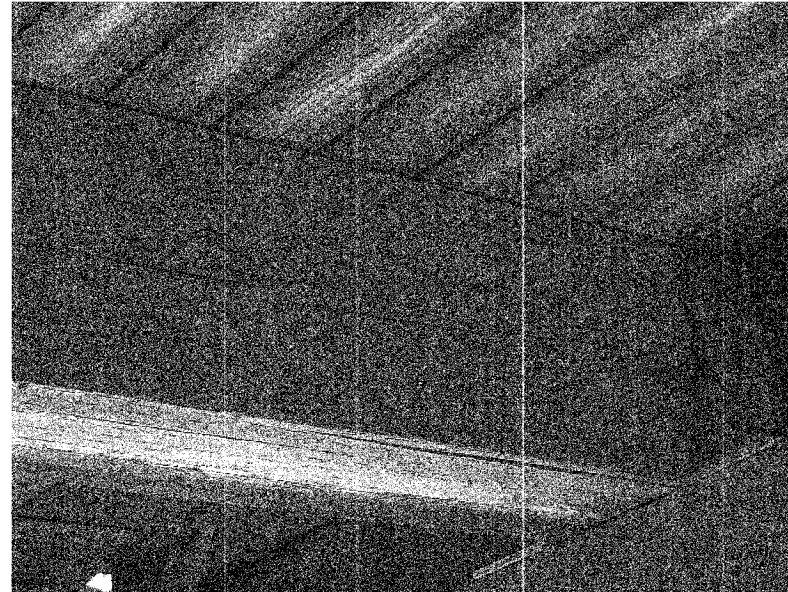
Photo 15 - (First Level) 10"x14" Intermediate Floor Beam at North Interior edges showing Horizontal cracks at Mid Depth for the Full Length

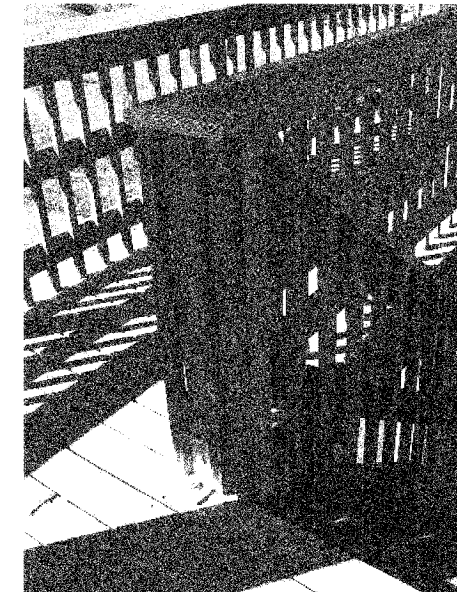
Photo 17 - Loose Railing End Posts (Typical)

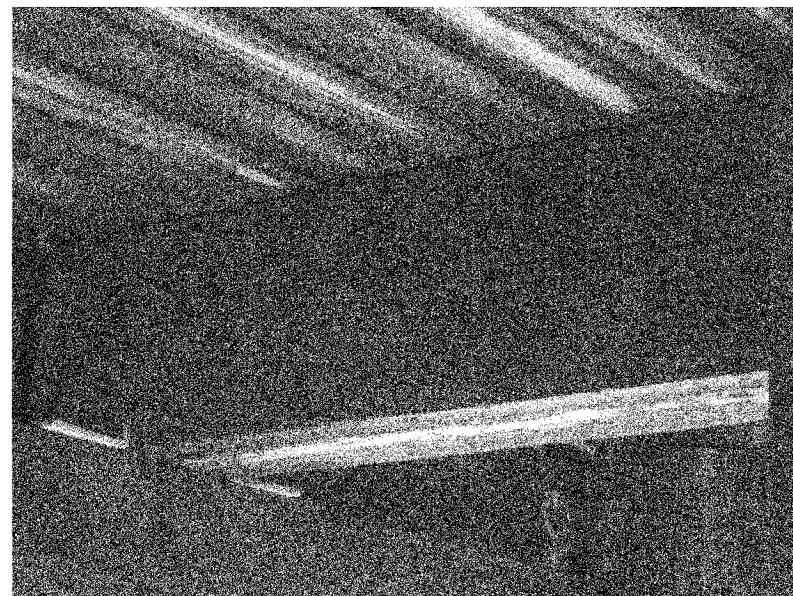
Photo 14 - (First Level) 10" x 14" Intermediate Floor Beam at South Interior edges of landing showing Horizontal cracks at Mid Depth for the Full Length.

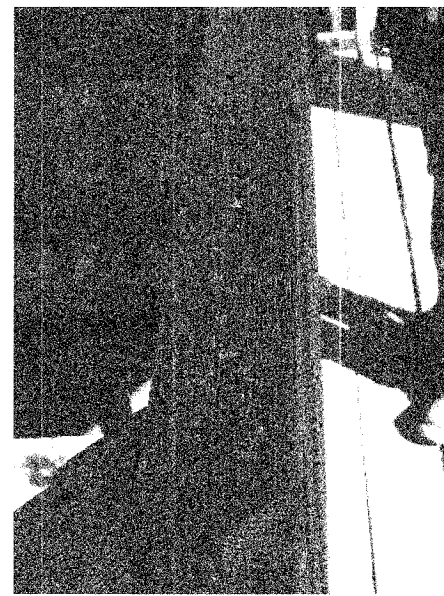
Photo 16 - Railing Showing very Rough surface and Loose Splinters

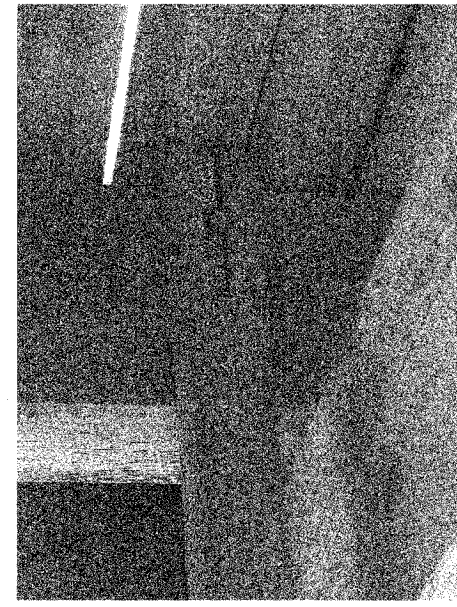
Photo 18 - Split Hanger at Top Support (Typical)

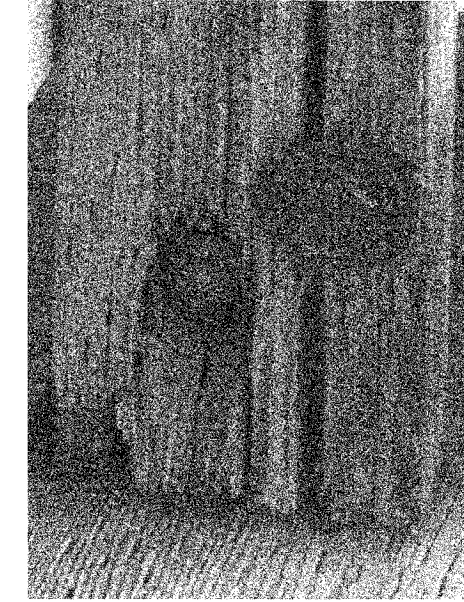
Photo 23 - Deteriorated member-to-member end connection with missing washers.

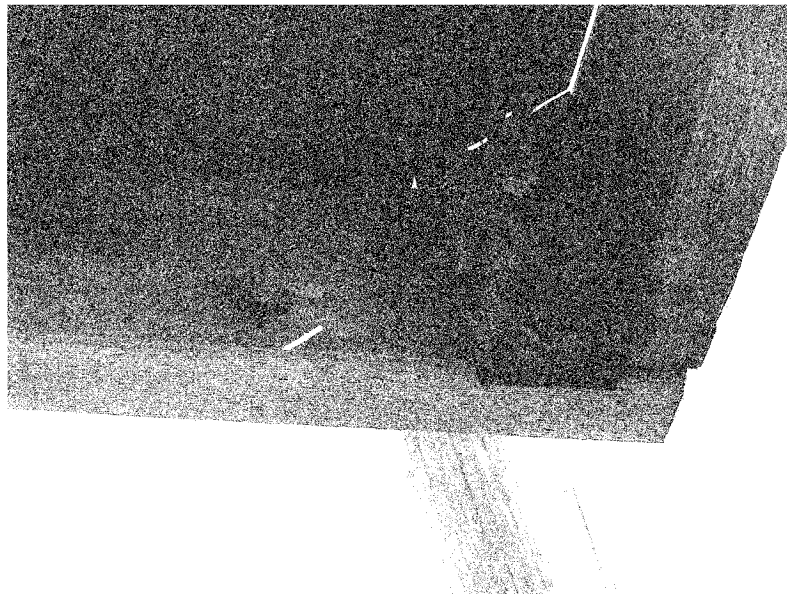
Photo 20 - Hanger Detail Connection at landing showing split wood and Rusted Washers.

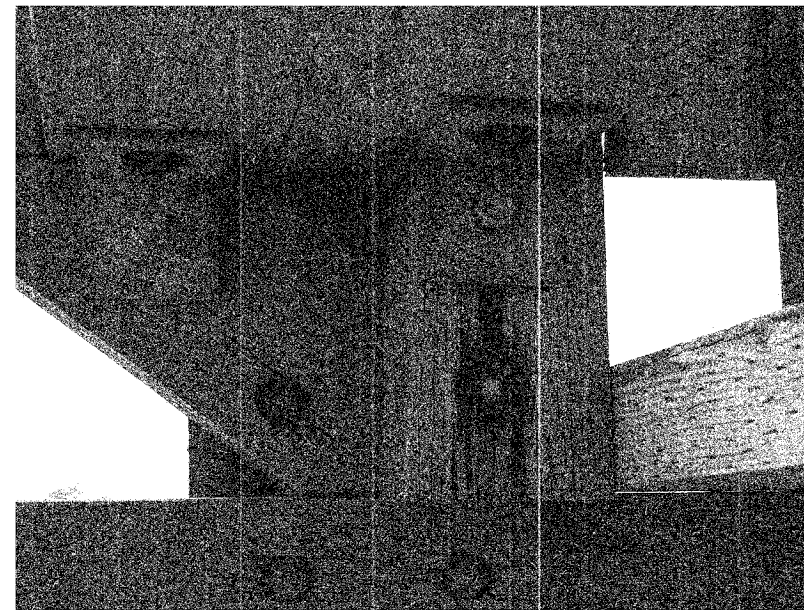
Photo 22 - Stair Railing Posts with cracks at Connection location (Typical)

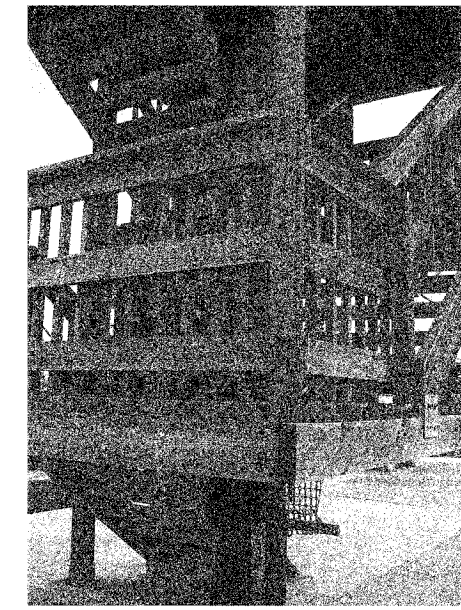
Photo 24 - Deterioration in Member-to-Member Connection with missing Washers.

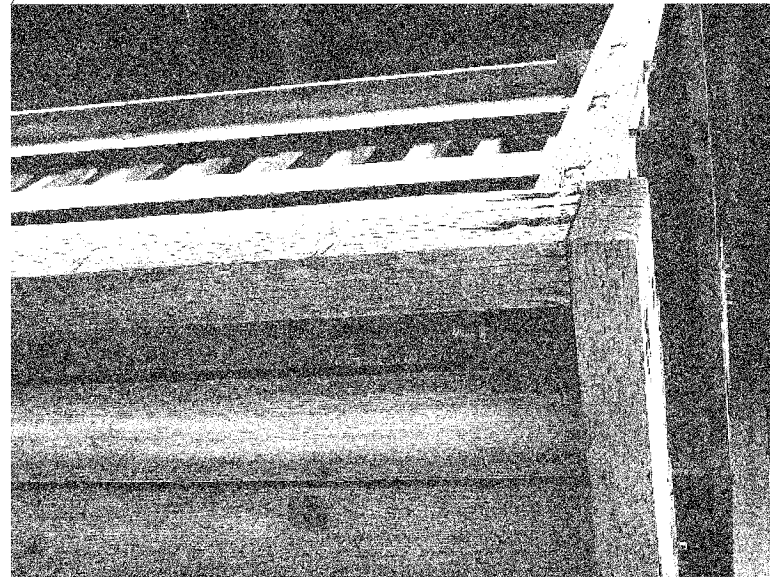
Photo 25 - Deterioration in member-to-member connections with missing washers.

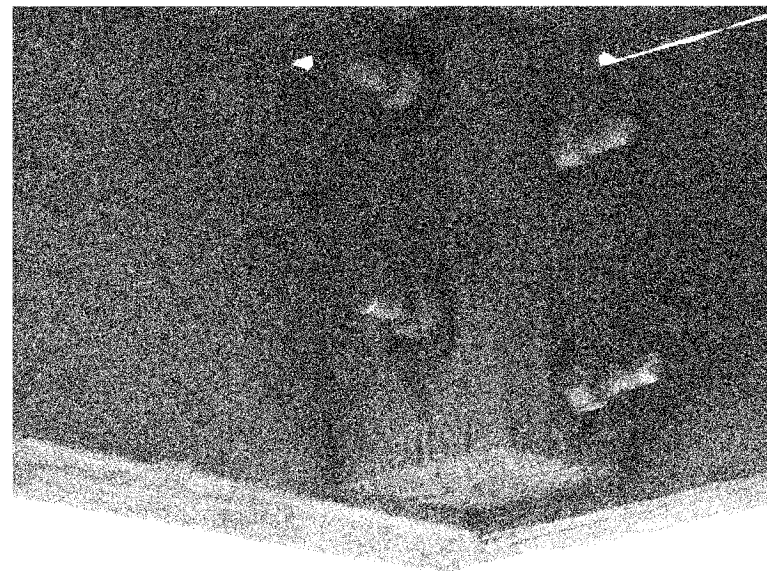
Photo 25 - Rusted Washers.
