DRAINAGE STRUCTURE IMPROVEMENT DETAIL LOCATION #5 STA. 847+44

LOC. #5 STA. 847+44

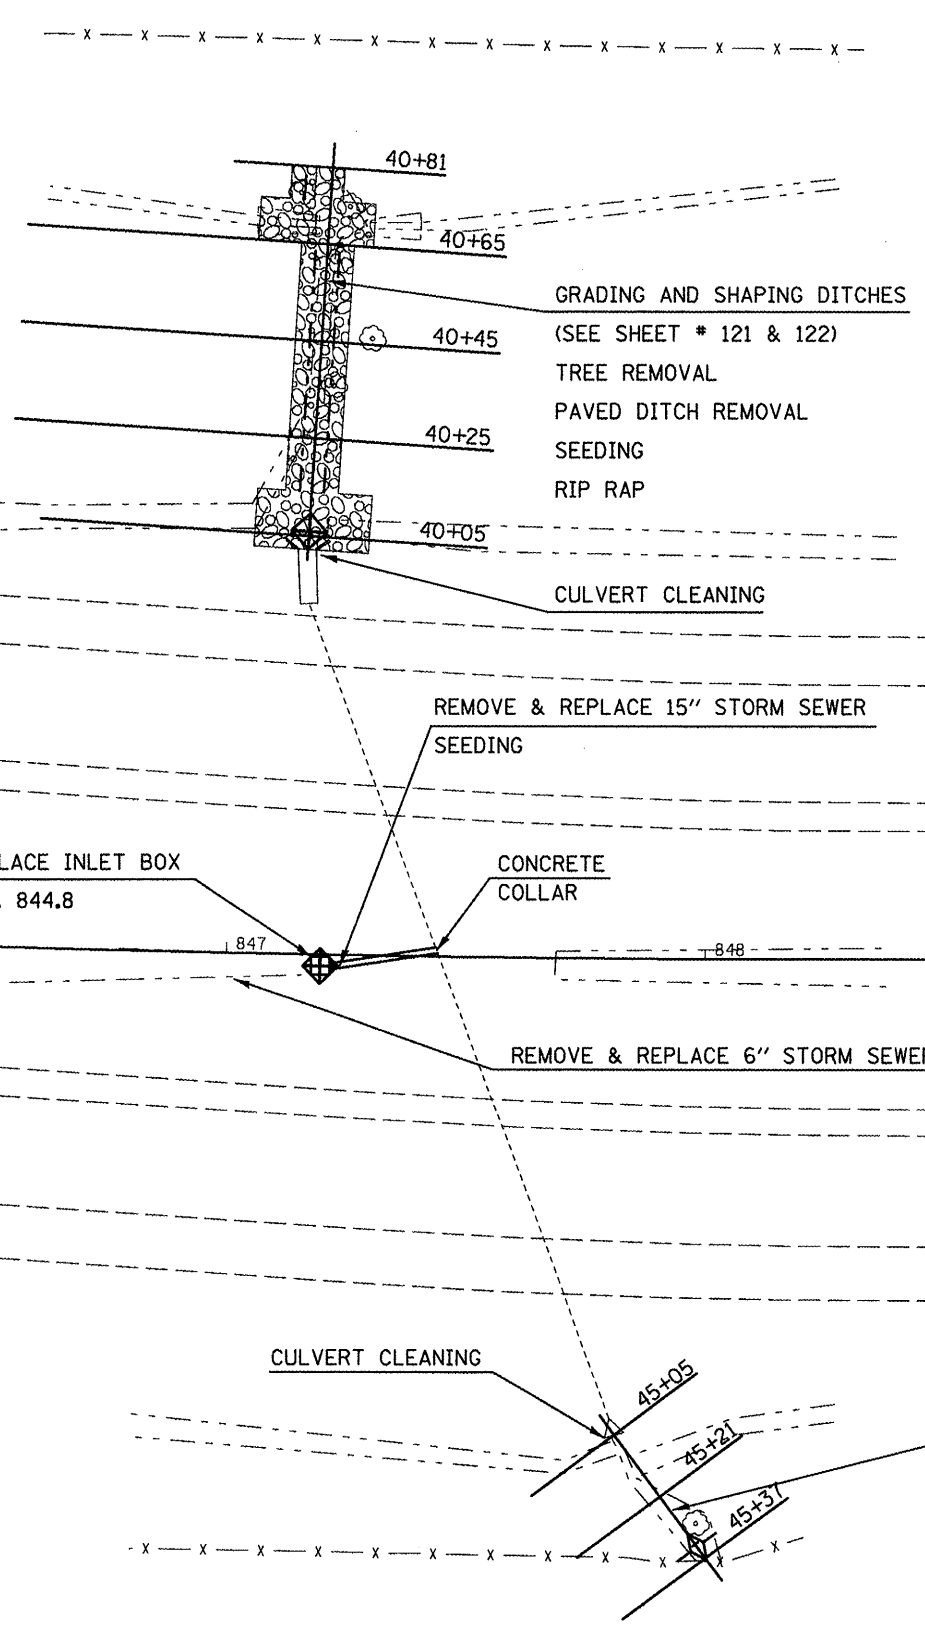
NOTE:
 THE EXISTING STRUCTURE AT STATION 847+44 CONSISTS OF A 24" R.C.C.P. WITH AN OFFSET MEDIAN INLET. THE STRUCTURE IS IN FAIR CONDITION WITH THE FOLLOWING DEFICIENCIES. THE 15" C.M.P. CONNECTING THE INLET BOX TO THE STRUCTURE HAS FAILED AND IS CAUSING A SINKHOLE IN THE MEDIAN. ALSO, THERE IS A 6" C.M.P. ENTERING THE INLET BOX THAT IS HEAVILY RUSTED. THE UPSTREAM AND DOWNSTREAM ENDS OF THE STRUCTURE HAVE EXPERIENCED HEAVY SILTATION. ALSO, A PAVED DITCH THAT IS LOCATED ON THE BACKSLOPE UPSTREAM OF THE STRUCTURE HAS FAILED AND SEVERE UNDERMINING HAS RENDERED IT A SAFETY HAZARD TO MAINTENANCE AT THIS TIME.

THE RECOMMENDED SCOPE OF WORK IS TO REPLACE THE MEDIAN INLET BOX WITH A NEW FLUSH INLET BOX. THE 15" C.M.P. SHALL BE REPLACED WITH A 15" STORM SEWER, CLASS "B" AND THE 6" C.M.P. SHALL BE REPLACED AS WELL. THE UPSTREAM AND DOWNSTREAM CHANNELS SHALL BE GRADED AND SHAPED TO PROVIDED POSITIVE DRAINAGE TO AND AWAY FROM THE STRUCTURE, AND THE PAVED DITCH SHALL BE REMOVED AND REPLACED WITH A RIPRAP DITCH. TREES SHALL BE REMOVED AT EACH END OF THE STRUCTURE. FINALLY, THE CULVERT SHALL BE CLEANED OUT TO REMOVE SILTATION FROM BOTH ENDS.
