ROADWAY GEOTECHNICAL REPORT\_REVISION 2  
IL 127 near Amphitheater  
Campground, Slope Stability  
PTB 199-039 – WO 2 and 3, Loc. 1  
JACKSON COUNTY, ILLINOIS

Subject: ROADWAY GEOTECHNICAL REPORT\_REVISION 2, IL 127 NEAR  
AMPHITHEATER CAMPGROUND, SLOPE STABILITY  
PTB 199-039 – WO 2 AND 3, LOC. 1, JACKSON COUNTY, ILLINOIS

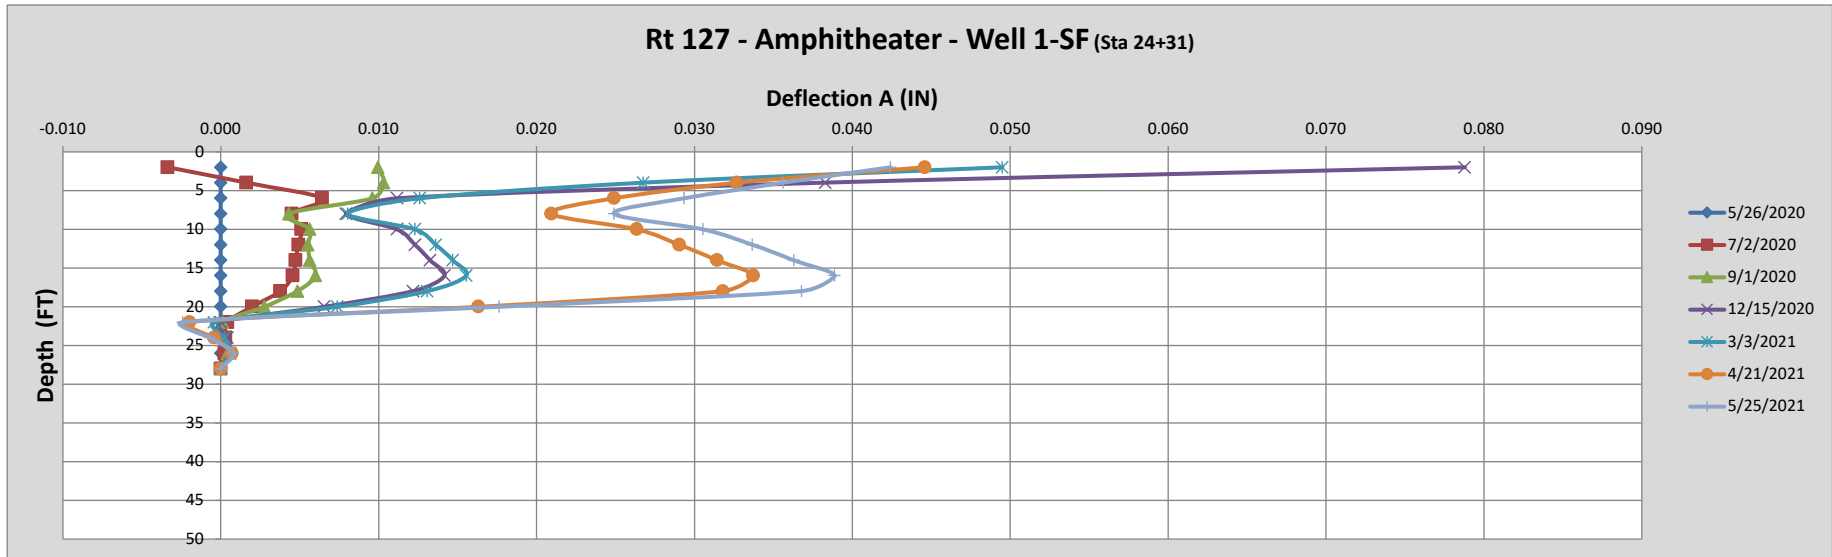
Inclinometer\_1-SF

Max movement near EL 525.9  
 (15.8 feet below ground surface)

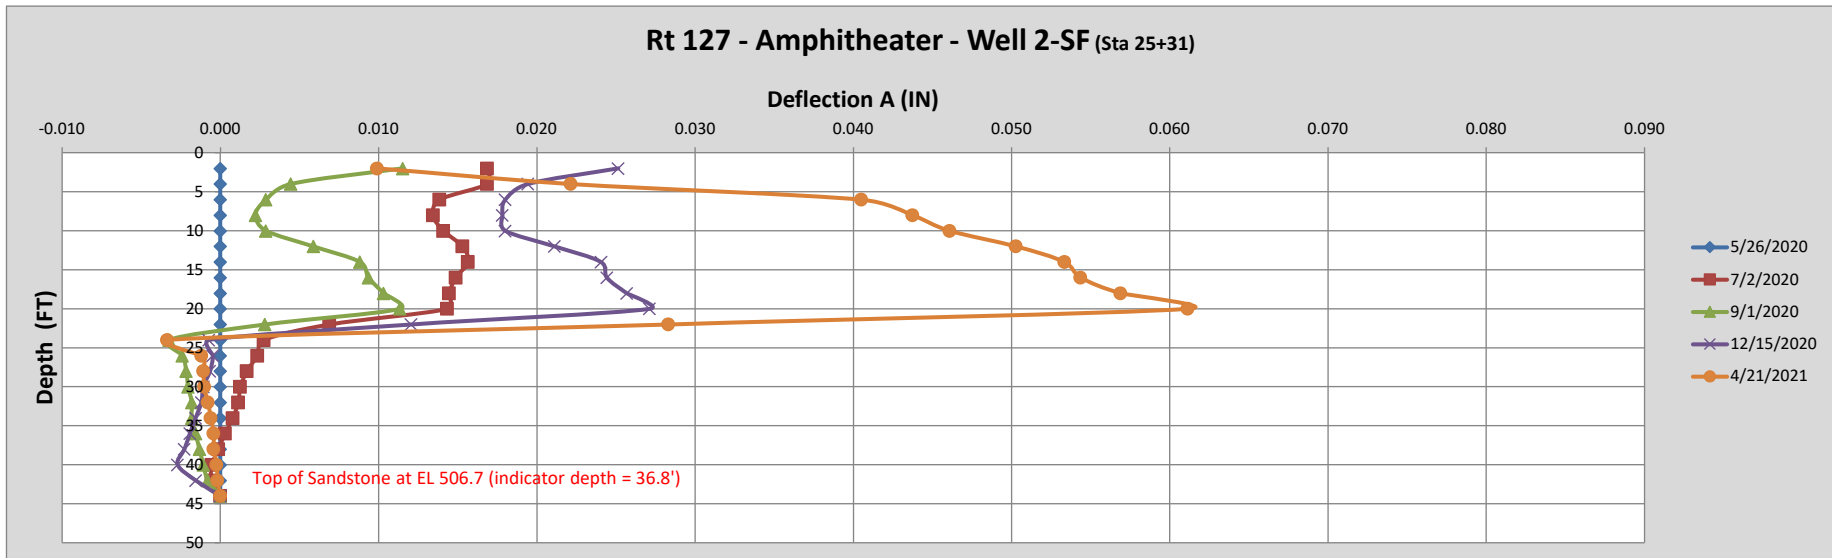
Inclinometer\_2-SF

Max movement near EL 523.5  
 (17.7 feet below ground surface)

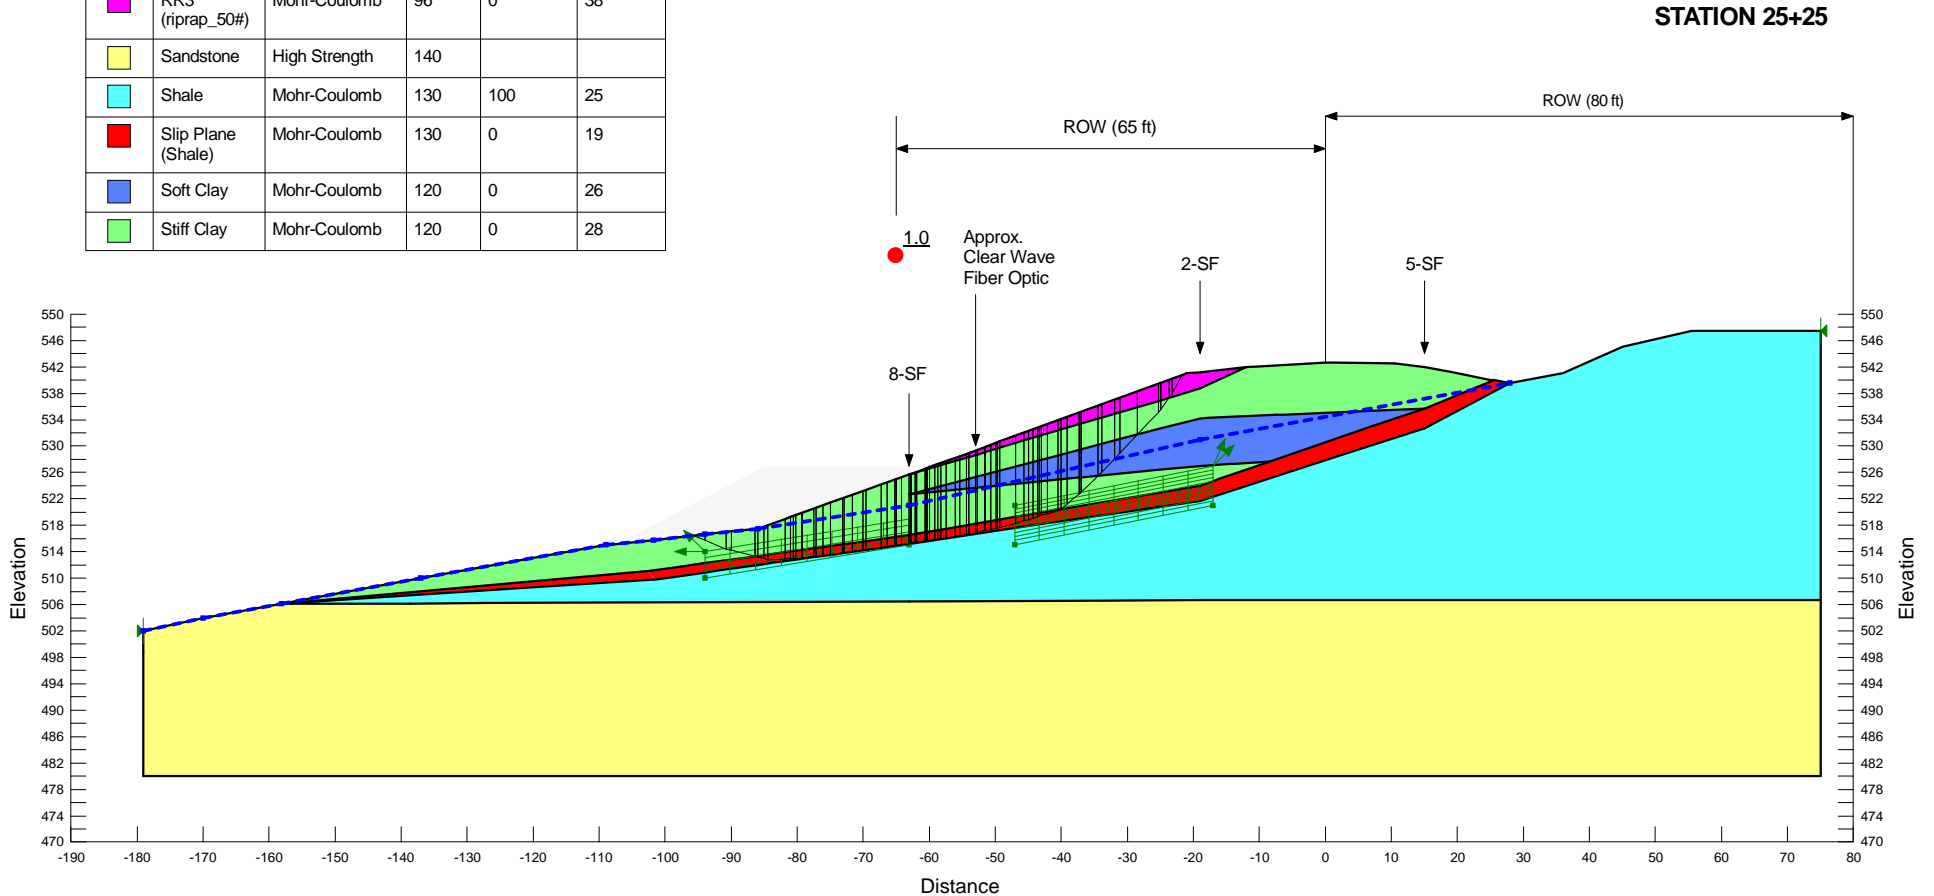
Illinois 127, MP 4.0, Jackson County, IL  
 Station 25+25 stability analysis\_Rev.3.gsz  
 Drained 1 (Buttress) (2) 2  
 Slip Surface Option: Block  
 Analysis Type: Morgenstern-Price
