FATIGUE RETROFIT

STATE OF ILLINOIS
DEPARTMENT OF TRANSPORTATION
REHABILITATION AND RETROFIT REPAIRS
FAI ROUTE 70
POPLAR STREET BRIDGE APPROACHES
ST. CLAIR COUNTY

STRUCTURE NO.
SCALE: N.T.S.
DATE: 02/01/2007

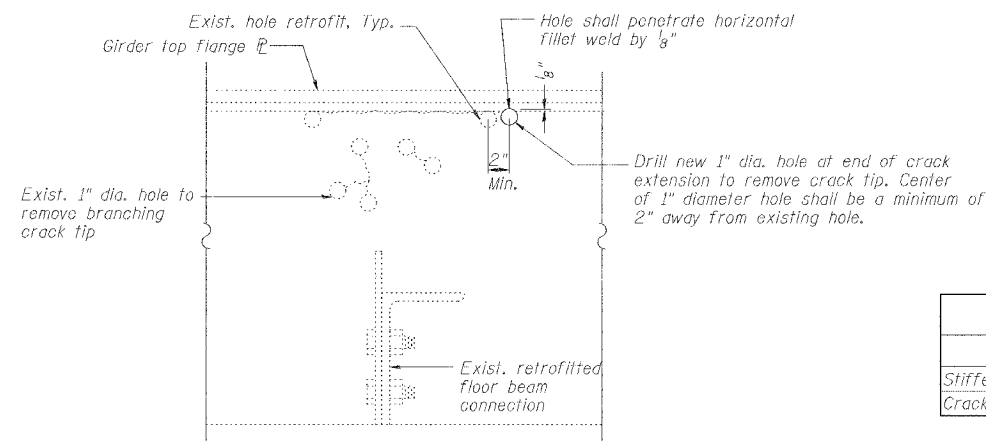
4 CRACK EXTENSION RETROFIT AT FIRST INTERIOR FLOOR BEAMS
S22

Note A: No crack extension retrofits identified at this time. An allowance of 5 retrofits for Ramp T have been included in the Contract.

Procedure - Detail 4/S22:

- At location directed by the Engineer, inspect girder web plate in region of existing retrofits to determine location of crack extension and crack tip using magnetic particle inspection (MT) methods (Cost included with crack extension retrofit at first interior floor beam).
- Drill 1" diameter hole at end of crack extension to remove crack tip. Center of 1" diameter hole shall be positioned in accordance with Detail 4/S22.
- Cored surfaces shall have a roughness average (Ra) of 500 or less.
- Re-inspect area using MT methods to verify crack does not extend past the newly drilled holes.
- Obtain approval of Engineer.
- Clean and paint steel surfaces adjacent to the repair in accordance with the Special Provisions.
