Contract No. 62853 *2004-108 BR

CONCRETE DECK BEAM REPAIRS

WOLF RD. OVER PALATINE RD.

STRUCTURE NO. 016-0680

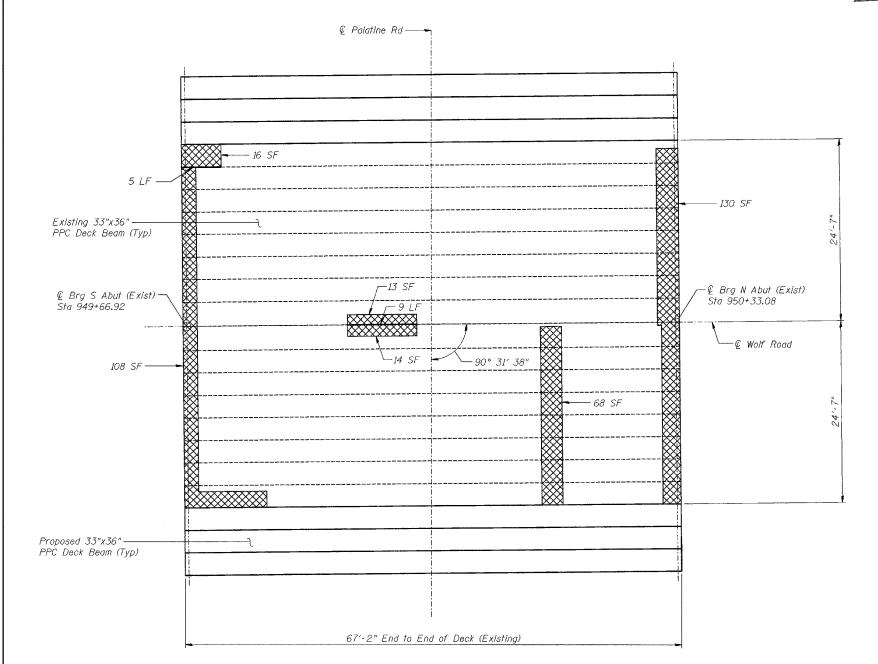
PLAN OF CONCRETE DECK BEAM REPAIRS

- Length of Keyway Repair based on Infrared Survey dated 12/21/92.

Area Showing Possible Delaminations of Top of Beam based on Infrared Survey dated 12/21/92

Repair areas shown are the surveyed areas of deterioration. The actual area to be repaired shall be as directed by the Engineer.

Surveyed areas that show possible delamination should be investigated after removal of the bituminous overlay. Any areas with delamination extending to the top mat of reinforcement on the beam shall be cleaned of any loose concrete and filled back up with the concrete overlay. Cost included with "Concrete Wearing Surface." Any area where the damage extends below the top mat of reinforcement on the beam shall be brought to the attention of the Bureau of Bridges and Structures for further disposition.
