FILE NAME =	USER NAME = oconnellte	DESIGNED -	REVISED -	STATE OF ILLINOIS DEPARTMENT OF TRANSPORTATION	LOCATION 1	SN 016-0806	F.A. RTE.	SECTION	COUNTY	TOTAL SHEETS	SHEET NO.
cr:\pwork\puidot\oconnellte\d0228385\10	750510-shd-plan.dgn	DRAWN -	REVISED -		PIER STRUCTURAL REPAIR	PIER 21	2010-068 BR	COOK	69	44	
	PLOT SCALE = 1/8" = 1' / IN.	CHECKED -	REVISED -		SCALE:	SHEET NO. 39 OF 48 SHEETS	STA.	TO STA.	CONTRACT NO. 60L51		
	PLOT DATE = 9/1/2010	DATE -	REVISED -		ILLINOIS FED. AID PROJECT

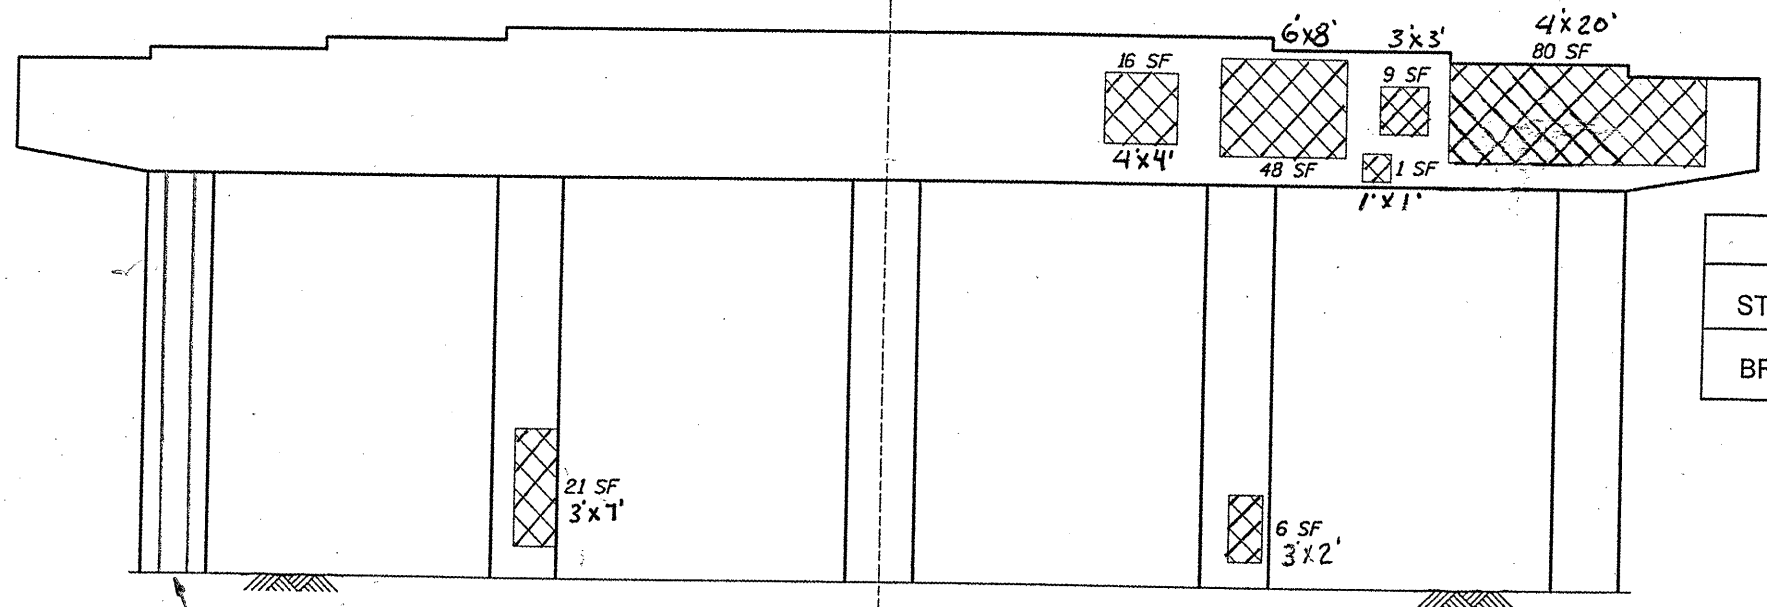
PIER 21 - NORTH FACE ELEVATION

ON WEST END OF PIER 21, STRAIGHT PIPE (26 FT.) IS CRACKED AND NEEDS REPLACEMENT. INCLUDED IN THE COST OF DOWNSPOUT DRAINAGE SYSTEM.

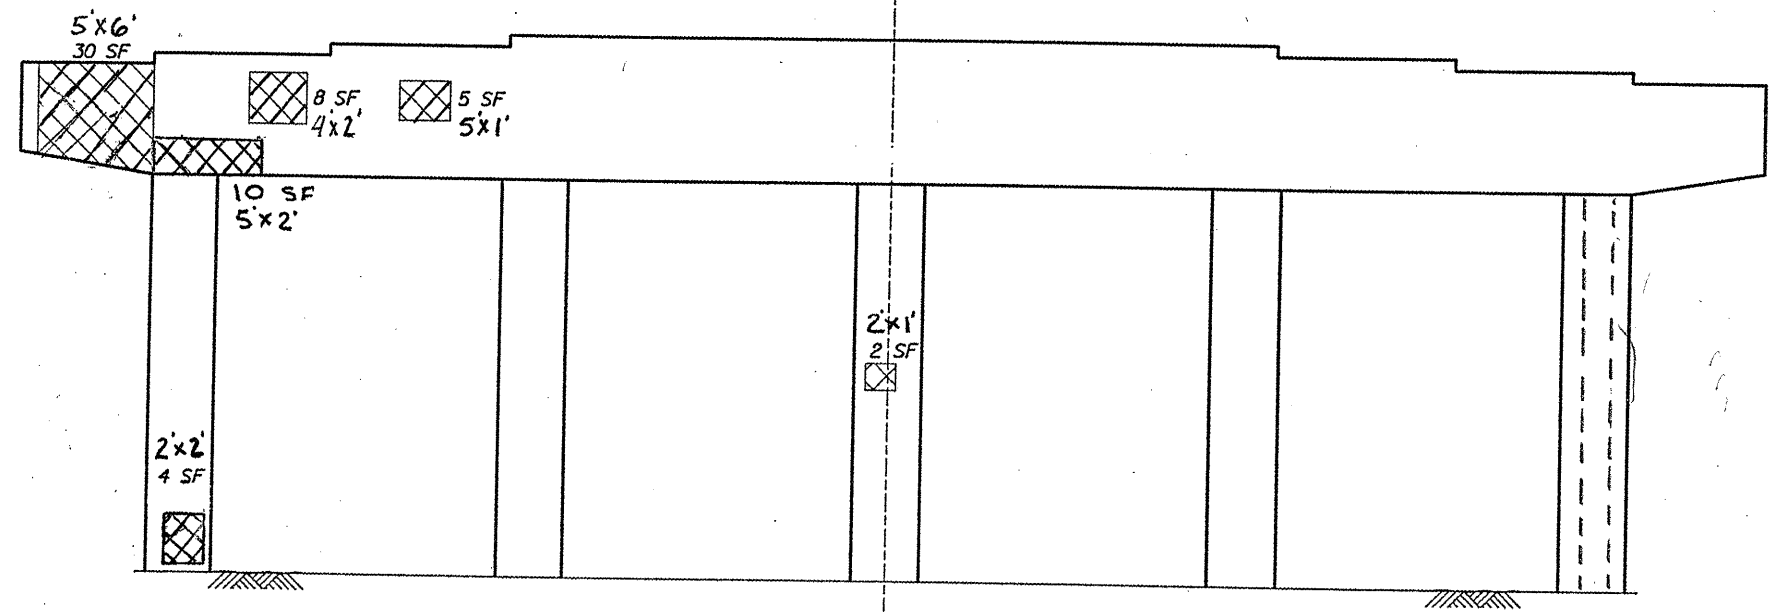
PIER 21 - SOUTH FACE ELEVATION

REPLACE METAL BAND AND STEEL BRACKET SUPPORTING PIPE, REPAIR SPALLED AREA AROUND CONCRETE ANCHORS. INCLUDED IN COST OF BRIDGE DRAINAGE SYSTEM REPAIRS

STRUCTURAL REPAIR OF CONCRETE $\leq 5"$
