DECK REPAIR PLAN
(Spans 6 thru 8)

DECK REPAIR DETAILS
SPANS 6-8

VACHEL LINDSAY BRIDGE REHABILITATION
LONG BAY DRIVE OVER LAKE SPRINGFIELD
SPRINGFIELD, ILLINOIS

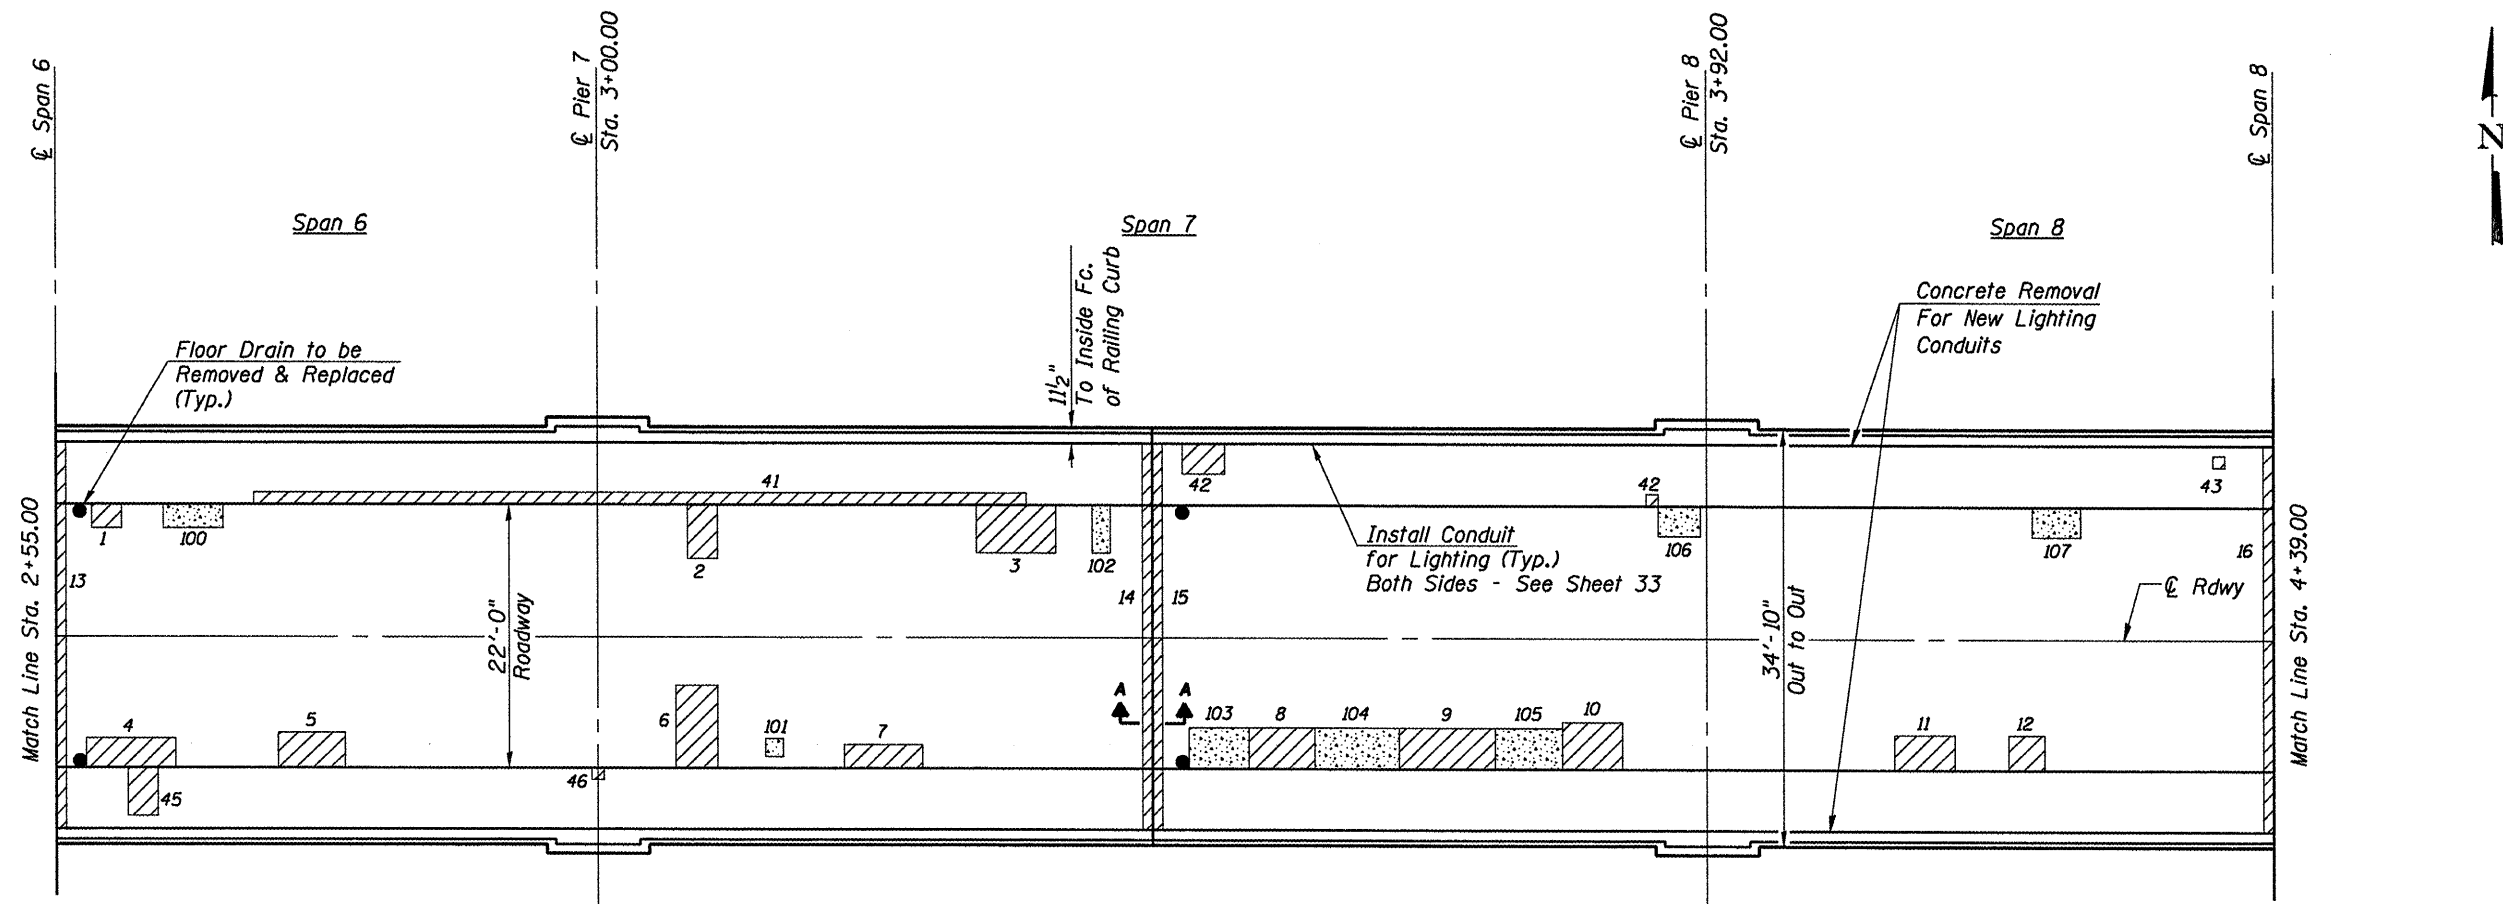
DECK SLAB RESTORATION-ROADWAY SPANS 6-8
DECK SLAB REPAIR (PARTIAL)

DECK SLAB RESTORATION-SIDWALK SPANS 6-8
DECK SLAB REPAIR (PARTIAL)

POLYMER OVERLAY PRETREATMENT
SPANS 6-8

EXPANSION JOINT REPAIRS-SPANS 6-8
DECK SLAB REPAIR (PARTIAL)
