DECK REPAIR PLAN
(Spans 16 thru 21)

DECK REPAIR DETAILS
SPANS 16-21

VACHEL LINDSAY BRIDGE REHABILITATION
LONG BAY DRIVE OVER LAKE SPRINGFIELD
SPRINGFIELD, ILLINOIS

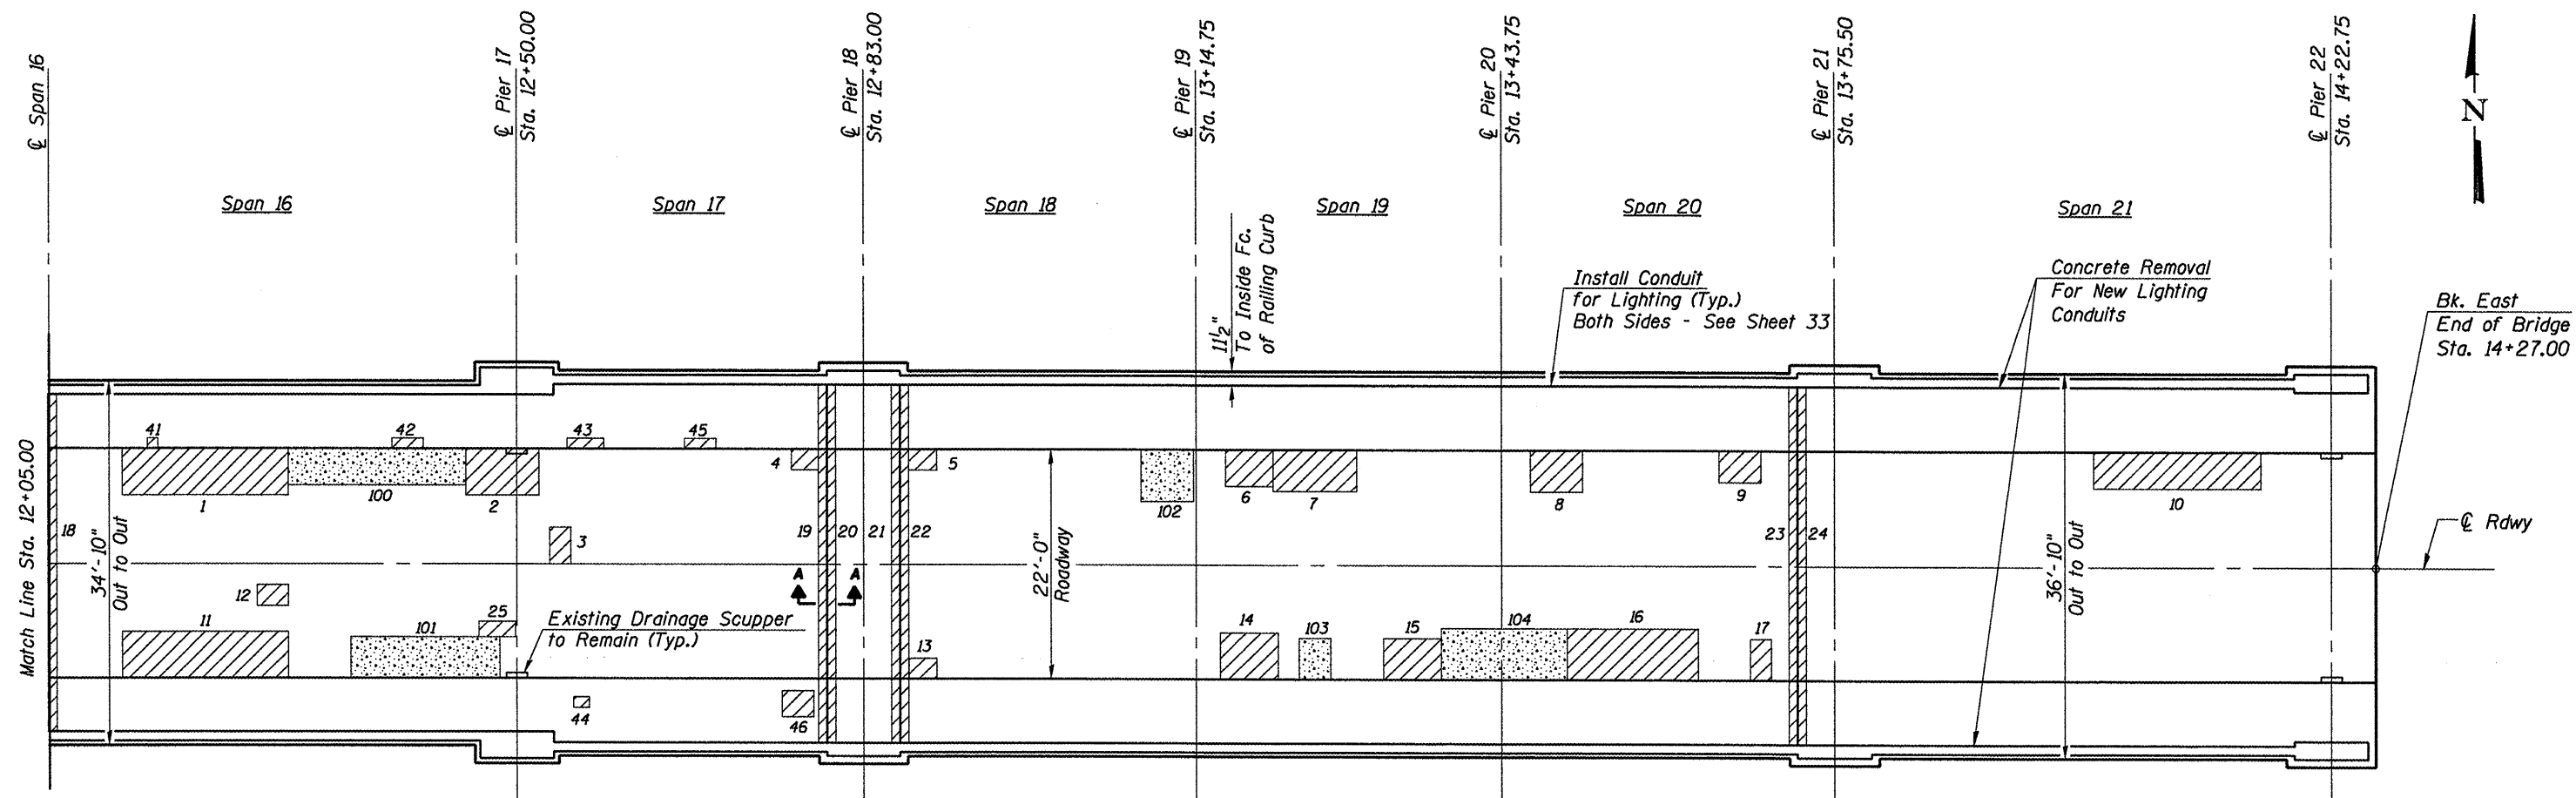
DECK SLAB RESTORATION-ROADWAY SPANS 16-21
DECK SLAB REPAIR (PARTIAL)

DECK SLAB RESTORATION-SIDEWALK SPANS 16-21
DECK SLAB REPAIR (PARTIAL)

POLYMER OVERLAY PRETREATMENT
SPANS 16-21

EXPANSION JOINT REPAIRS-SPANS 16-21
DECK SLAB REPAIR (PARTIAL)

Indicates Area to be Repaired (depth ≤ 5 Inch)

Indicates Area to be Pretreated
