**STRUCTURE REPAIR DETAILS**  
**SPAN 16**

**VACHEL LINDSAY BRIDGE REHABILITATION**  
**LONG BAY DRIVE OVER LAKE SPRINGFIELD**  
**SPRINGFIELD, ILLINOIS**

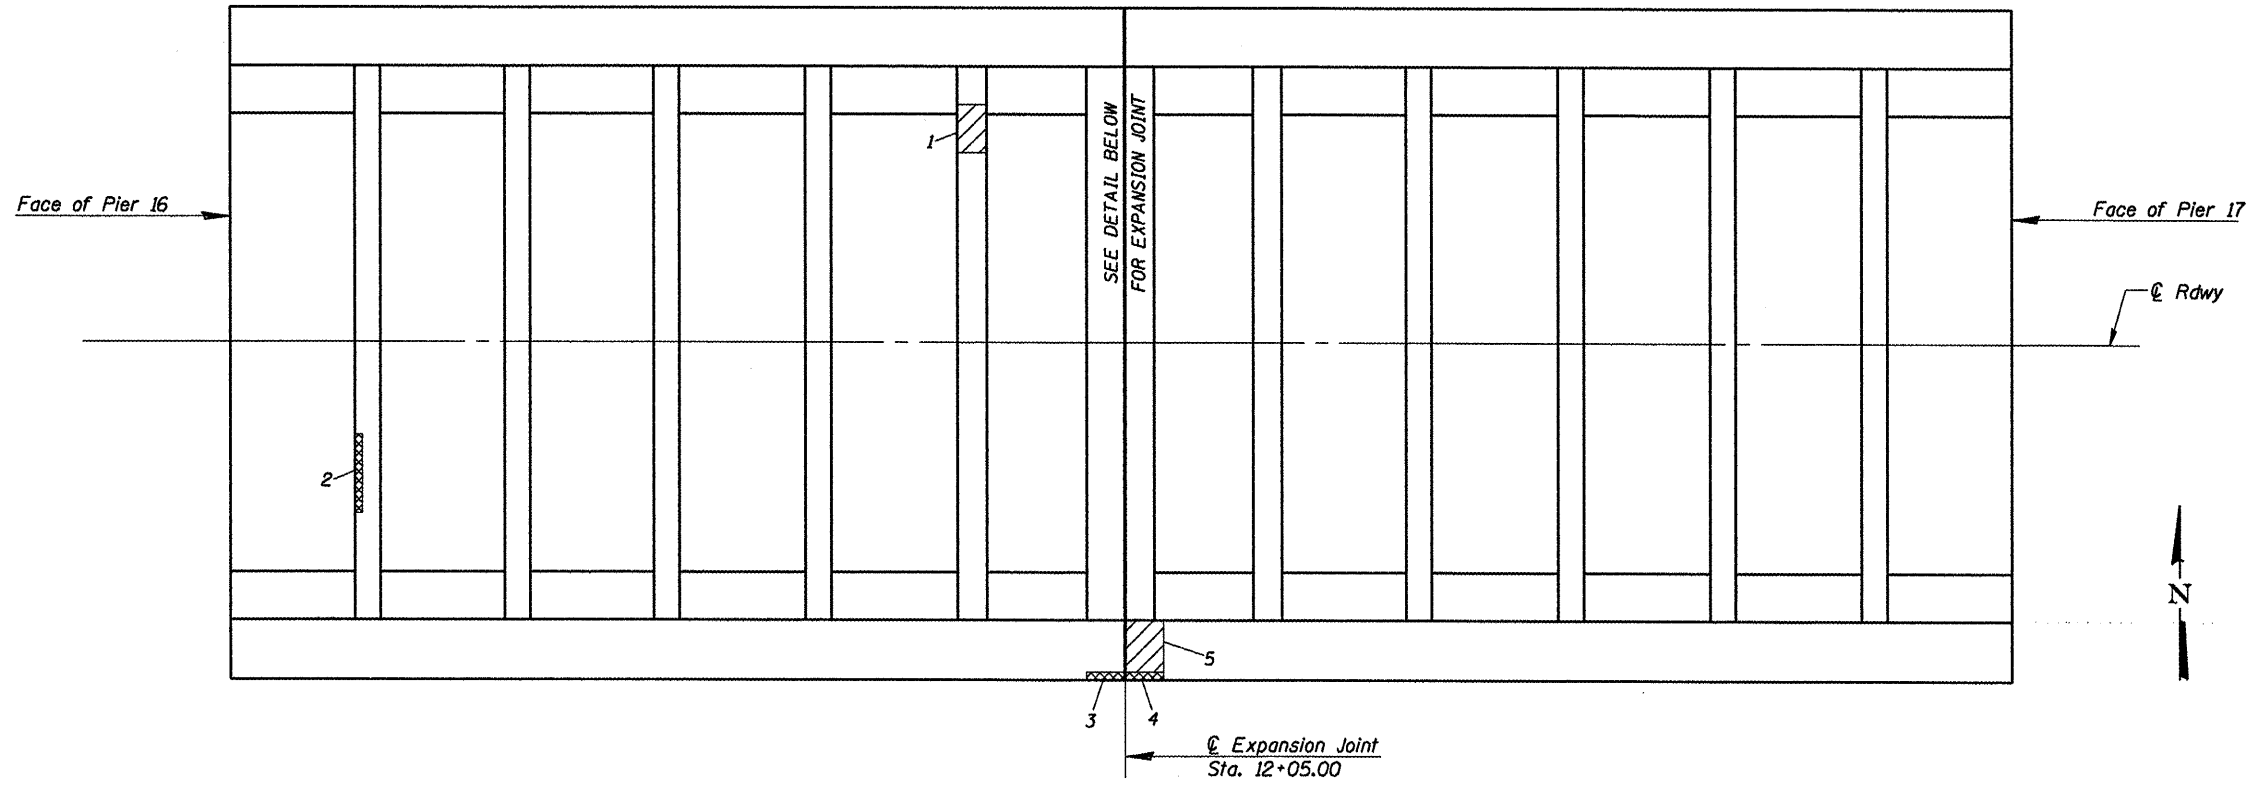
**STRUCTURE REPAIR PLAN AT FLOOR BEAMS**  
(Span 16)

Patch No.	Vert. or Horiz.	Dimensions	Area (SQ. FT.)
1	H	2.50'x1.33'	3.33
2	V	4.00'x1.00'	4.00
3	V	1.00'x2.00'	2.00
4	V	2.00'x2.00'	4.00
5	H	3.50'x1.33'	4.66
Subtotal of Vertical Repair Areas			10.00
Subtotal of Horizontal Repair Areas			7.99
Subtotal			17.99

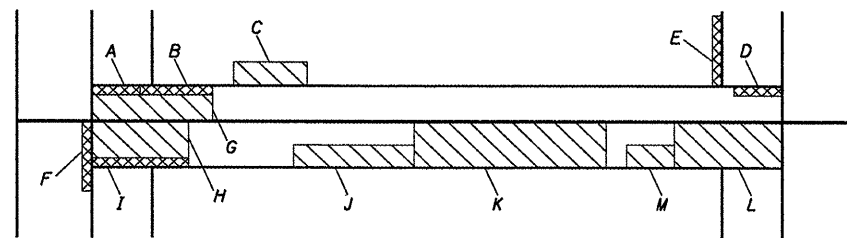
**PLAN AT EXPANSION JOINT**

Patch No.	Vert. or Horiz.	Dimensions	Area (SQ. FT.)
A	V	2.00'x1.00'	2.00
B	V	1.25'x3.00'	3.75
C	H	3.00'x1.00'	3.00
D	V	2.00'x1.00'	2.00
E	V	3.00'x1.00'	3.00
F	V	3.00'x1.50'	4.50
G	H	5.00'x1.33'	6.65
H	H	4.00'x2.00'	8.00
I	V	4.00'x0.50'	2.00
J	H	5.00'x1.00'	5.00
K	H	8.00'x2.00'	16.00
L	H	4.50'x2.00'	9.00
M	H	2.00'x1.00'	2.00
Subtotal of Vertical Repair Areas			17.25
Subtotal of Horizontal Repair Areas			49.65
Subtotal			66.90
