STRUCTURAL REPAIR OF CONCRETE
SPAN 17

STRUCTURAL REPAIR OF CONCRETE
SPAN 5

STRUCTURE REPAIR DETAILS
SPANS 5 & 17
VACHEL LINDSAY BRIDGE REHABILITATION
LONG BAY DRIVE OVER LAKE SPRINGFIELD
SPRINGFIELD, ILLINOIS

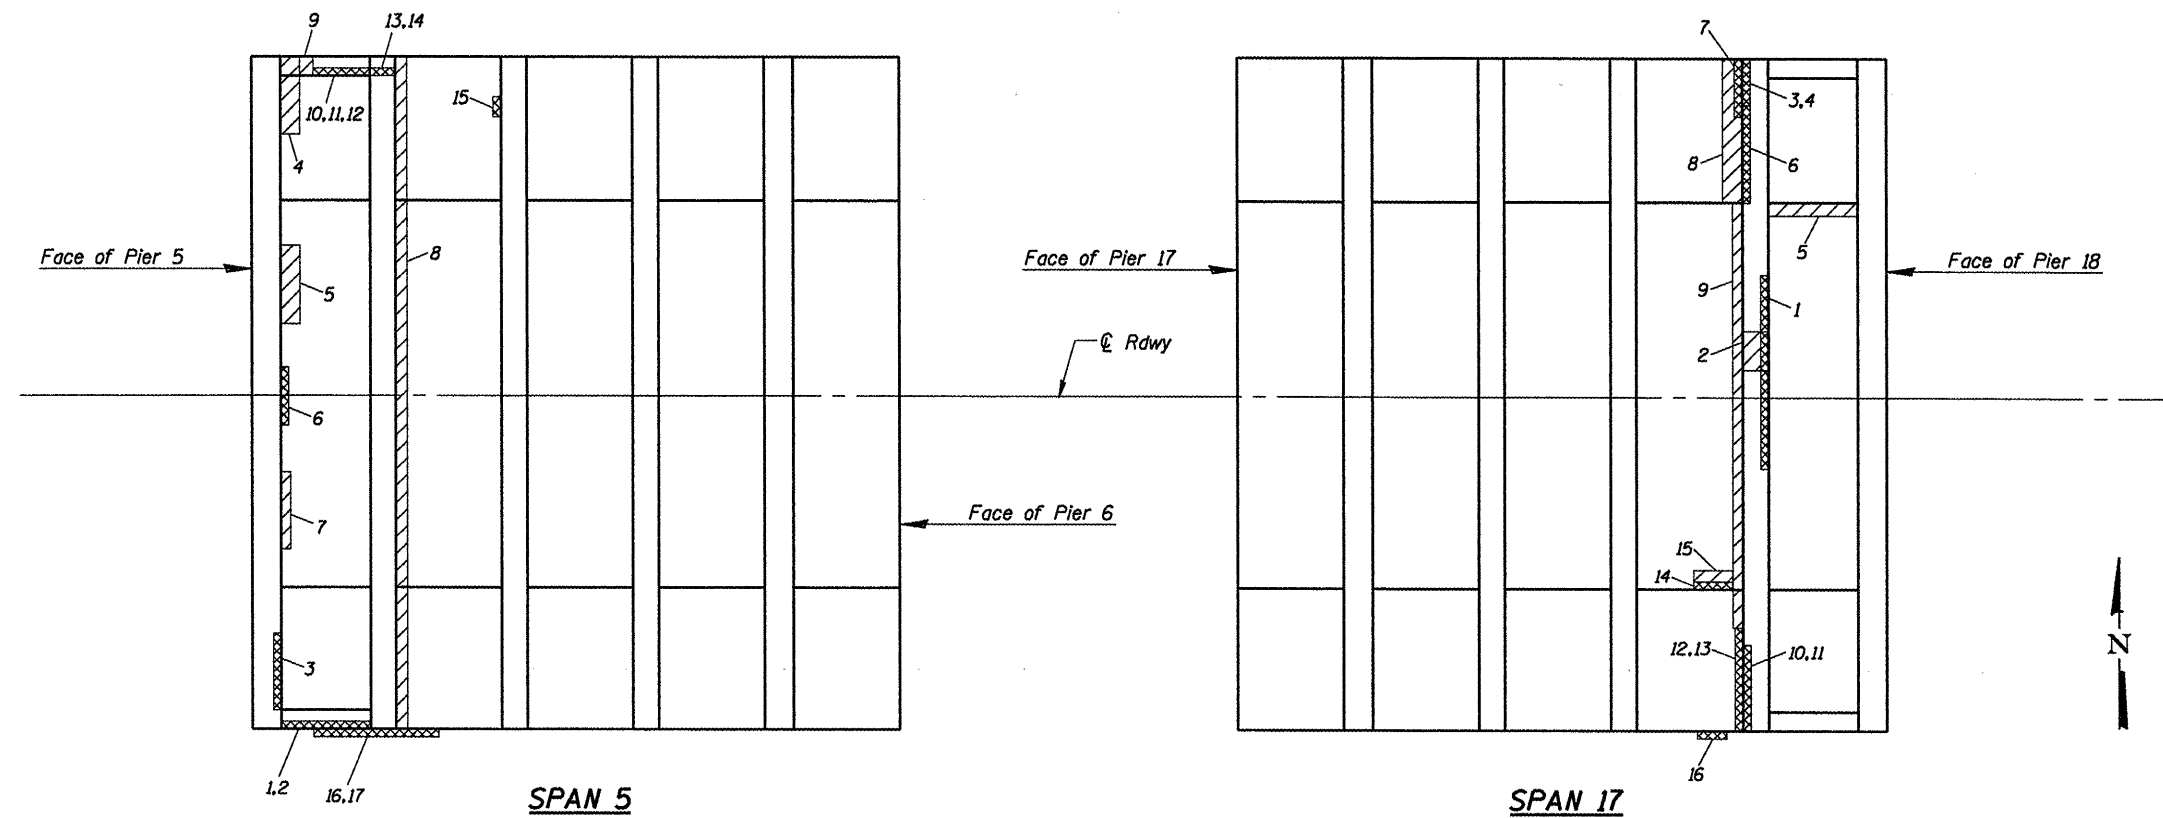
STRUCTURE REPAIR PLAN AT FLOOR BEAMS

Patch No.	Vert. or Horiz.	Dimensions	Area (SQ. FT.)
1	V	10.00x1.00'	10.00
2	H	2.00x1.33'	2.66
3	V	4.00x0.67'	2.68
4	V	4.00x0.50'	2.00
5	H	0.67x4.50'	3.00
6	V	(5.00x3.00)/2*	7.50
7	V	3.00x1.00'	3.00
8	H	1.00x8.00'	8.00
9	H	0.50x22.00'	11.00
10	V	1.00x4.50'	4.50
11	V	1.00x2.00'	2.00
12	V	3.00x1.00'	3.00
13	H	7.00x1.00'	7.00
14	V	0.50x2.00'	1.00
15	H	1.00x2.00'	2.00
16	V	1.50x1.50'	2.25
Subtotal of Vertical Repair Areas			37.93
Subtotal of Horizontal Repair Areas			33.66
Subtotal			71.59

Patch No.	Vert. or Horiz.	Dimensions	Area (SQ. FT.)
1	V	2.75x8.00'	22.00
2	V	0.50x3.00'	1.50
3	V	(3.00x3.00)/2*	4.50
4	H	4.00x1.00'	4.00
5	H	4.00x1.00'	4.00
6	H	4.50x1.00'	4.50
7	H	0.50x4.00'	2.00
8	H	1.00x31.00'	31.00
9	V	1.00x7.00'	7.00
10	V	1.00x4.00'	4.00
11	V	2.00x5.50'	11.00
12	V	1.00x7.00'	7.00
13	V	1.00x3.50'	3.50
14	V	1.00x3.00'	3.00
15	V	1.00x1.00'	1.00
16	V	6.50x2.00'	13.00
17	V	2.00x1.00'	2.00
Subtotal of Vertical Repair Areas			79.50
Subtotal of Horizontal Repair Areas			45.50
Subtotal			125.00
