STATE OF ILLINOIS  
DEPARTMENT OF TRANSPORTATION

REPAIR DETAILS  
FAU-2744 SHERIDAN RD. OVER BUCKLEY RD.  
SEC. 71 HB-I-1  
LAKE COUNTY  
STATION 120+00.00  
STRUCTURE NO. 049-0161

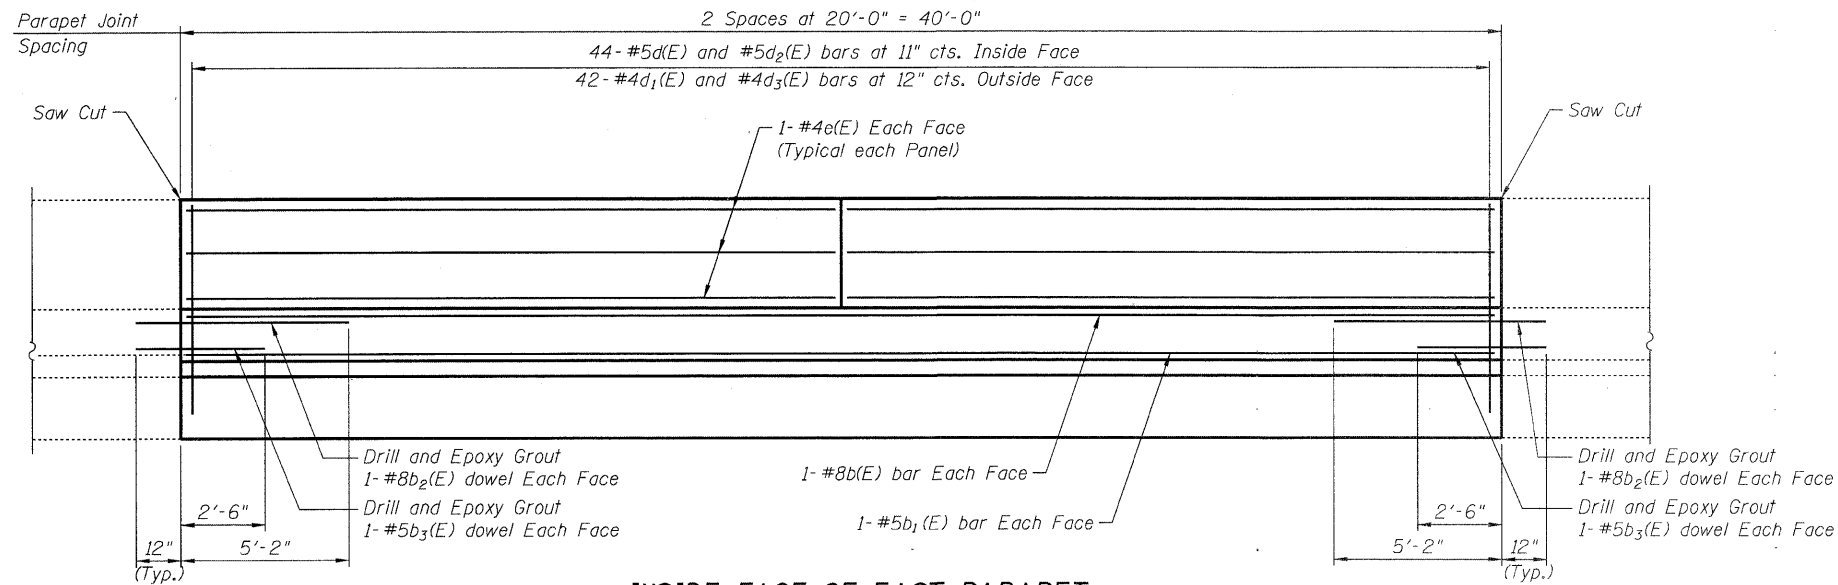
INSIDE FACE OF EAST PARAPET

The damaged parapet is composed of two (2) twenty (20) foot long sections on the northeast side. The actual location of the two sections will be field determined by the Engineer. The cost of backfill to correct settlement of the damaged barrier is included in the pay item "Concrete Superstructure". The bar lengths in the Reinforcement Bill of Material shall be cut and the epoxy coating repaired as required for the 2 - 20 foot sections.

Care shall be taken during concrete removal for parapet repairs, to preserve, clean and reuse existing reinforcing steel in bridge slab. Locate limits of repairs as directed by the Engineer such that existing adjacent joints are a minimum distance of 5'-0" away. Removal of existing parapet to be paid for as Concrete Removal.
