STATE OF ILLINOIS
DEPARTMENT OF TRANSPORTATION

SPAN 8 FBO REPAIR DETAILS
STRUCTURE NO. 090-0030

SHEET NO. 3	F.A. RTE. 669	SECTION 103B-I-5	COUNTY ••	TOTAL SHEETS 18	SHEET NO. 8
13 SHEETS	CONTRACT NO. 68987			ILLINOIS FED. AID PROJECT

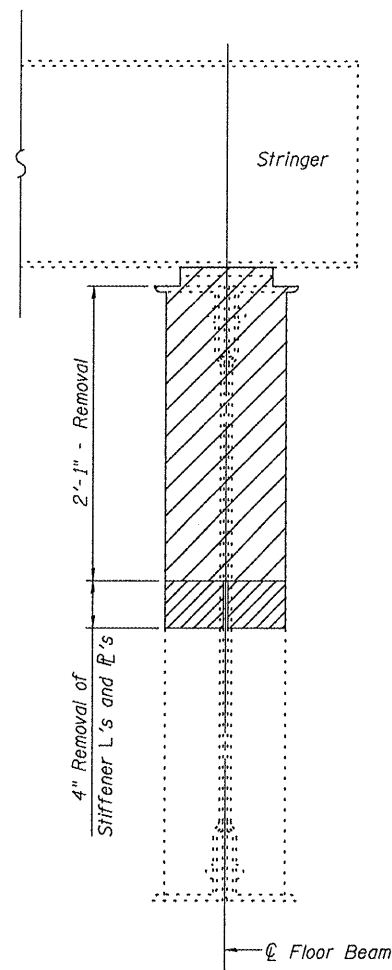
SECTION A-A

Notes:
Hatched areas indicate removal of existing structural steel. Cost included with "Structural Steel Repair".

After removal of existing structural steel all removed edges of steel to remain in place shall be ground smooth.
