STATE OF ILLINOIS
DEPARTMENT OF TRANSPORTATION

SUGGESTED BEAM STRAIGHTENING METHODS

REPAIR DETAILS
CH 19 OVER I-72
SN 010-0146

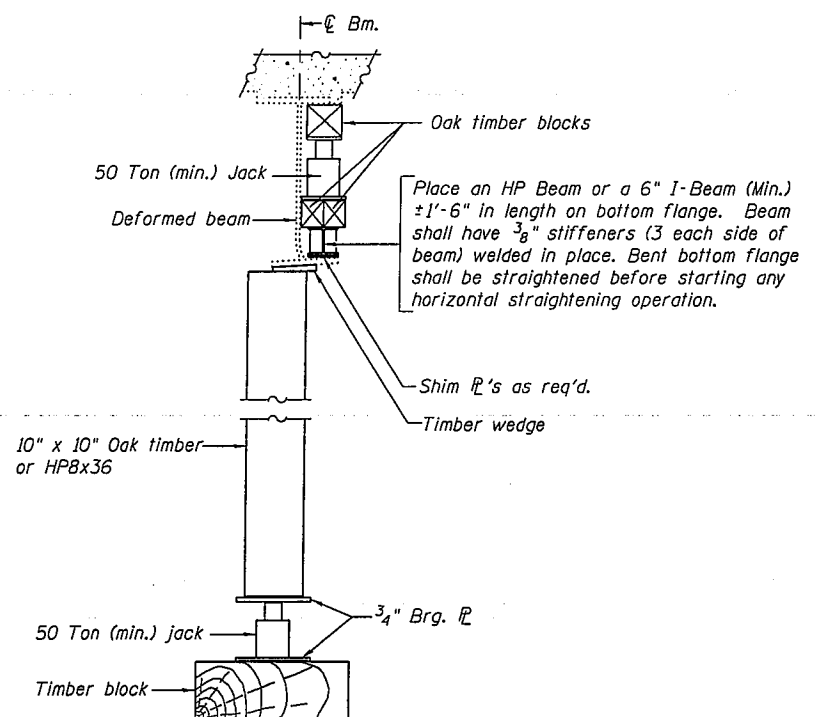
SUGGESTED VERTICAL STRAIGHTENING DETAIL
(To correct localized vertical flange deformations.)

Straightening force shall be maintained on all load transfer blocking during beam straightening.

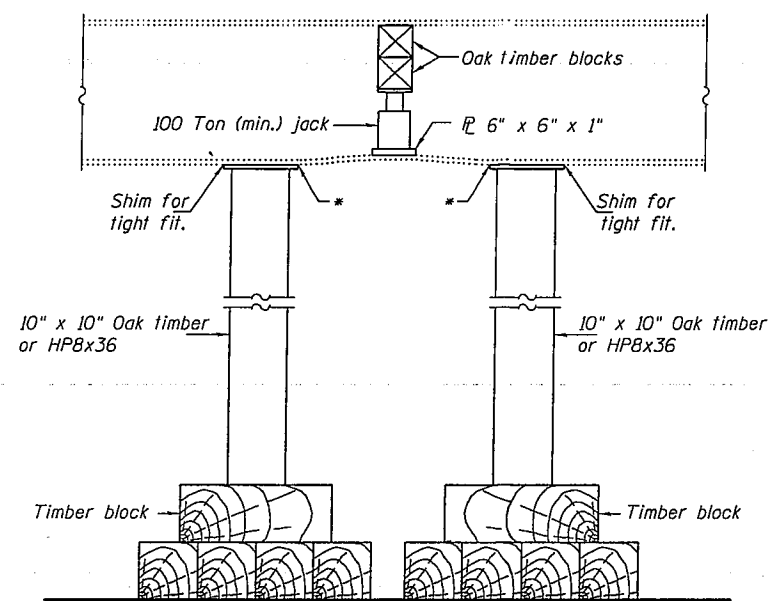
SUGGESTED VERTICAL STRAIGHTENING DETAIL
(To correct localized vertical flange deformations.)

* Edge of plate shall line up with edge of deformation.

Note:
Braces and jack assembly shall be placed on same side of web.
Bent bottom flange shall be straightened before starting any horizontal straightening operations.
