STATE OF ILLINOIS
DEPARTMENT OF TRANSPORTATION

DECK PLAN (SB)
STRUCTURE NO. 058-0101(NB) & 0102(SB)

SHEET 4 OF 26	F.A.P. RTE. 322	SECTION (58-20)RS	COUNTY MACON	TOTAL SHEETS 151	SHEET NO. 69
	STA. 133+62.02		CONTRACT NO. 74150		
FED. ROAD DIST. NO. ILLINOIS FED. AID PROJECT

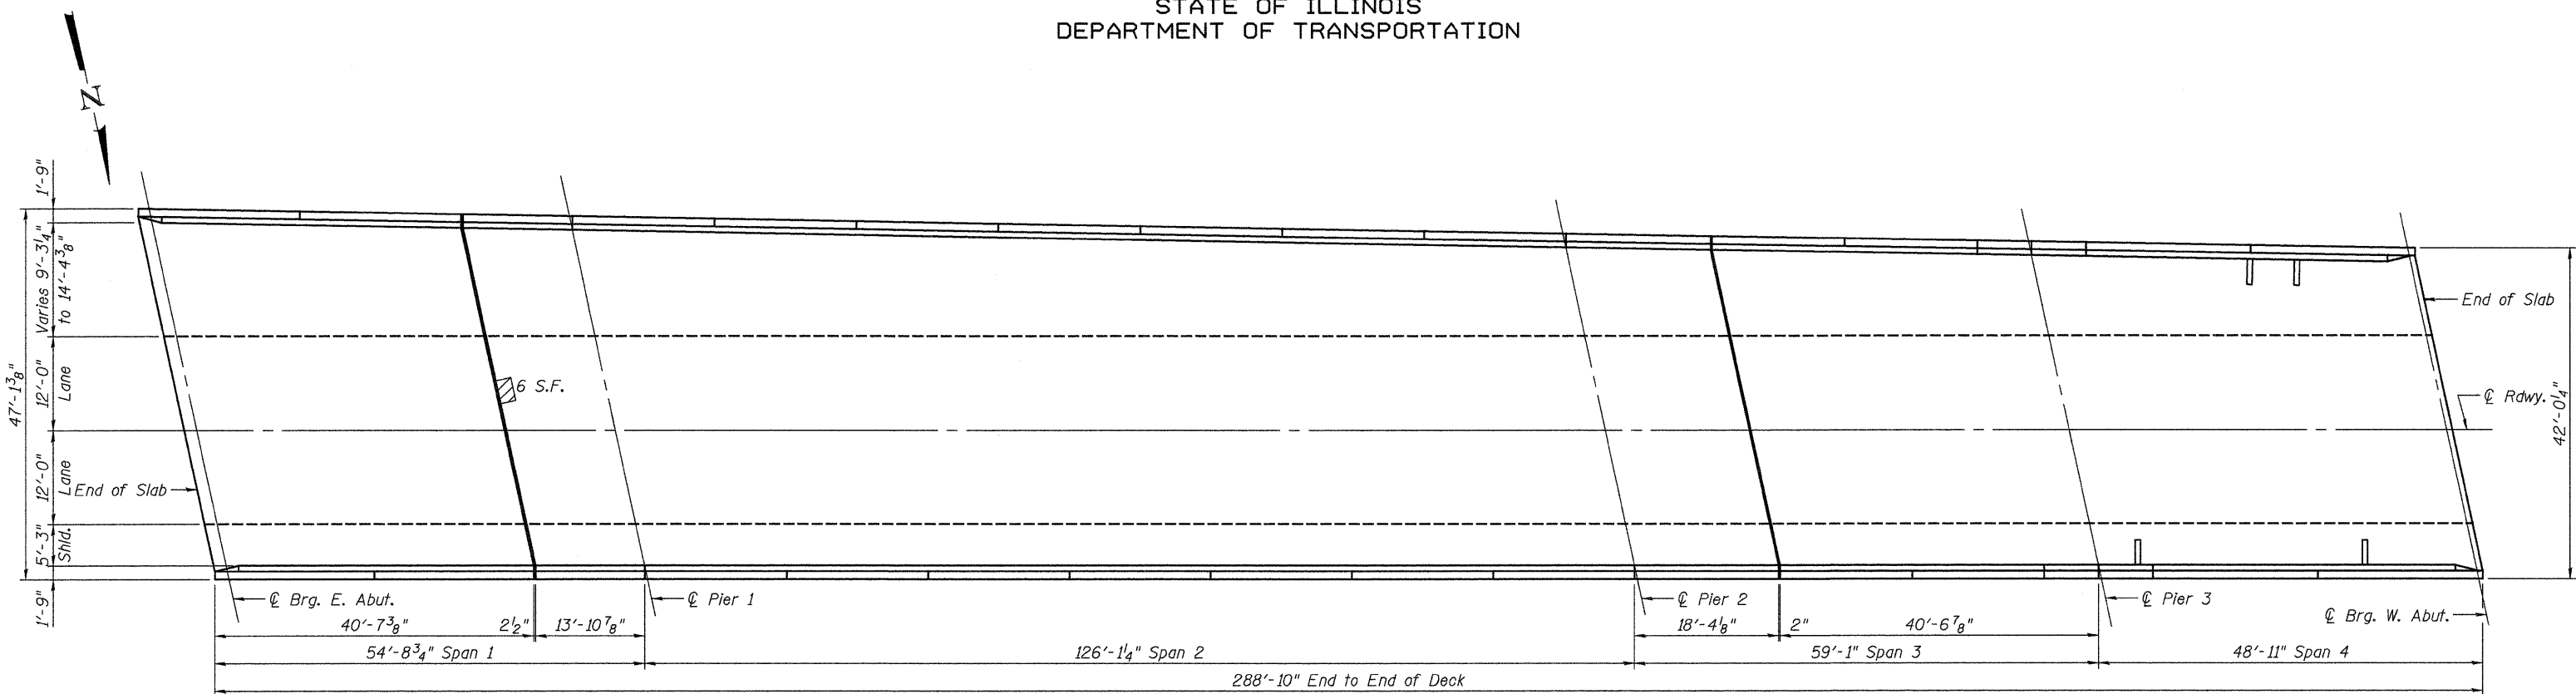
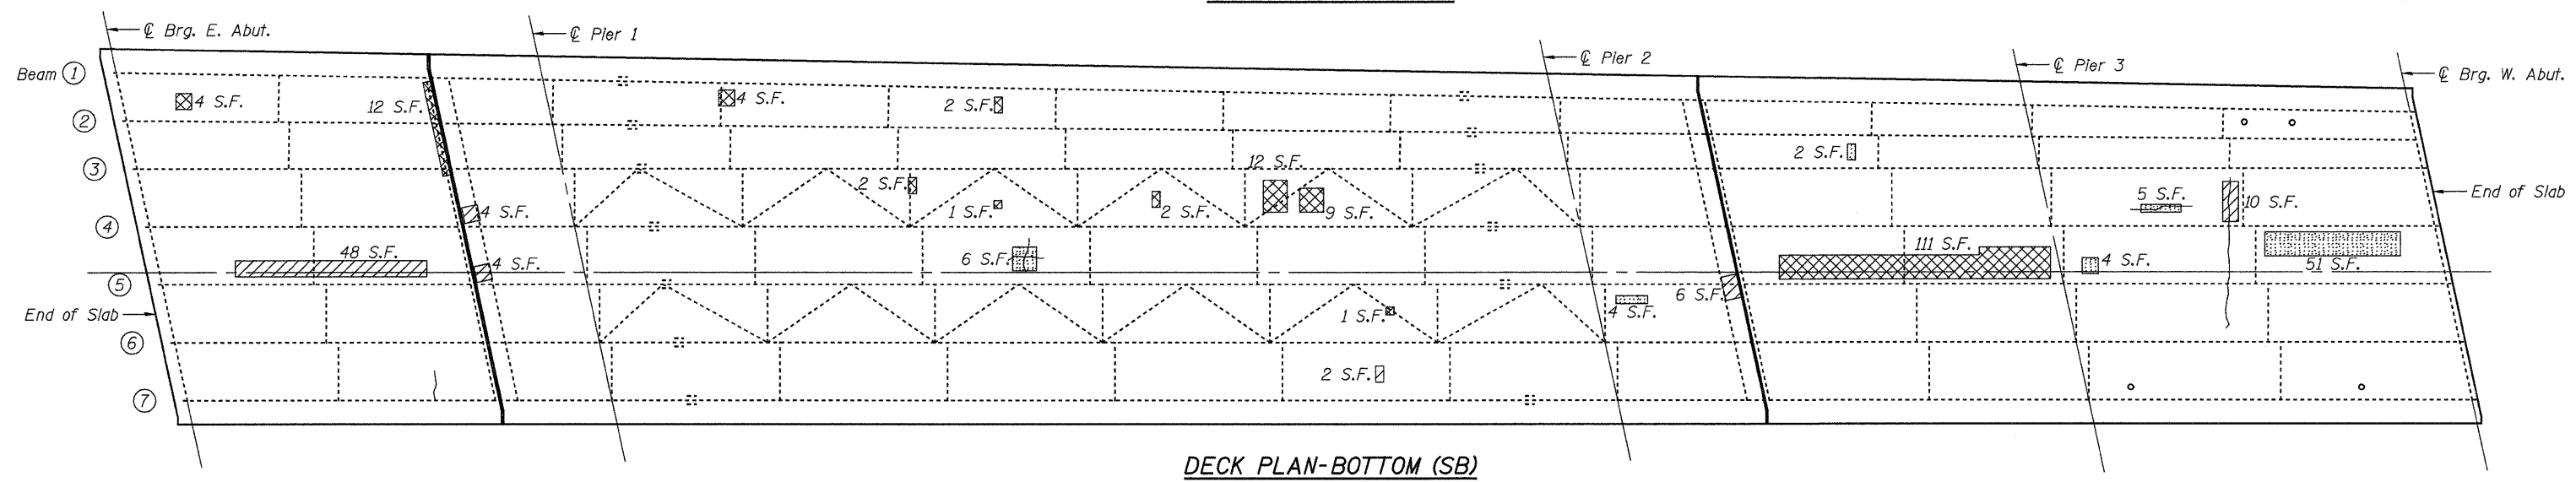
Notes:
Deck Condition Survey performed 9/16/2009.
Plan quantities assume that areas of "exposed reinforcing" greater than 5 sq. ft. will use Full-depth Type II repair.
Repair areas are estimated, the Engineer shall determine actual repair locations and record them on the As-Built plans.
Partial depth repairs are included with Bridge Deck Hydro-scarification, see Special Provision for Bridge Deck Microsilica Concrete Overlay.

Item	Unit	Total
Deck Slab Repair (Full Depth, Type II)	Sq. Yd.	15
