STATE OF ILLINOIS
DEPARTMENT OF TRANSPORTATION

DECK PLAN (SB)
STRUCTURE NO. 058-0104(NB) & 0105(SB)

SHEET 3 OF 11	F.A.P. RTE. 322	SECTION (58-20)RS	COUNTY MACON	TOTAL SHEETS 151	SHEET NO. 94
	STA. 142+55.53			CONTRACT NO. 74150	
FED. ROAD DIST. NO.		ILLINOIS FED. AID PROJECT

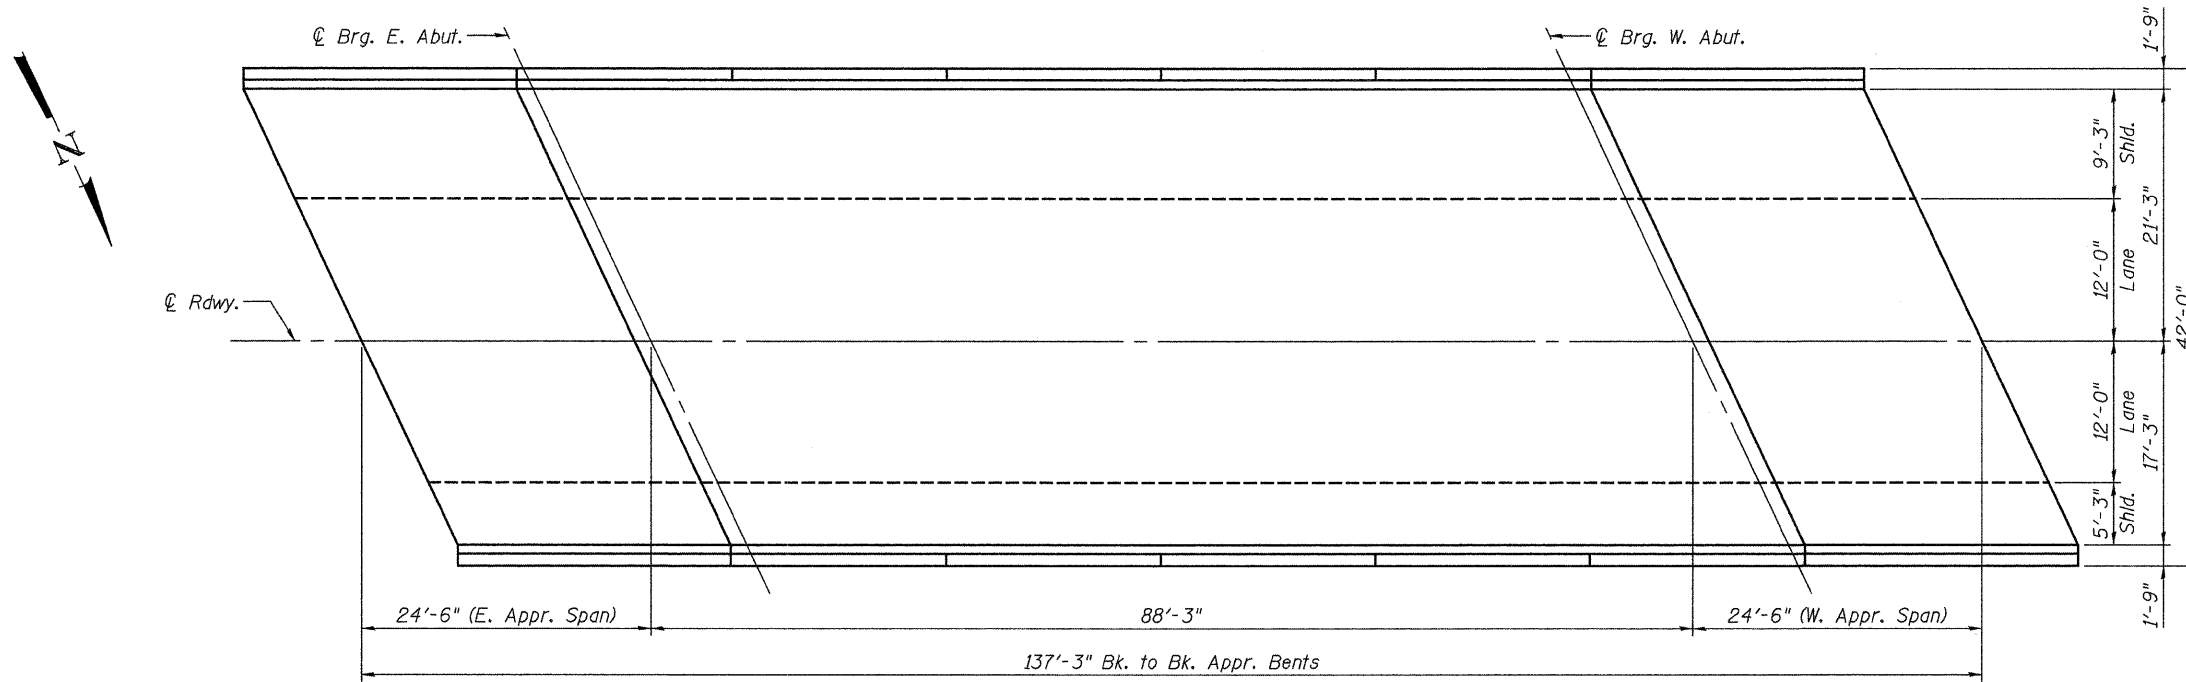
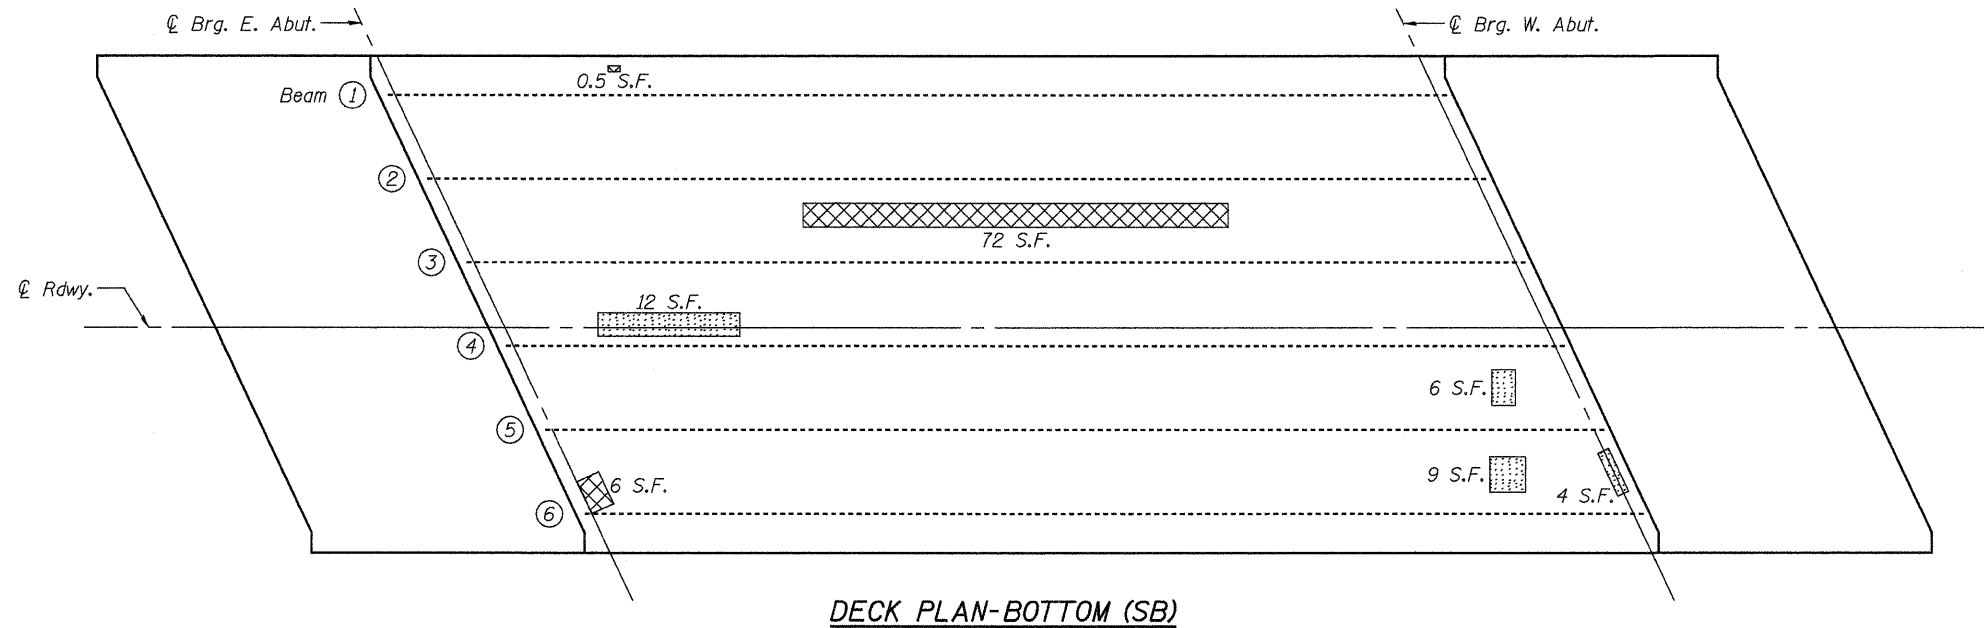
DECK PLAN-BOTTOM (SB)

Deck Condition Survey performed 9/16/2009.

Plan quantities assume that areas of "exposed reinforcing" greater than 5 sq. ft. will use Full-depth Type II repair.

Repair areas are estimated, the Engineer shall determine actual repair locations and record them on the As-Built plans.

Partial depth repairs are included with Bridge Deck Hydro-scarification, see Special Provision for Bridge Deck Microsilica Concrete Overlay.
