STATE OF ILLINOIS
DEPARTMENT OF TRANSPORTATION

DECK PLAN (SB)
STRUCTURE NO. 058-0108(SB) & 0109(NB)

| SHEET 4 OF 26 | F.A.P. RTE. 322 | SECTION (58-20)RS | COUNTY MACON | TOTAL SHEETS 151 | SHEET NO. 106 |

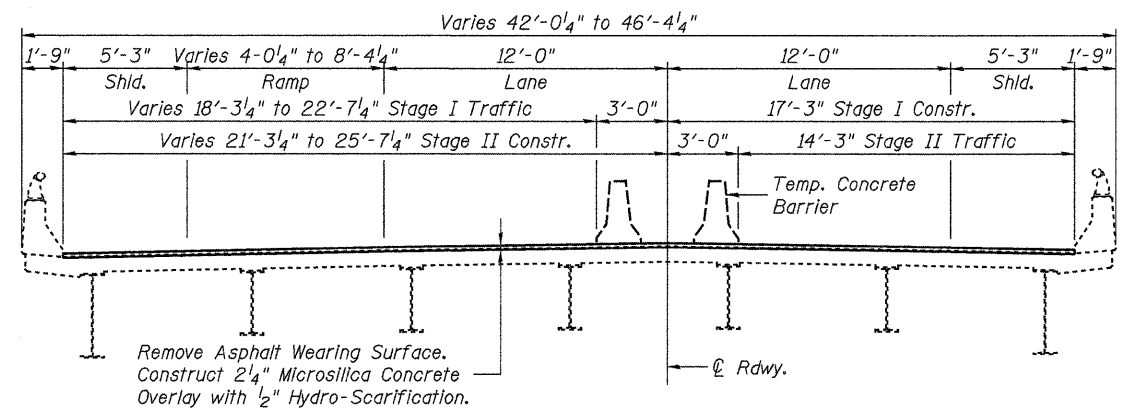
DECK PLAN-BOTTOM (SB)

Notes:
 Deck Condition Survey performed 9/17/2009.
 Plan quantities assume that areas of "exposed reinforcing" greater than 5 sq. ft. will use Full-depth Type II repair.
 Repair areas are estimated, the Engineer shall determine actual repair locations and record them on the As-Built plans.
 Partial depth repairs are included with Bridge Deck Hydro-scarification, see Special Provision for Bridge Deck Microsilica Concrete Overlay.
