ILLINOIS DEPARTMENT OF TRANSPORTATION
F.A.I. 94/90 (DAN RYAN EXPRESSWAY)
DAN RYAN ELEVATED BRIDGE
BEARING REPLACEMENT & STEEL REPAIR
STEEL REPAIRS - DETAIL B, D & F

BOWMAN, BARRETT & ASSOCIATES INC.
CONSULTING ENGINEERS
Chicago, Illinois
312.228.0100
www.bbainc.com

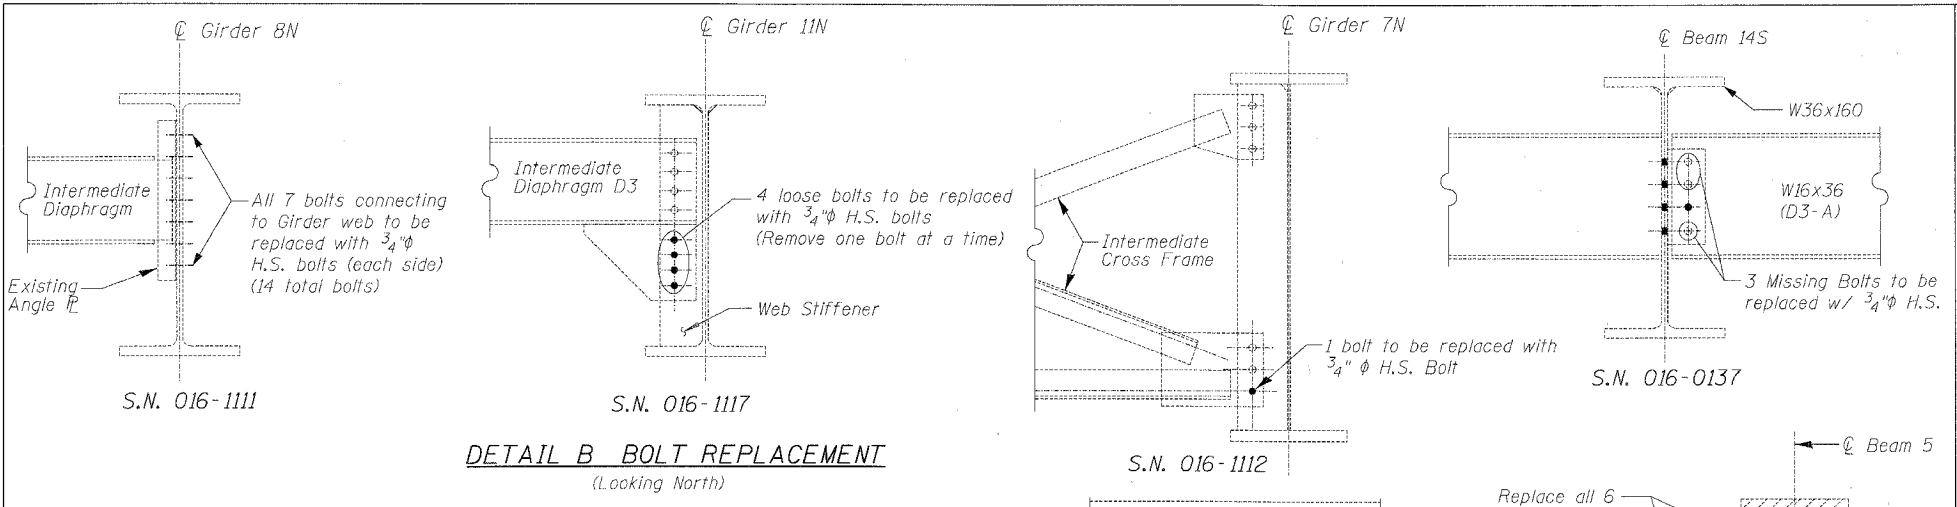
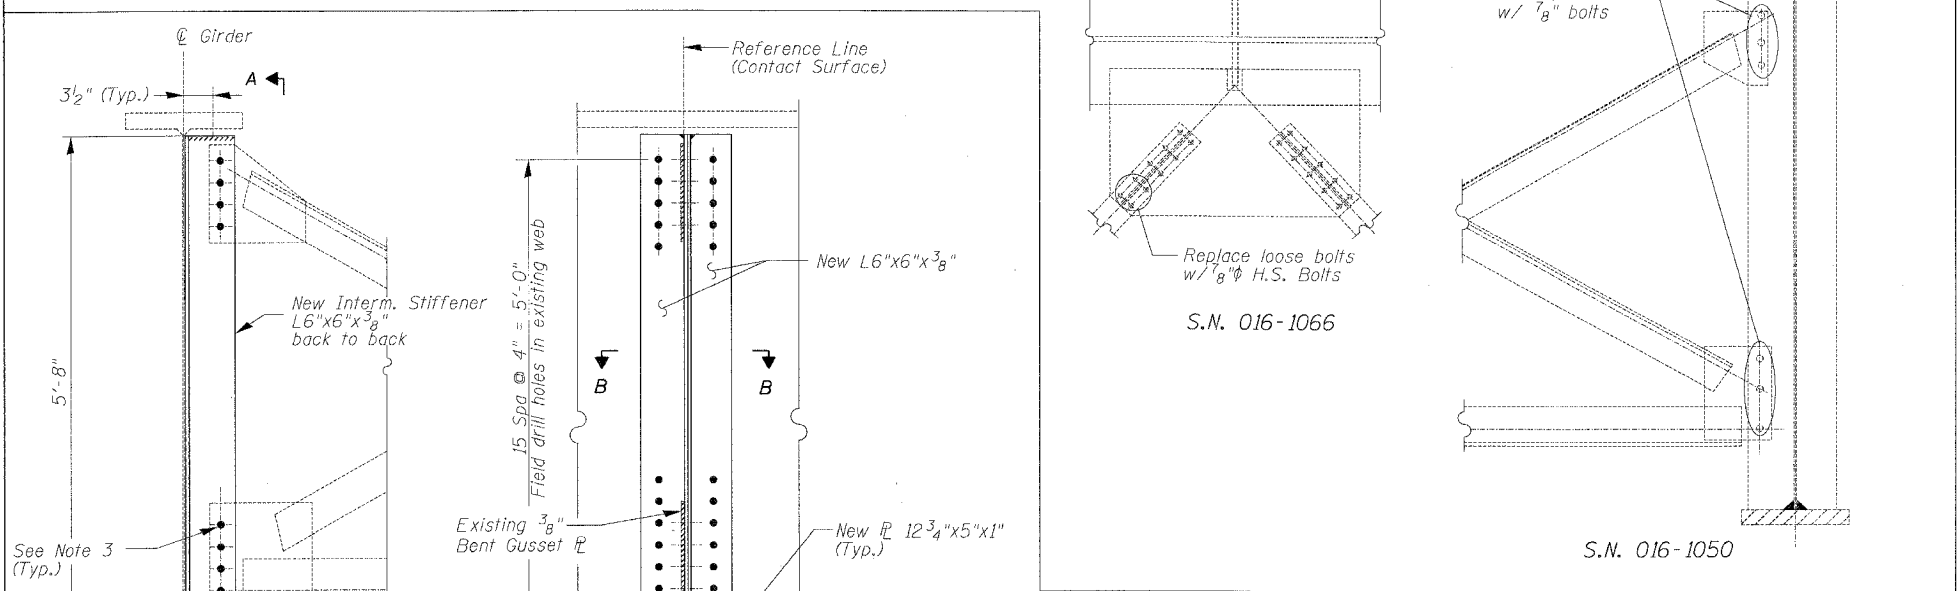
- Notes:**
1. Remove existing stiffener prior to install new bolted stiffener. See Structural Steel Repair Detail A For Cut Web Stiffener Detail.
 2. New stiffener to be vertical & 90 degrees to web.
 3. For gusset plate connections, bolt holes shall be field drilled to match existing locations or as directed by Engineer. For location where gusset plate is not present (S.N. 016-1114, Girder 1N of Span 3), no connection bolt and hole is required.
