ROUTE NO.	SECTION	COUNTY	TOTAL SHEETS	SHEET NO.
FAP 698 (IL 89)	(IB-D) I-2	BUREAU/ PUTNAM	8	7
FED. ROAD DIST. NO. 7	ILLINOIS	CONTRACT NO. 66727

SHEET NO. 3
OF 4 SHEETS

LACING BAR REPAIR DETAILS
SPRING VALLEY BRIDGE OVER ILLINOIS RIVER
F.A.P. 698 (IL 89) SEC. (IB-D)I-2
BUREAU/PUTNAM COUNTIES
S.N. 078-0006

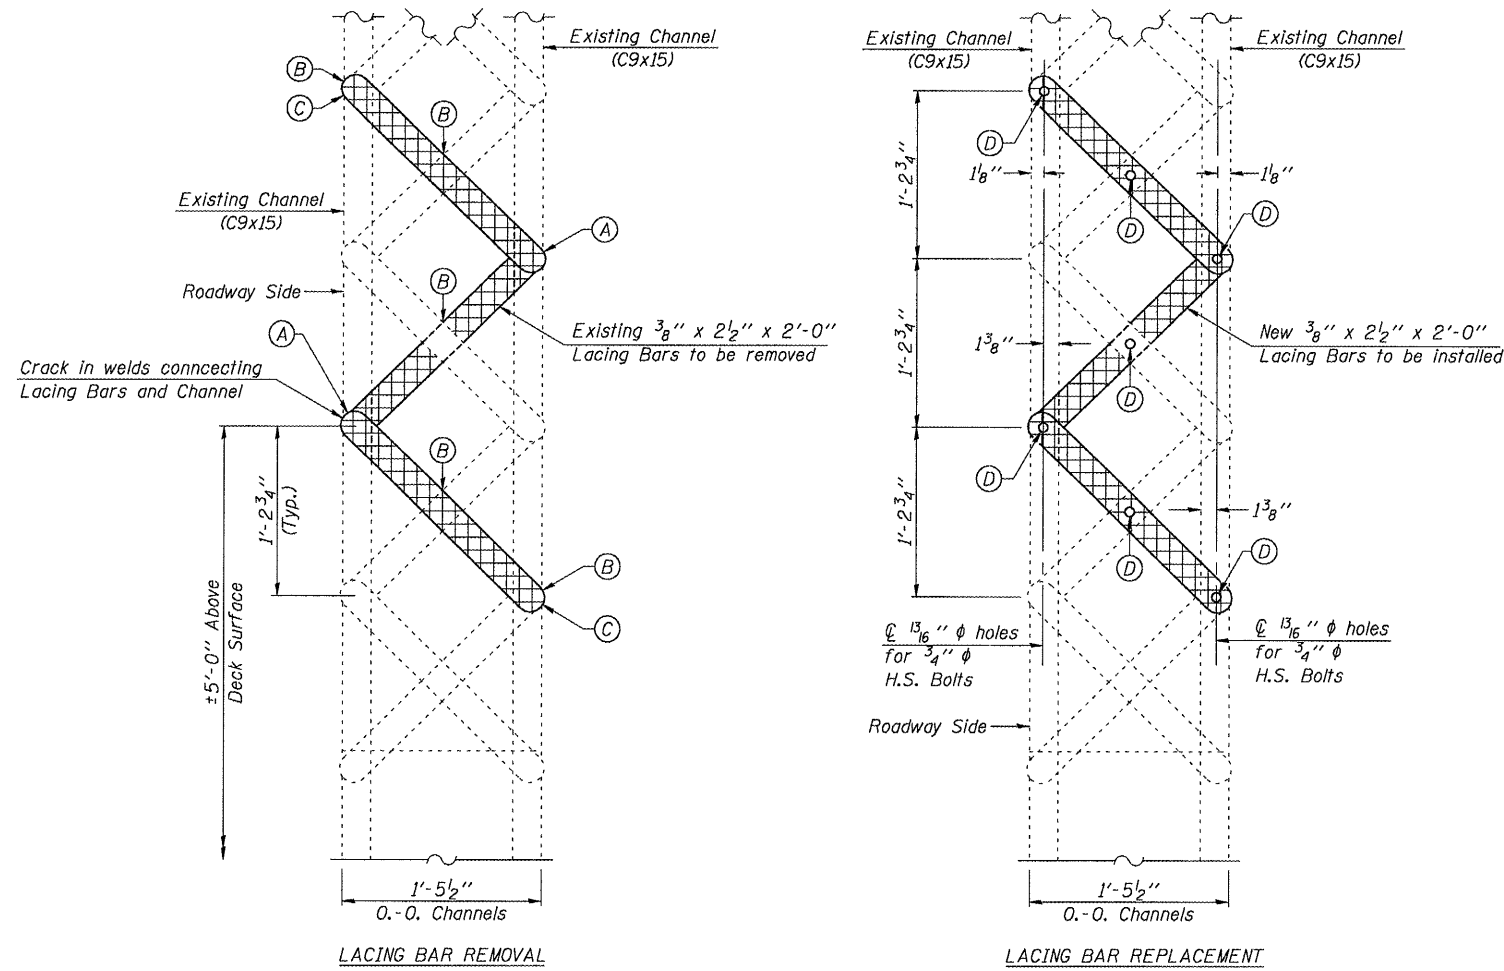
**LACING BAR RETROFIT AT
VERTICAL U₃L₃ - EAST TRUSS - SPAN 10**
(Looking North)
(Retrofit Applied Only to South Face of Vertical)

Notes: Cross hatching indicated lacing bars to be removed and replaced.

All existing lacing bars at Vertical U₃L₃ are welded to the vertical channel sections and to intersection lacing bars.

- (A) Remove the lacing bars and all weld material from the surface of the channel flange. All weld material at the location where the lacing bars were attached to the channel flange shall be removed by grinding. The grinding shall be sufficient to remove all cracks and defects in the surface of the channel section and should be done in a vertical direction parallel to the longitudinal axis of Vertical U₃L₃. The grinding shall provide a smooth transition from the deepest point of grinding to the original surface of the channel flange. After grinding, the surface shall be inspected using Magnetic Particle Testing to ensure that no cracking is present in the base metal of the channel section. If grinding to a depth of 1/8 inch is accomplished and cracks are identified in the base metal of the channel section, grinding operation shall be suspended and conditions reported to the Bureau of Bridges and Structures for further disposition.

- (B) The welds, connecting the lacing bars to be removed, to the lacing bars to remain, shall be removed by grinding. The grinding shall be sufficient to provide a flat and even contact surface to facilitate the installation of new lacing bars.

- (C) After the top lacing bar is removed, the weld material connecting the lower lacing bar to the channel section shall be ground to remove defects and inspected by Magnetic Particle Testing to verify that no cracks are present in the weld material or base metal of the channel section. If cracks are identified, the installation of new lacing bars and the drilling of bolt holes at the cracked location shall be suspended and conditions reported to the Bureau of Bridges and Structures for further disposition.

- (D) Using new lacing bars as a template, drill 13/16 inch dia. holes in existing lacing bars and channel flanges; connect lacing bars with 3/4 inch dia. H.S. bolts.
