STATE OF ILLINOIS  
DEPARTMENT OF TRANSPORTATION

ROUTE NO.	SECTION	COUNTY	SHEET NO.	SHEET	SHEET NO. 13 18 SHEETS
FAS 899	8BR-2	SALINE	75	48	
FED. ROAD DIST. NO. 9	ILLINOIS	FED. AID PROJECT

EAST ABUTMENT  
OLD IL 13 OVER BANKSTON FORK  
FAS ROUTE 899 - SECTION 8BR-2  
SALINE COUNTY  
STATION 802+60.00  
STRUCTURE NO. 083-0036

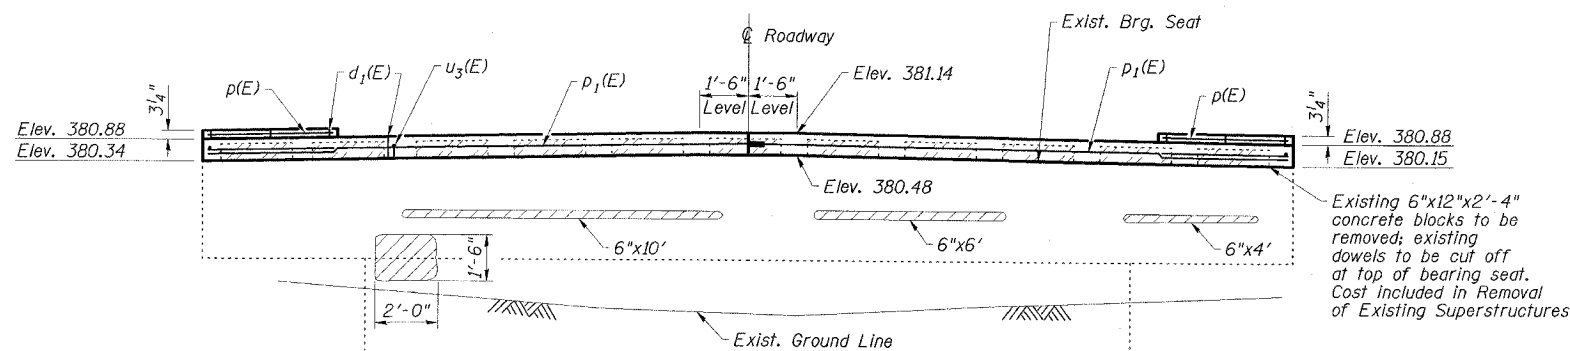
ELEVATION

ABUTMENT CRACK REPAIR LENGTHS AND STRUCTURAL REPAIR OF CONCRETE AREAS ARE ESTIMATED FROM 12-11-07 SURVEY WORK. ACTUAL LOCATIONS AND QUANTITIES OF REPAIRS SHALL BE SHOWN BY THE ENGINEER ON THE AS-BUILT PLANS FOR THIS SECTION.

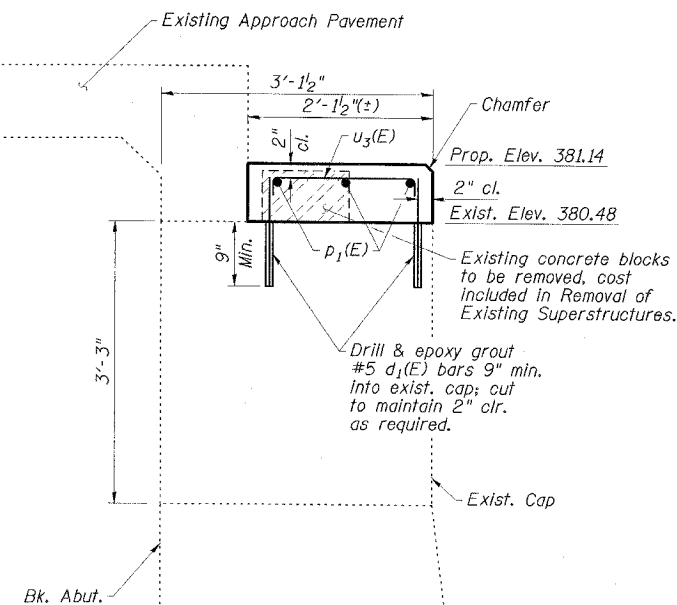
SECTION THRU ABUTMENT  
@ ROADWAY

EXISTING BEARING SEAT TO BE INSPECTED BY THE ENGINEER AFTER DECK BEAM REMOVAL. DETERIORATED CONCRETE AREAS SHALL BE REPAIRED (ESTIMATED 15 S.F. STRUCTURAL REPAIR OF CONCRETE DEPTH  $\leq$  5") AND CRACKS SHALL BE SEALED (ESTIMATED 20' EPOXY CRACK INJECTION) IF FOUND.
