Re: Asbestos Survey Report  
**Work Order No: 641**  
Parcel No. 1MF0122  
Single Family Residence  
303 Elm Road  
Barrington, Illinois 60010  
PSI Project No. 00472669

## **ASBESTOS SURVEY REPORT**

Route: US 14  
Section: At CNN RR  
County: Lake  
Parcel No: 1MF0122  
IDOT Job No: R-91-001-15  
IDOT Work Order No: 641

Single Family Residence  
303 Elm Road  
Barrington, Illinois 60010

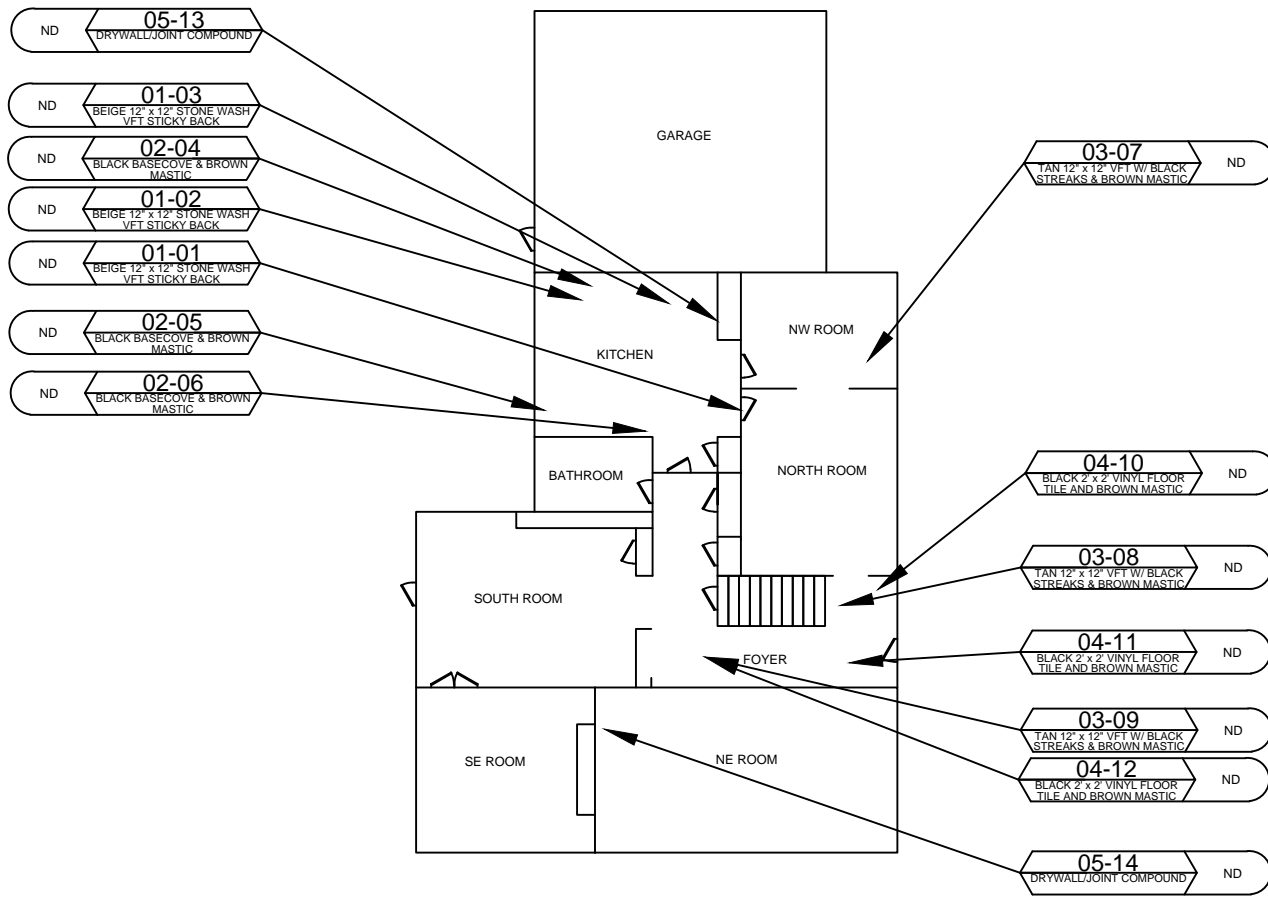
# FIRST FLOOR

ND 05-15  
DRYWALL/JOINT COMPOUND
