PRELIMINARY ENVIRONMENTAL SITE ASSESSMENT

FINAL REPORT

LOCATION: FAP 301 (US 20) from Mississippi River to Barge Terminal Road, East Dubuque, Jo Daviess County; Dubuque South and Menominee quadrangles (USGS 7.5-minute topographic map), T29N, R2W, Sections 19, 20, 28, 29, 30, 33, and 34.

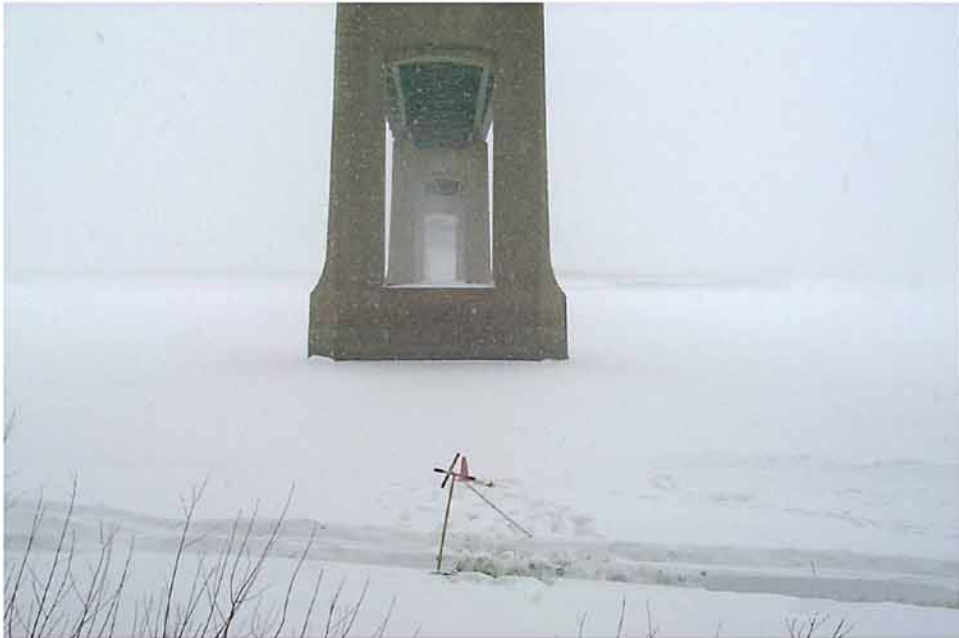
- Mississippi River (Site 1167-1), arsenic
- Former Chicago Dubuque Foundry Corp. (Site 1167-3), arsenic, lead
- J & L Vending (Site 1167-5), arsenic

2A. Mississippi River (Site 1167-1). Cone marks location of soil sample 1167-1. Photograph taken from beneath Julien Dubuque Bridge, looking west.

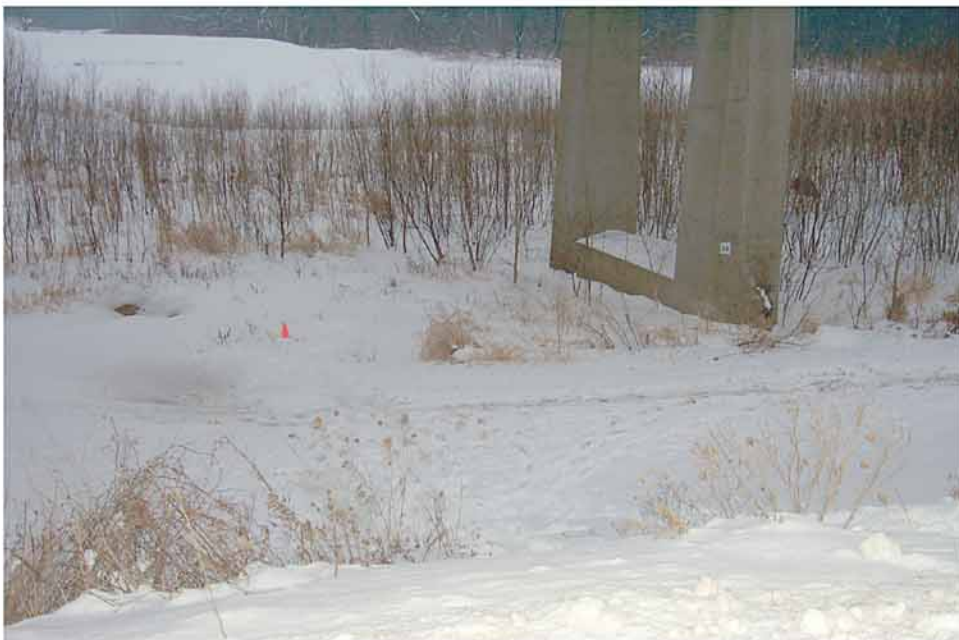
2B. Former City Garage (Site 1167-2). Cone marks location of borehole 1167-2b. Photograph taken from Boat Ramp Road, looking south.

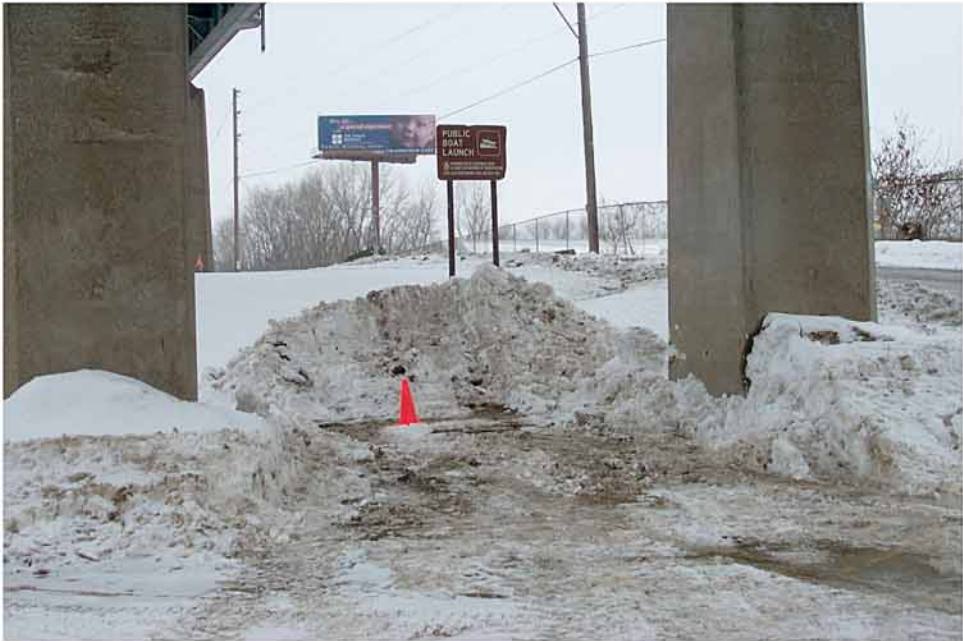
Site 1167-3. Former industrial/former UST/former RCRA site: former Chicago Dubuque Foundry Corp., northwest quadrant of 2nd Street and US 20 (210 2nd Street). This parcel contained a vacant paved lot. During the ISV, one semi-trailer was observed parked on the lot, located just south of three small buildings along the north edge. The entire lot was surrounded by a barbed-wire-topped chain-link fence.

2C. Former Chicago Dubuque Foundry Corp. (Site 1167-3). Cone marks location of borehole 1167-3b. Photograph taken from 2nd Street (foreground), looking west. Julien Dubuque Bridge is overhead. Fence at right surrounds former foundry.

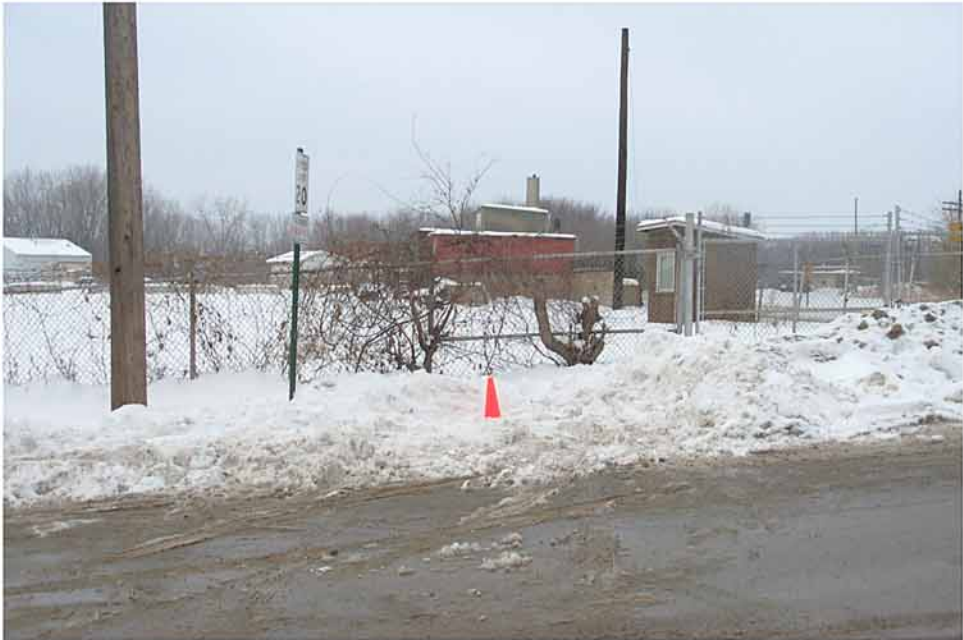
2D. Former Chicago Dubuque Foundry Corp. (Site 1167-3). Cone marks location of borehole 1167-3c; soil sample 1167-3B was also collected at approximately the site of the cone. Photograph taken from 2nd Street (foreground), looking west. Remains of foundry are at center of photograph. Current city garage and waste water treatment plant are in background.

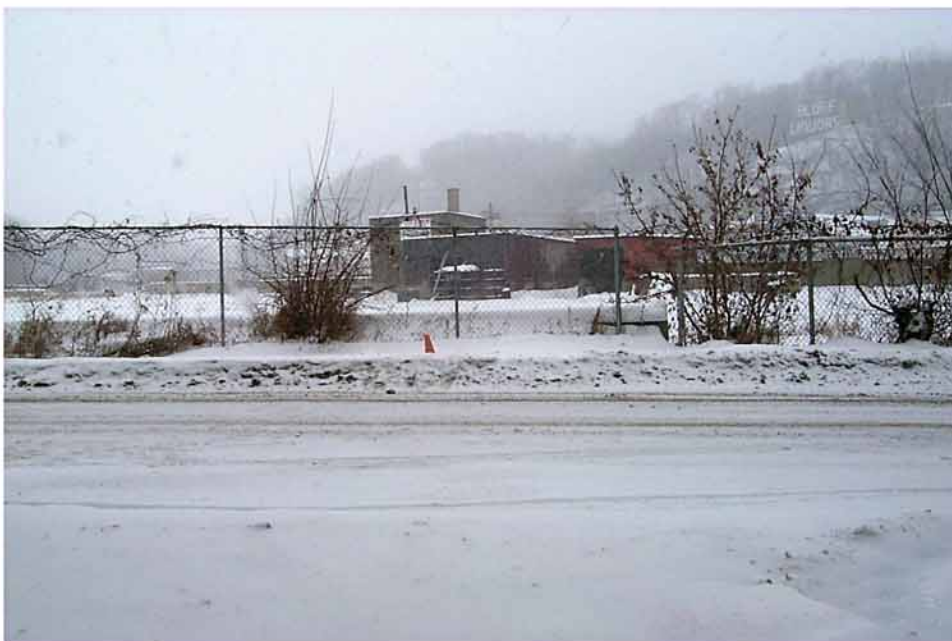
2E. Former Chicago Dubuque Foundry Corp. (Site 1167-3). Cone marks location of metals sample 1167-3A; borehole 1167-3a was bored at this approximate location also. Photograph taken from south of Boat Ramp Road (foreground), looking north.

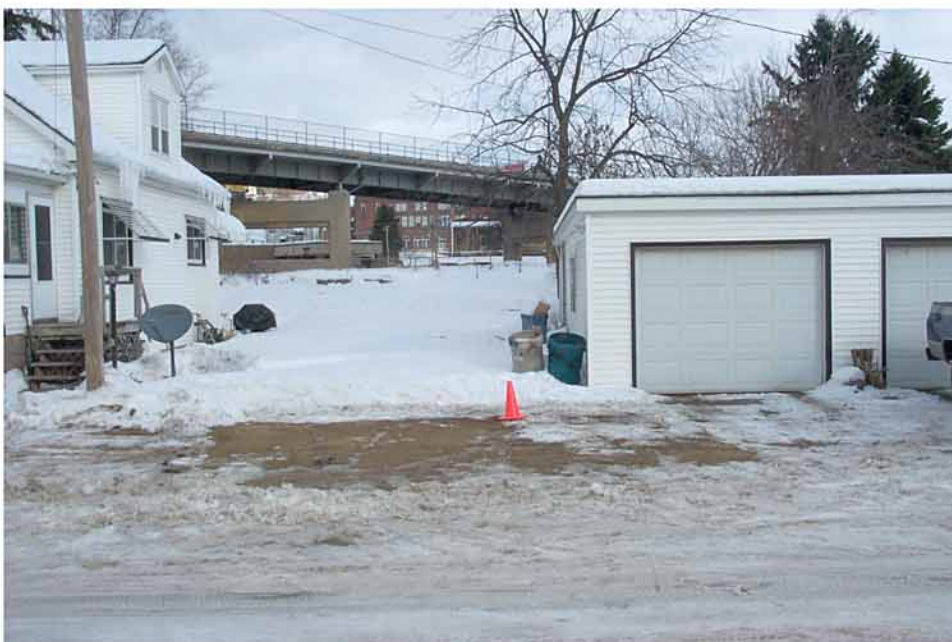
Site 1167-4. RCRA site: Residence with garage, northwest quadrant of Menominee Avenue and 3rd Street (295 Menominee Avenue). A small, single-story residence occupied this parcel. A single-stall attached garage was located on the southwest edge of the building, and a larger double-stall unattached garage was to the west. At the rear of the stand-alone garage was a steel building. Automotive body parts were observed along the north side of the garage, west of the steel building.

2F. Residence with garage (Site 1167-4). Cone marks location of borehole 1167-4a. Photograph taken from Menominee Avenue (foreground), looking north. House at left is not part of this site.

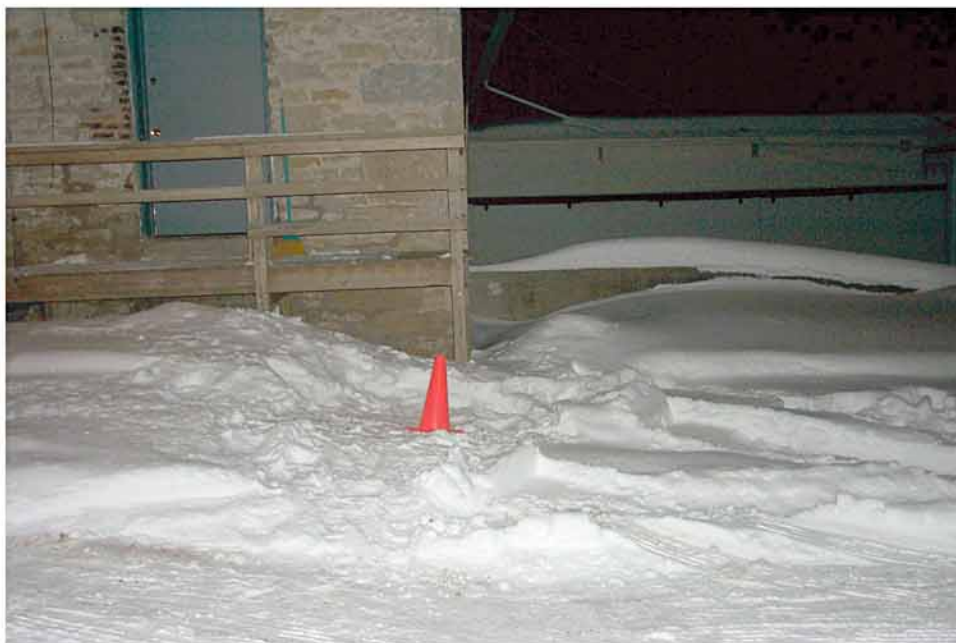
Soil retrieved from borehole 1167-5a consisted of a medium brown sandy gravel fill at 0.9 m (3 ft), a light brown sandy gravel with broken limestone at 1.8 m (6 ft), and a light brown sand at 2.7 m (9 ft). Borehole 1167-5b contained a dark brown clayey topsoil at 0.9 m (3 ft), a medium brown fine- to medium-grained sand at 1.8 m (6 ft), and a dark brown clayey silt or silty clay at 2.7 m (9

2G. J & L Vending (Site 1167-5). Cone marks location of borehole 1167-5a. Photograph taken from 3rd Street (foreground), looking east.

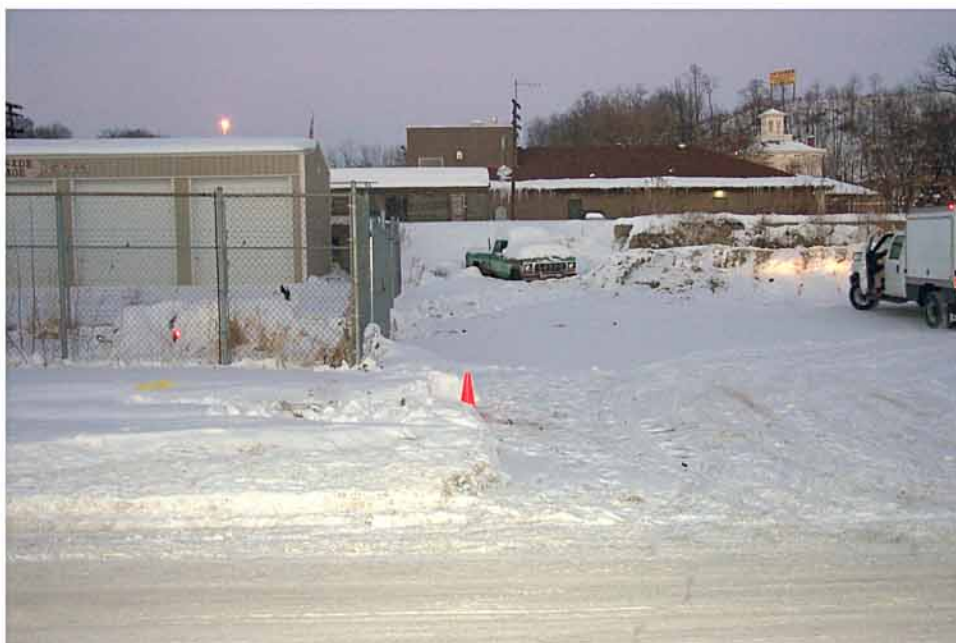
2H. J & L Vending (Site 1167-5). Cone marks location of borehole 1167-5B. Photograph taken from 3rd Street (foreground), looking east. Railroad tracks are on rise in background.

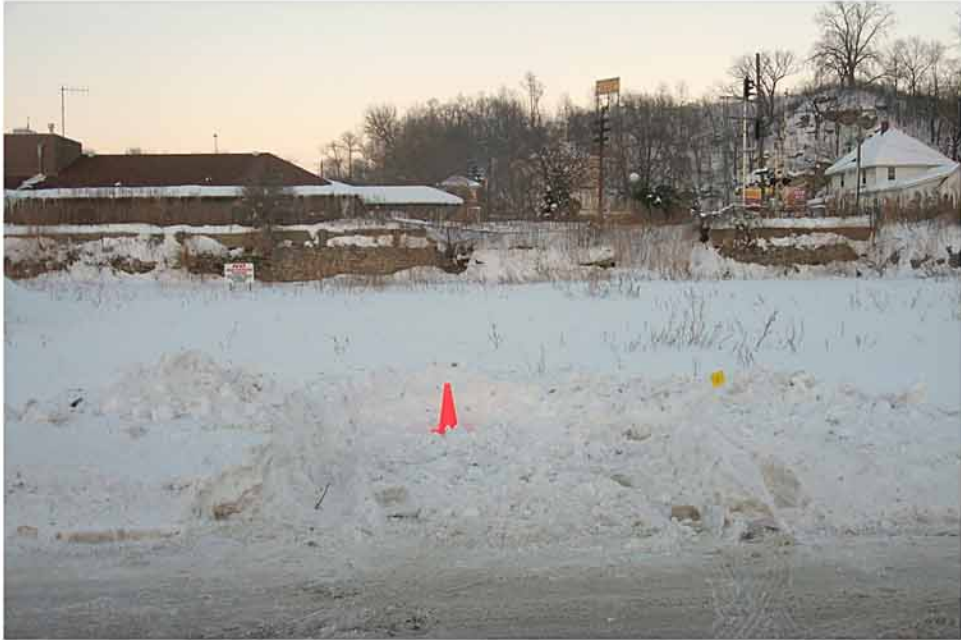
2I. J & L Vending (Site 1167-5). Cone marks location of borehole 1167-5c. Photograph taken from Menominee Avenue (foreground), looking north. Railroad tracks are on rise in background.

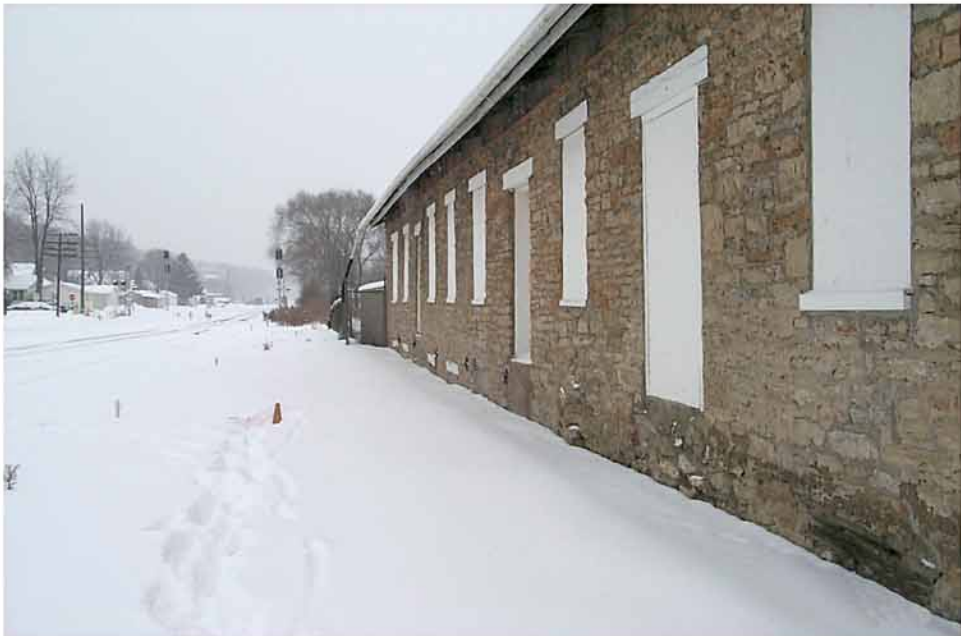
2J. J & L Vending (Site 1167-5). Cone marks location of soil sample 1167-5. Photograph taken from west end of building, looking east. Railroad tracks area at left.

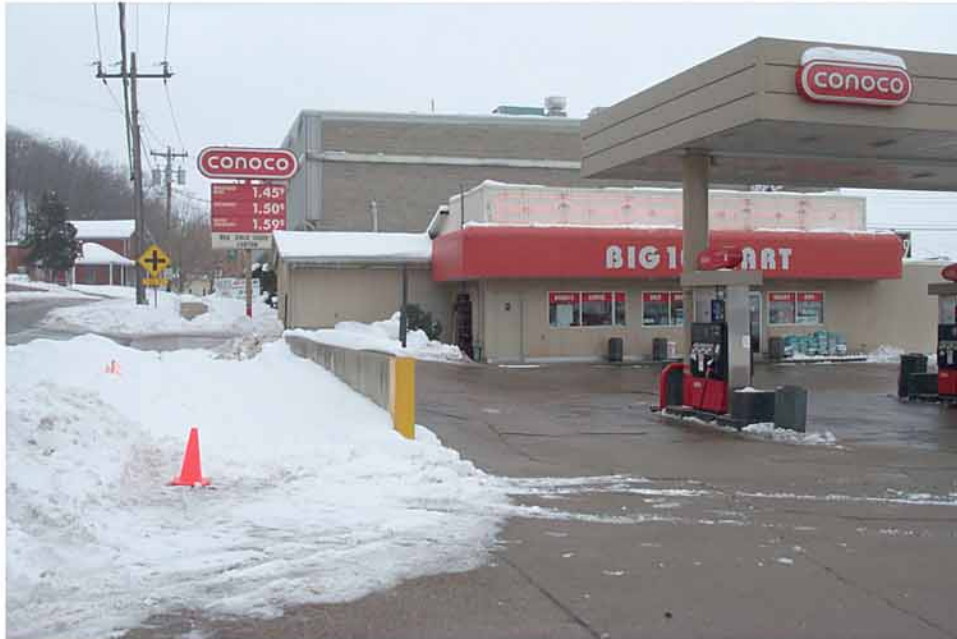
A sandy silt fill was retrieved from a depth of 0.9 m (3 ft) in borehole 1167-6a. An orangish brown silt was collected from a depth of 1.8 m (6 ft). Bedrock was encountered at a depth of 2.4 m (8 ft), and the material on top of bedrock consisted of broken limestone, dark brown silt, and light brown sand. Borehole 1167-6b penetrated silt throughout, ranging from a dark brown silt at a depth of 0.9 m (3 ft) to a reddish brown clayey silt at depths of 1.6 and 2.7 m (6 and 9 ft).

2K. Molo Big 10 Mart (Site 1167-6). Cone marks location of borehole 1167-6a. Photograph taken from northwest quadrant of parcel, looking east. US 20 is at left.

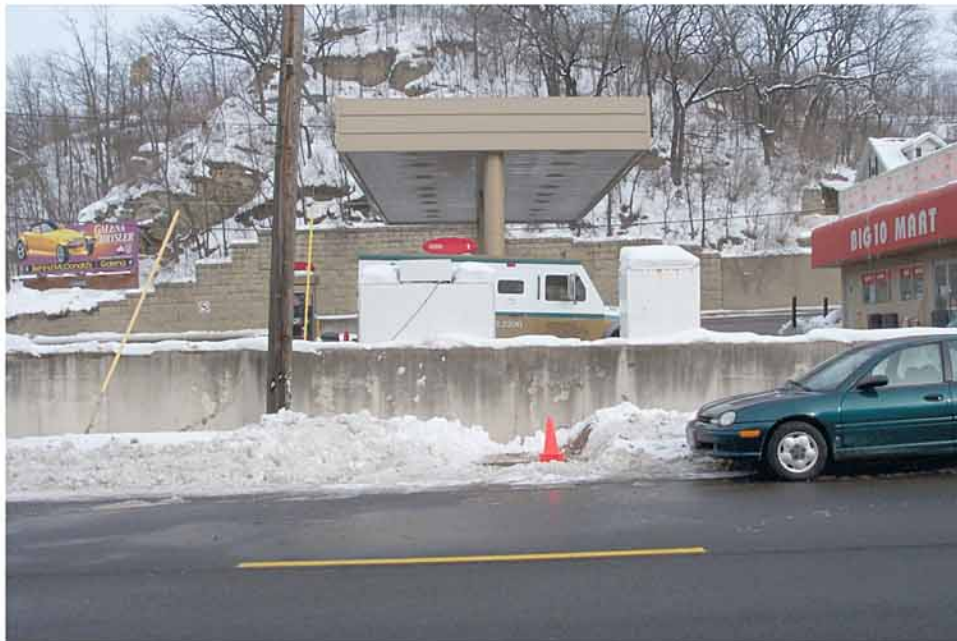
2L. Molo Big 10 Mart (Site 1167-6). Cone marks location of borehole 1167-6b. Photograph taken from south side of Wall Street (foreground), looking north. US 20 is in background, adjacent to retaining wall.

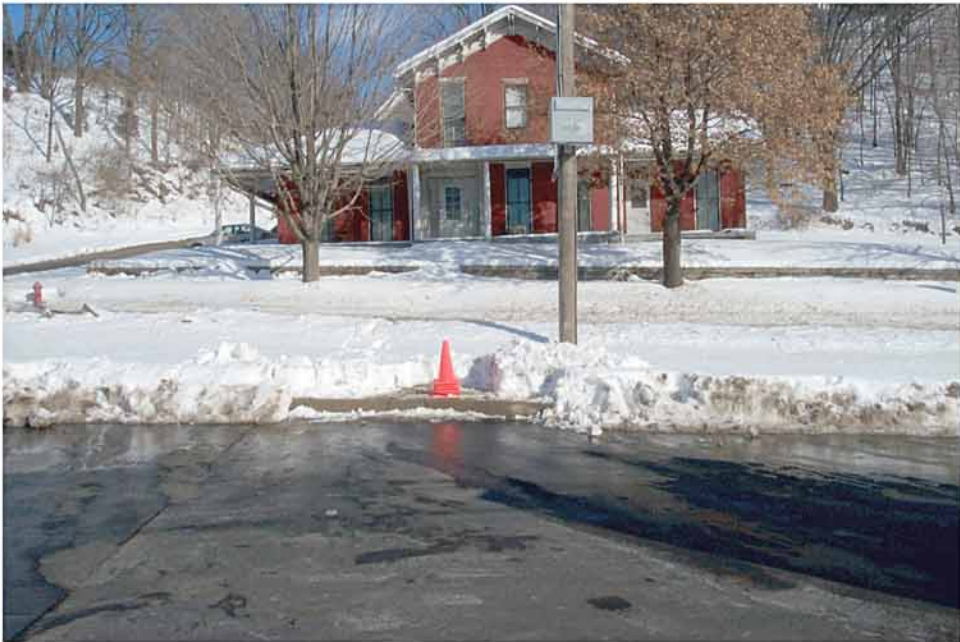
2M. Van's Liquor Store parking lot (Site 1167-7). Cone marks location of borehole 1167-7b. Photograph taken from parking lot (foreground), looking north. US 20 is on near side of red house.

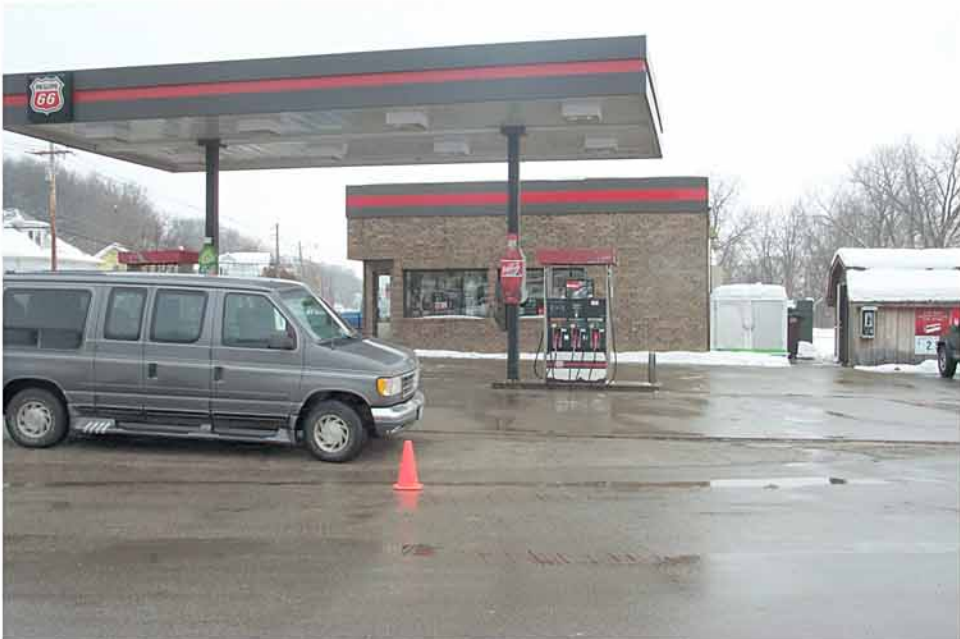
2N. Leibold Brothers Auto Center (Site 1167-8). Cone marks location of borehole 1167-8a. Photograph taken from west side of 6th Street, looking east. US 20 is at left.

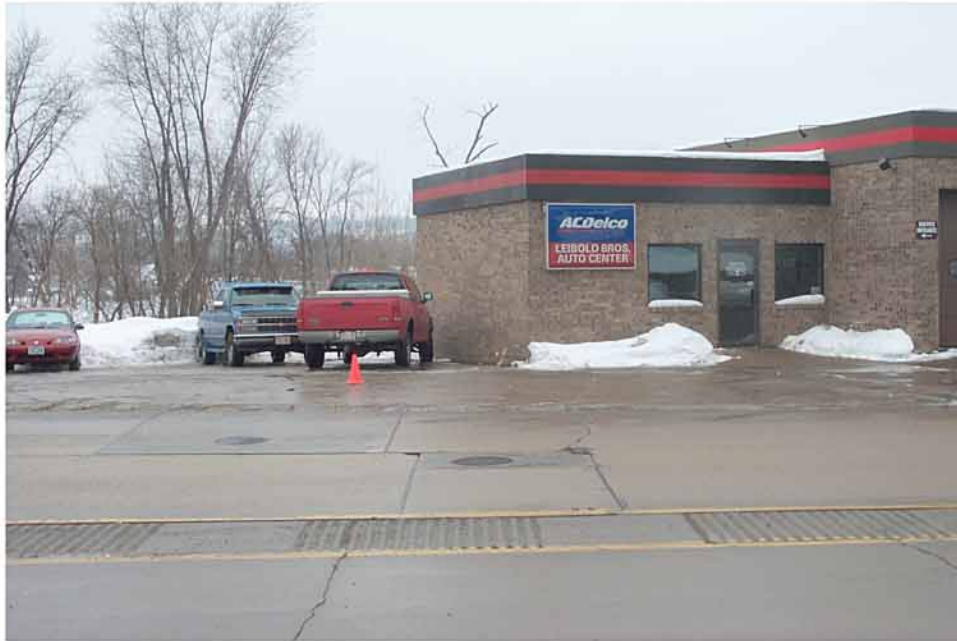
20. Leibold Brothers Auto Center (Site 1167-8). Cone marks location of borehole 1167-8c. Photograph taken from north side of US 20, looking south.

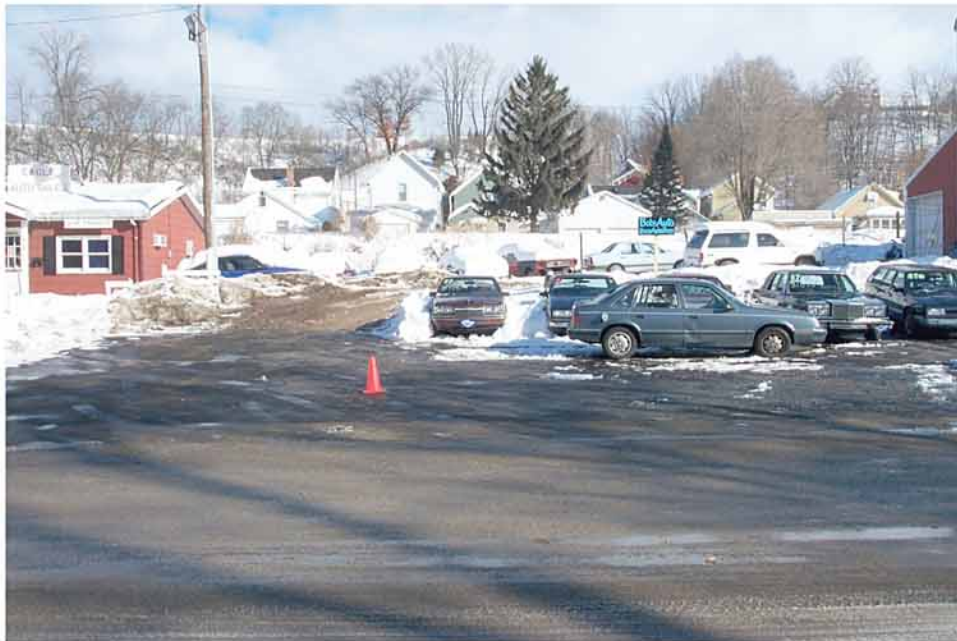
Site 1167-9. Former RCRA/commercial site: Custom Auto Repair and Service, northwest quadrant of Menominee Avenue and 6th Street (501 Menominee Avenue). The building in the northwest quadrant of this intersection contained two businesses. The building was backed by the BNSF railroad tracks. Used automobiles were for sale on the west side. A car wash was attached to the south side of the building. On the west end of the building was Custom Auto Repair and Service. The owner stated that he performed all types of automobile repair and also owned the car wash on the south side. He further stated that waste motor oil was placed in a 189-L (50-gal) AST located at the rear of the building. He said he had been here only since early 1999, and the AST had just been completely filled for the first time. Therefore, he did not know who would pick up the contents. Prior to the current business, this was the site of Kevin's Auto Diagnostic Center (Site 1167-Q). The business on the east end of the building, A & A Bait and Tackle, was closed, and that section of the building was for rent. When the site was visited on January 5, 2001, for testing, the east end of the building contained a laundromat.

2P. Custom Auto Repair and Service (Site 1167-9). Cone marks location of borehole 1167-9a. Photograph taken from south side of Menominee Avenue, looking north. Eagle Auto Sales (Site 1167-P) is at left; railroad tracks are on embankment in background.

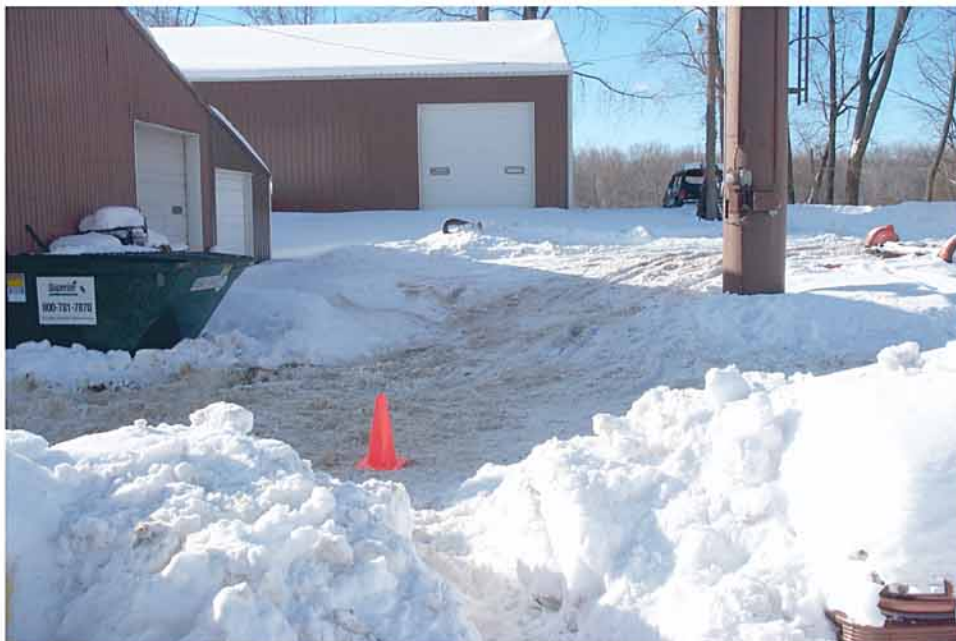
2Q. Obie's Foreign & Domestic Auto Repair (Site 1167-10). Cone marks location of borehole 1167-10a. Photograph taken from northwest quadrant of parcel, looking south. Auto service building is at left; body shop is in background.

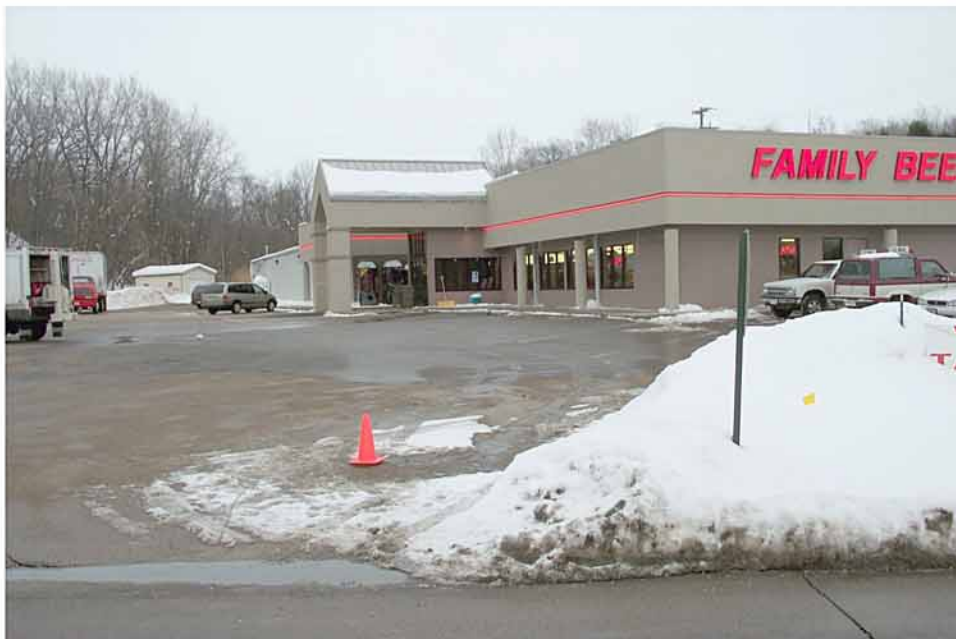
2R. Family Beer & Liquor (Site 1167-11). Cone marks location of borehole 1167-11a. Photograph taken from US 20 access road (foreground), looking north.

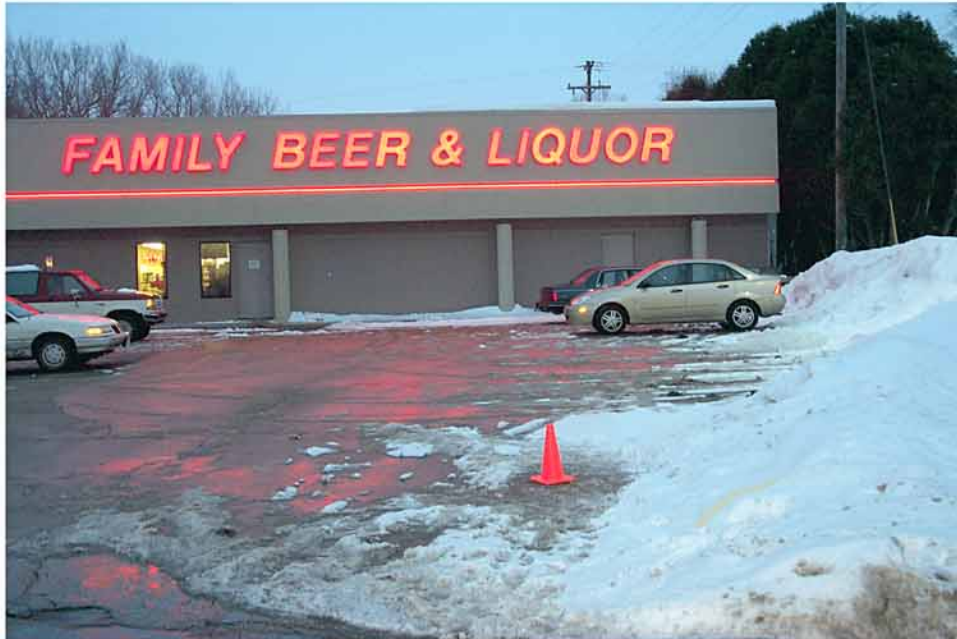
2S. Family Beer & Liquor (Site 1167-11). Cone marks location of borehole 1167-11b. Photograph taken from US 20 access road (just out of foreground), looking north.

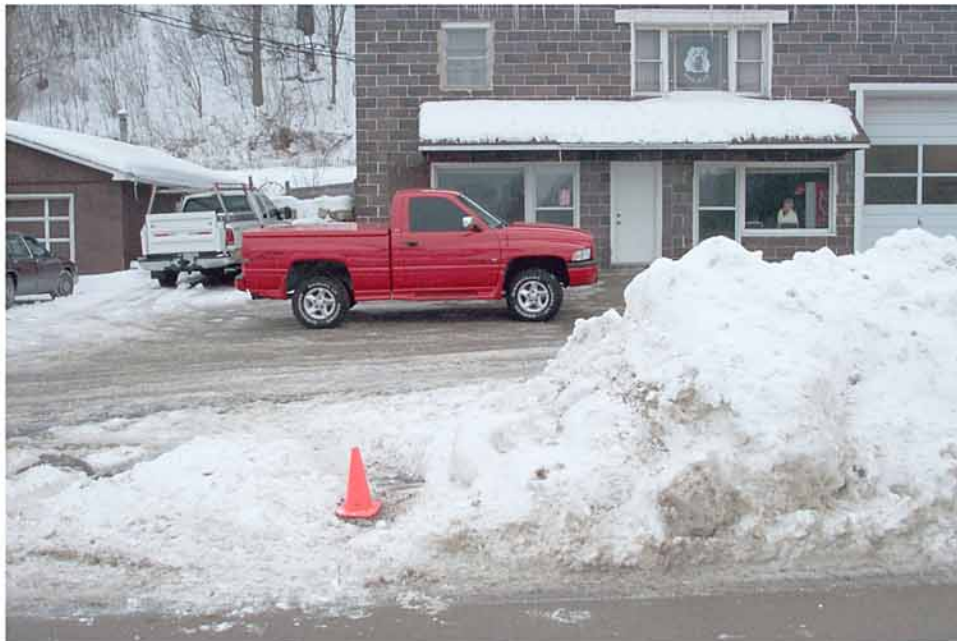
2T. Kieffer Body Shop (Site 1167-12). Cone marks location of borehole 1167-12a. Photograph taken from US 20 access road (foreground), looking north.

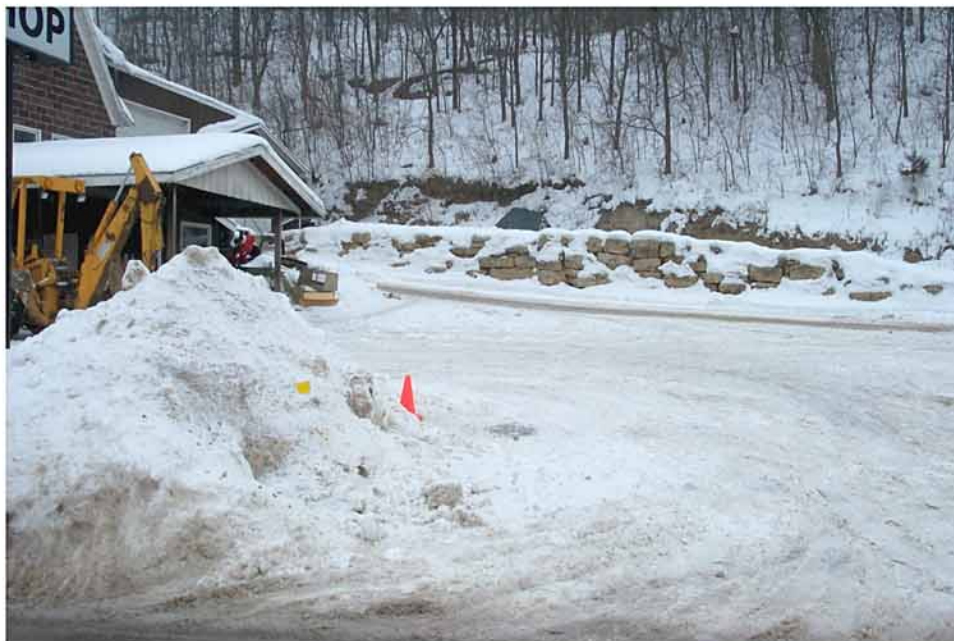
2U. Kieffer Body Shop (Site 1167-12). Cone marks location of borehole 1167-12b. Photograph taken from US 20 access road (foreground), looking north.

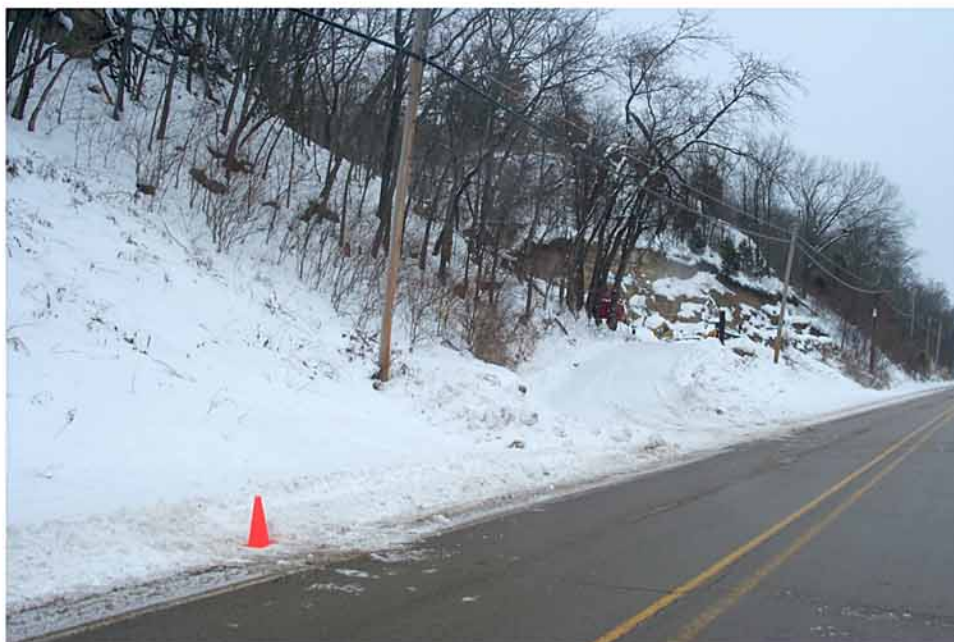
2V. Kieffer Construction storage yard (Site 1167-13). Cone marks location of borehole 1167-13a. Photograph taken from US 20 access road (foreground), looking northeast. Driveway to storage yard is at right.

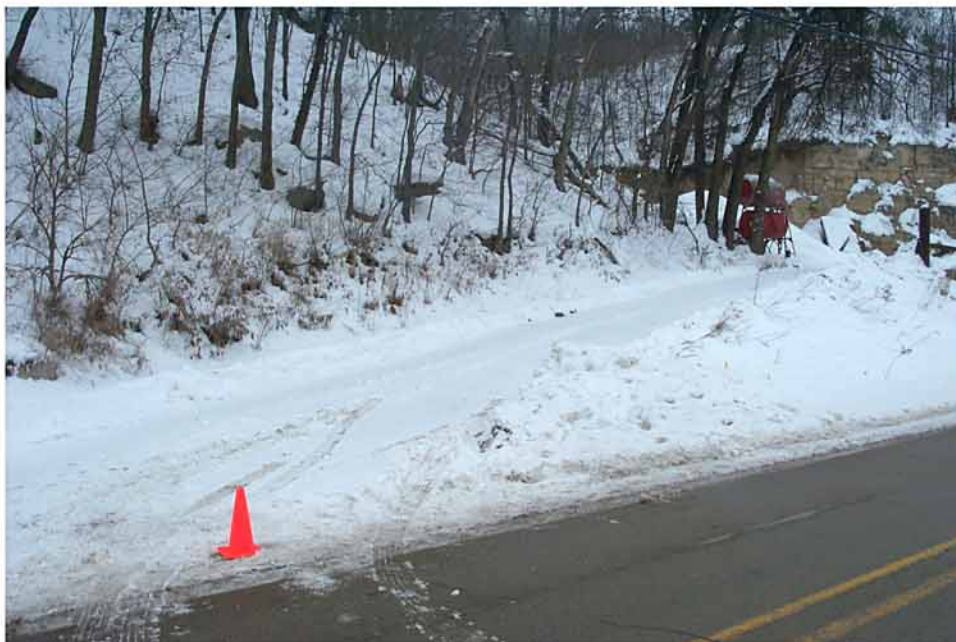
2W. Kieffer Construction storage yard (Site 1167-13). Cone marks location of borehole 1167-13b. Photograph taken from US 20 access road (foreground), looking northeast. Driveway leads to storage yard (far right).

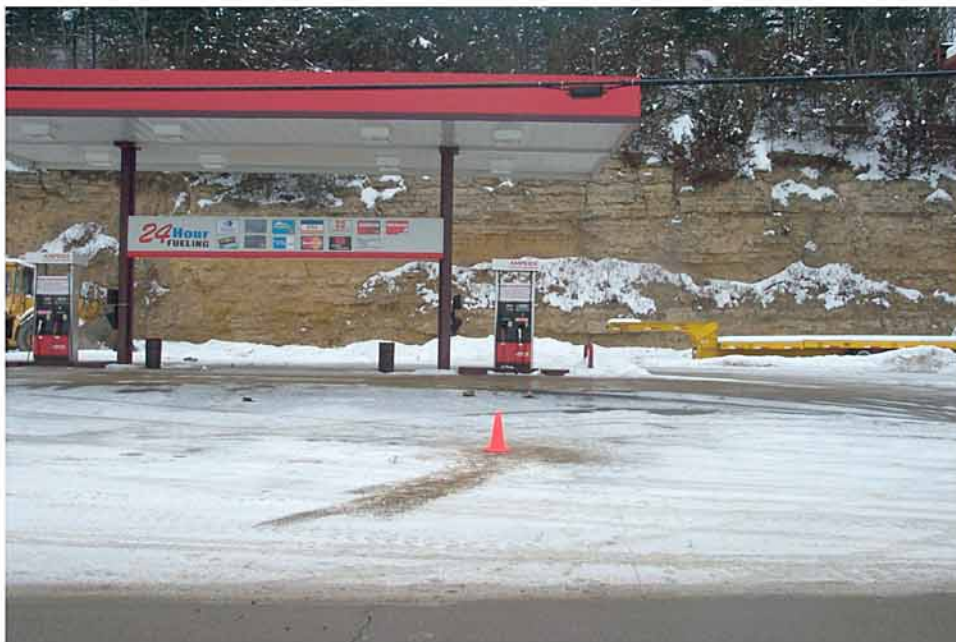
2X. Ampride gasoline station/Stewart Construction Co. (Site 1167-14). Cone marks location of borehole 1167-14a. Photograph taken from US 20 access road (foreground), looking north.

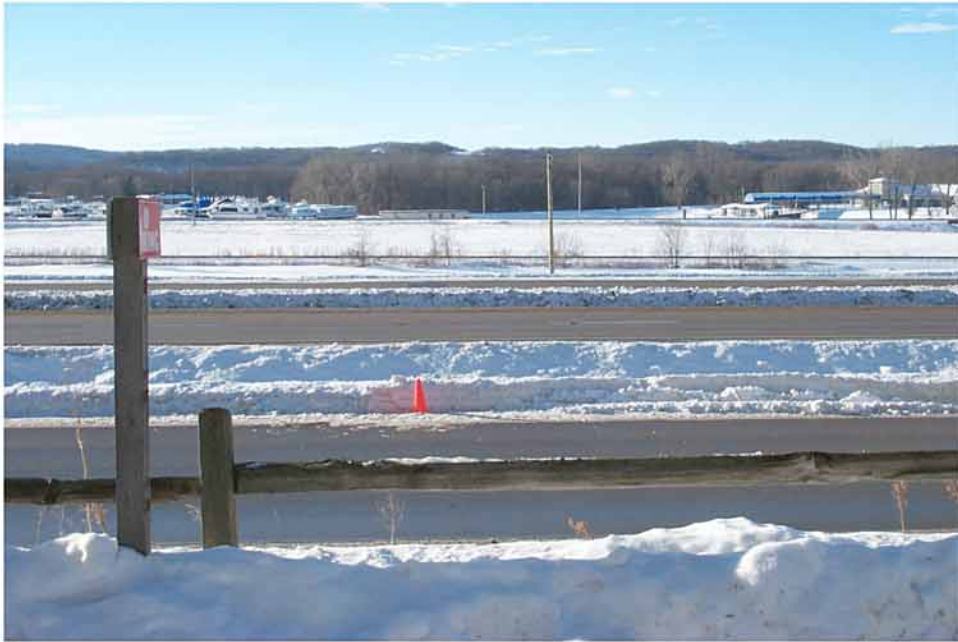
2Y. Ampride gasoline station/Stewart Construction Co. (Site 1167-14). Cone marks location of borehole 1167-14b. Photograph taken looking south from Stewart Construction Co. parking lot, north of US 20 access road (foreground). US 20 is at center of photograph; Silver Eagle Casino (Site 1167-R) is at far right.

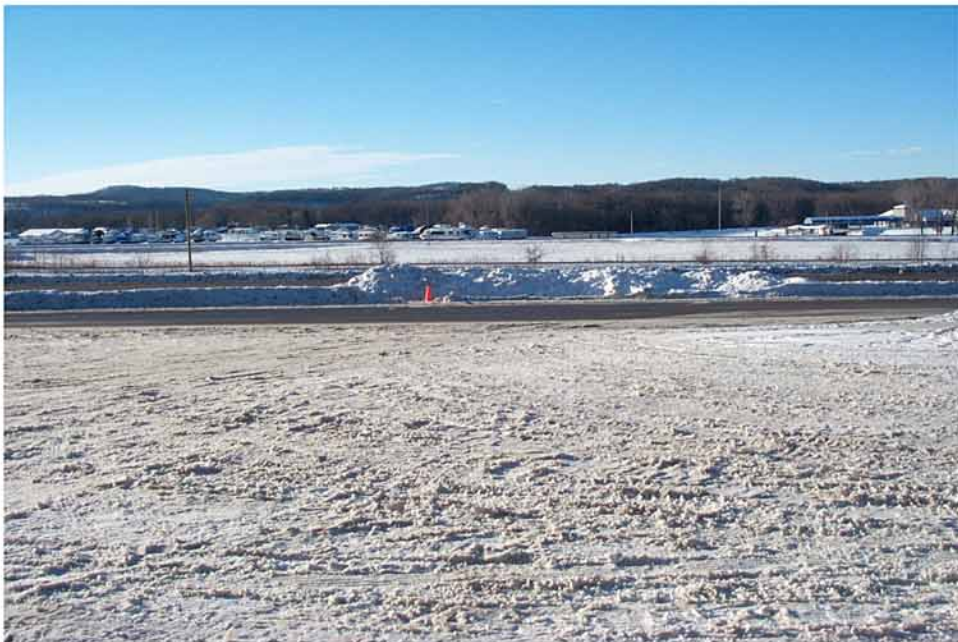
2Z. Ampride gasoline station/Stewart Construction Co. (Site 1167-14). Cone marks location of borehole 1167-14c. Photograph taken looking south from Ampride gasoline station parking lot. US 20 access road is at center of photograph, and US 20 is farther south. Silver Eagle Casino (Site 1167-R) is at far right.

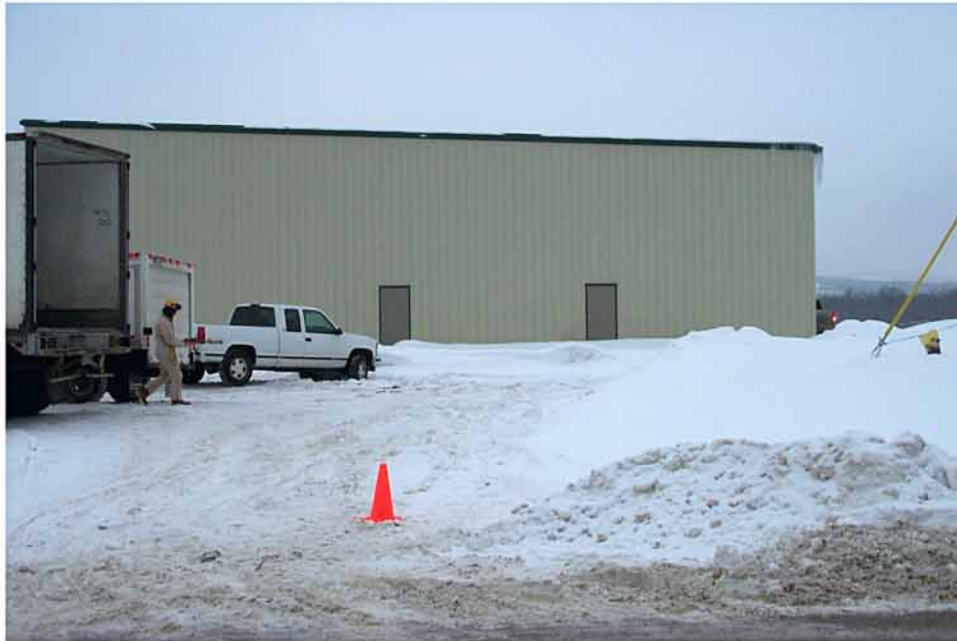
2AA. North Central Farm Lines repair shop (Site 1167-16). Cone marks location of borehole 1167-16a. Photograph taken looking south from US 20 access road (foreground). Northern Illinois Gas Station 290 (Site 1167-15) is at right.

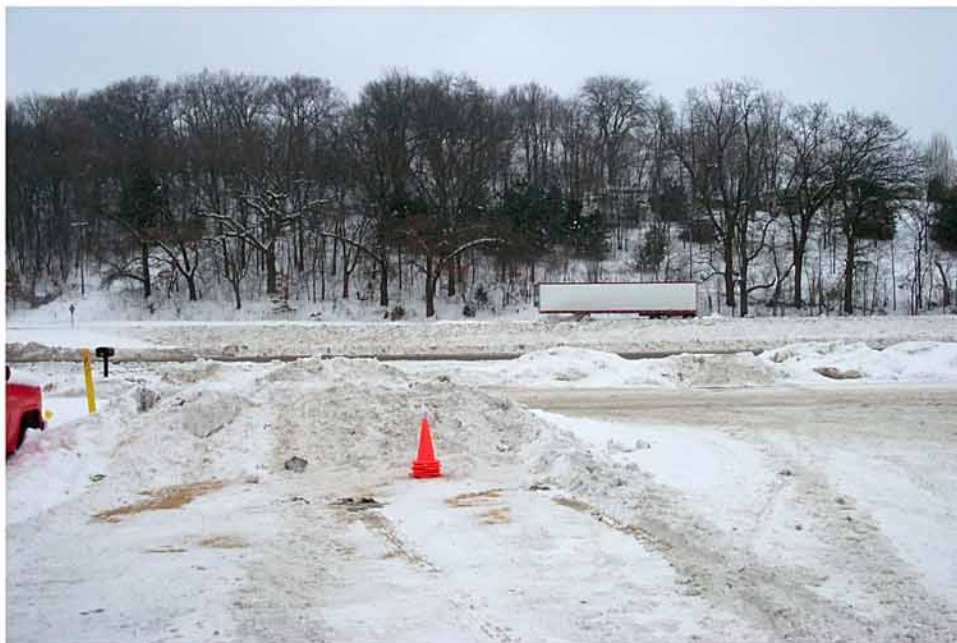
2AB. North Central Farm Lines repair shop (Site 1167-16). Cone marks location of borehole 1167-16b. Photograph taken looking north from repair shop parking lot. US 20 access road is at center of photograph; US 20 is in background.

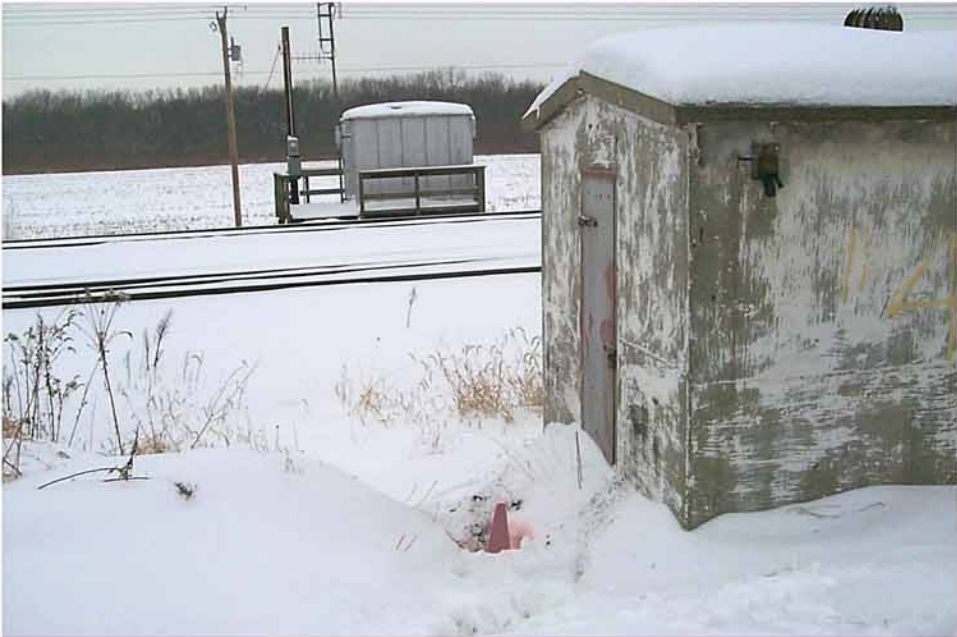
2AC. Burlington Northern Santa Fe Railroad, Murphy Bungalow (part of Site 1167-17). Cone marks location of soil sample 1167-17F. Photograph taken from south of US 20, looking south. New steel bungalow replaced old concrete bungalow.
