STATE OF ILLINOIS  
DEPARTMENT OF TRANSPORTATION

Notes:  
Deck Condition Survey performed 4/15/2010.

DECK REPAIRS  
STRUCTURE NO. 060-0195

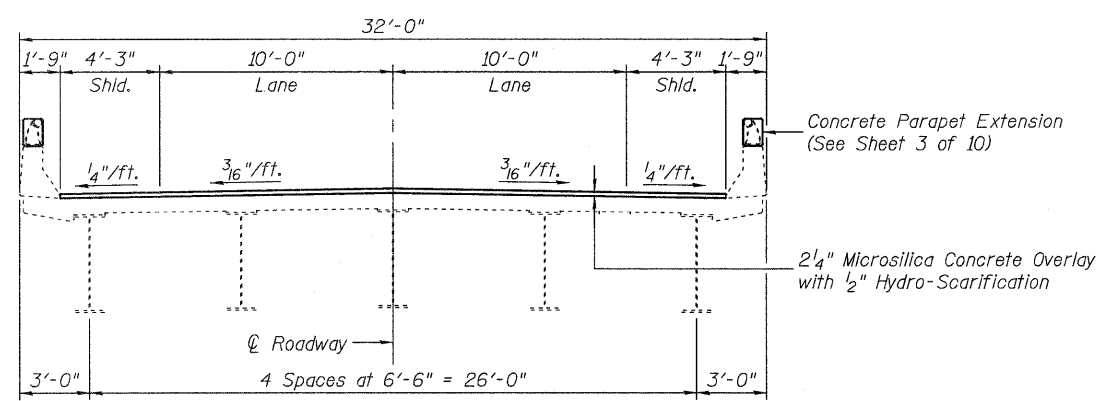
DECK PLAN-TOP

- Hollow or Unsound Concrete (380 sf)
- Spalled Concrete or Existing Asphalt Patch (348 sf)
- Spalled Concrete with Exposed Reinf. (0 sf)

Plan quantities assume that only labeled areas will use Full-depth repair. Other areas are shown for information only.

Repair areas are estimated, the Engineer shall determine actual repair locations and record them on the As-Built plans.

Partial depth repairs shall be included with Bridge Deck Hydro-scarification, see Special Provision for Bridge Deck Microsilica Concrete Overlay.
