STATE OF ILLINOIS
DEPARTMENT OF TRANSPORTATION

DECK REPAIRS
STRUCTURE NO. 060-0198

F.A.I. RTE.	SECTION	COUNTY	TOTAL SHEETS	SHEET NO.
55	60-3RS-1, 60-(3HB,3HB-1)I	MADISON	123	94
STA. 363+22.00		CONTRACT NO.	76601	
FED. ROAD DIST. NO.		ILLINOIS FED. AID PROJECT

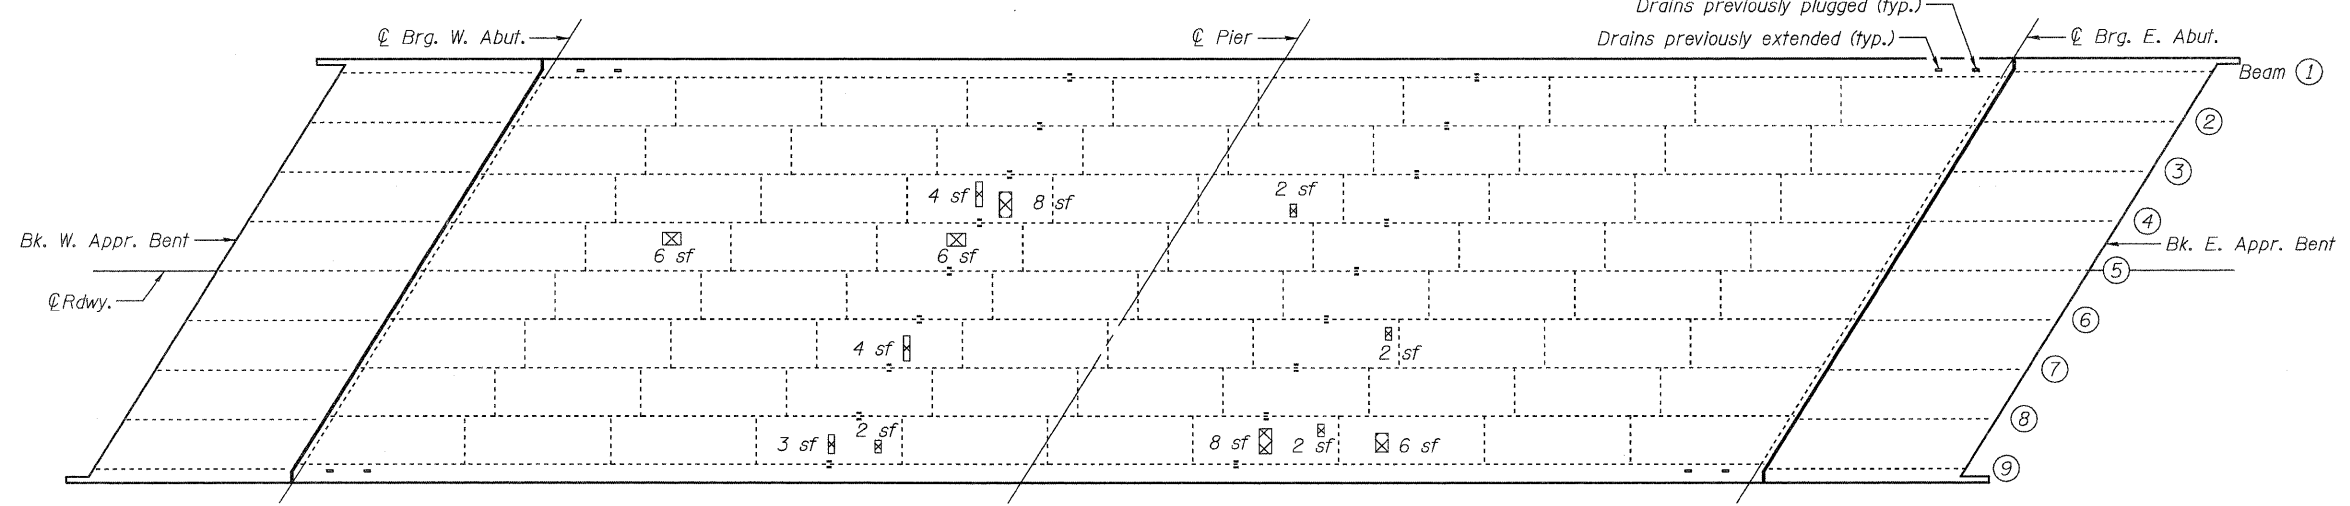
DECK PLAN-TOP

Notes:
Deck Condition Survey performed 4/15/2010.

Plan quantities assume that areas of "exposed reinforcing" greater than 5 sq. ft. will use Full-depth Type II repair. Other areas are shown for information only.

Repair areas are estimated, the Engineer shall determine actual repair locations and record them on the As-Built plans.

Partial depth repairs shall be included with Bridge Deck Hydro-scarification, see Special Provision for Bridge Deck Microsilica Concrete Overlay.
