STATE OF ILLINOIS  
DEPARTMENT OF TRANSPORTATION

DECK REPAIRS (SB)  
STRUCTURE NO. 060-0196(SB) & 0197(NB)

SHEET 3  
OF 14

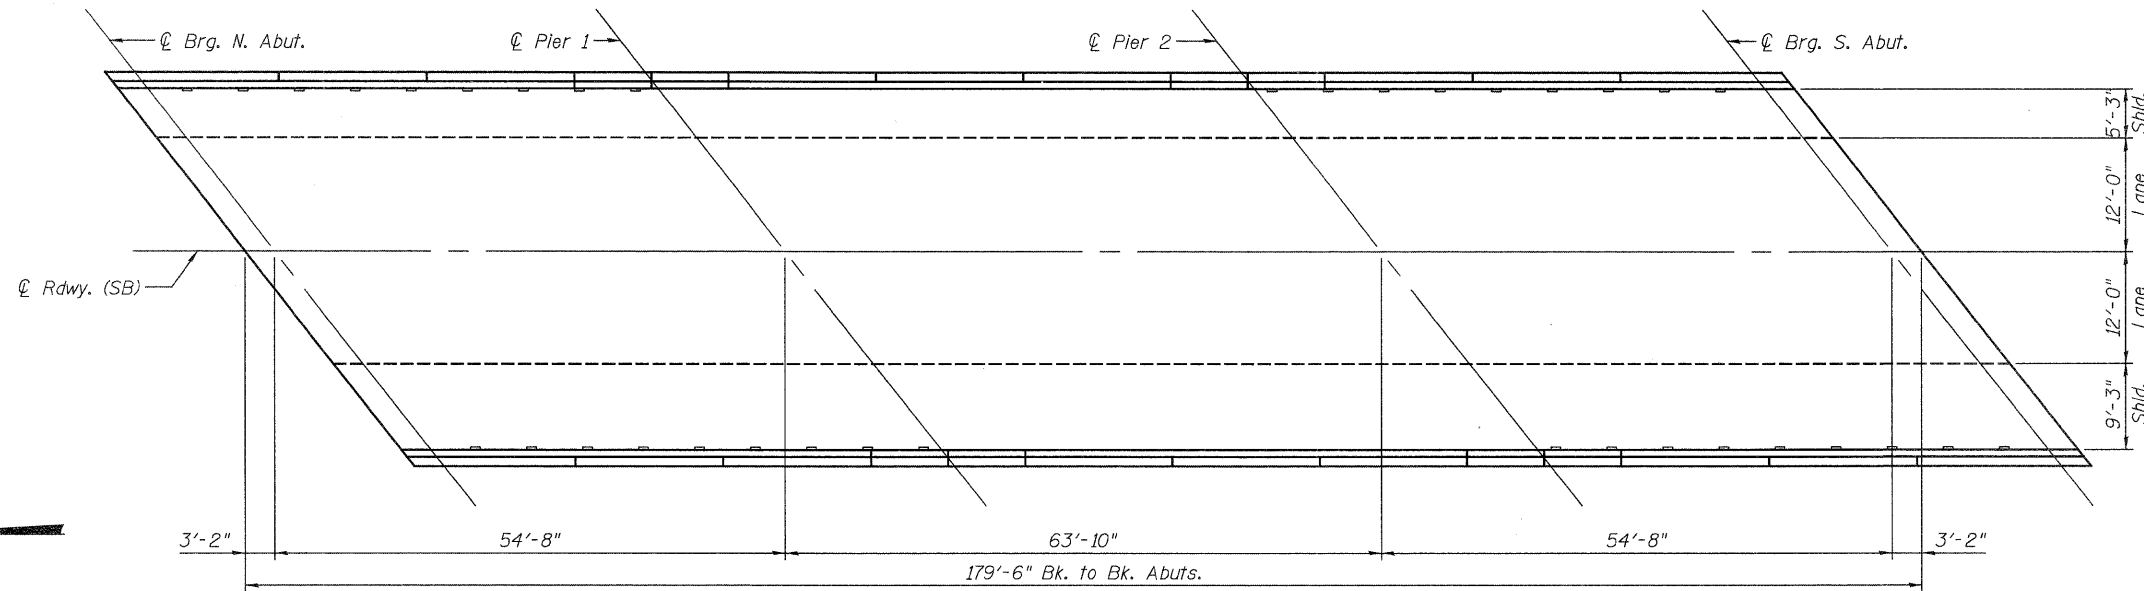
DECK PLAN-TOP (SB)

Notes:  
Deck Condition Survey performed 4/15/2010.

No full-depth repair areas are anticipated.

Repair areas are estimated, the Engineer shall determine actual repair locations and record them on the As-Built plans.

Partial depth repairs shall be included with Bridge Deck Hydro-scarification, see Special Provision for Bridge Deck Microsilica Concrete Overlay.
