STATE OF ILLINOIS
DEPARTMENT OF TRANSPORTATION

REPAIR DETAILS
SN 002-0005

SHEET NO. 11 OF 13 SHEETS

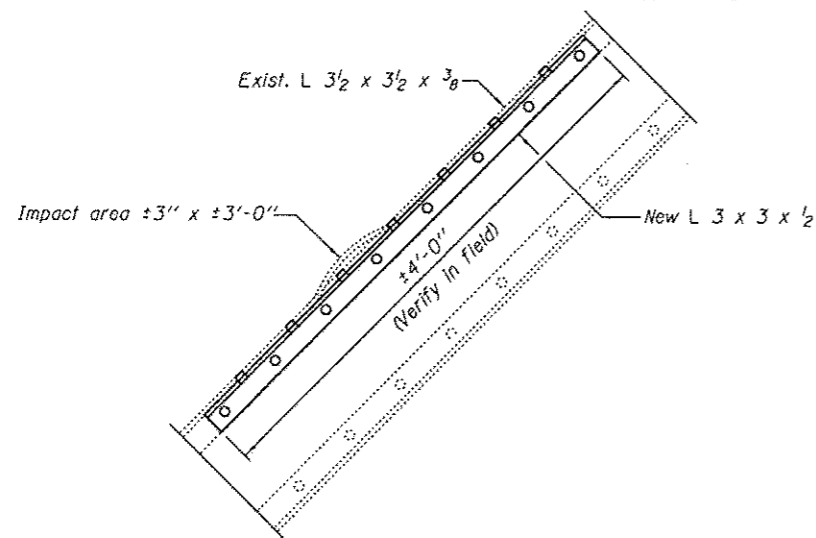
REPAIR ITEM 62

(L101W-U102W, looking west)
Use existing holes as a template for drilling holes in new angle. Cost of straightening member is included in the cost of Structural Steel Repair.

Impacted areas shall be straightened. See special provision Straighten Bent Members. Cost included with Straighten Bent Members. Typical for repair 62.

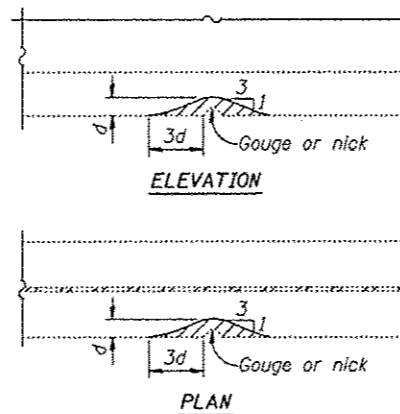
GRINDING DETAIL

REPAIR ITEMS 32 & 62

Grind existing nicks, gouges and shallow cracks in the damaged beams as detailed. Grinding shall be done parallel to the longitudinal axis of the member. Ground surfaces shall be inspected for cracks using dye penetrant or magnetic particle testing prior to initiating any beam straightening operations. Any cracks that cannot be removed by grinding approximately 1/4" deep shall be identified and reported to the Bureau of Bridges and Structures for further disposition. Ground surfaces shall be spot cleaned and painted with an aluminum epoxy mastic primer followed by a finish coat to match the color of the existing beam. Cost of grinding, testing and spot painting included with Structural Steel Repair.

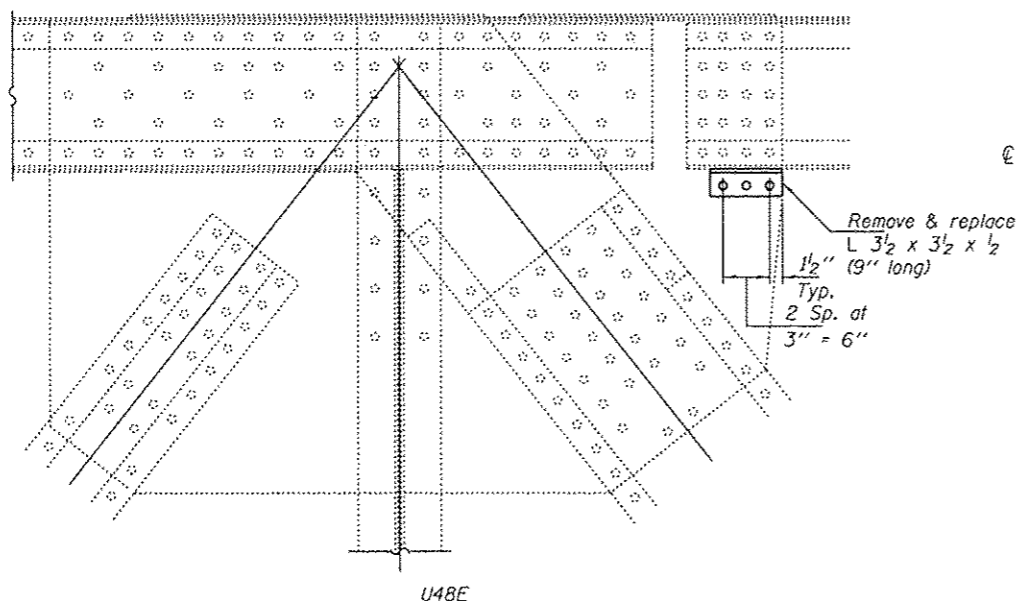
REPAIR ITEM 352

(Looking West)
Use existing holes as a template for drilling holes in new angle. Cost of straightening member is included in the cost of Structural Steel Repair.

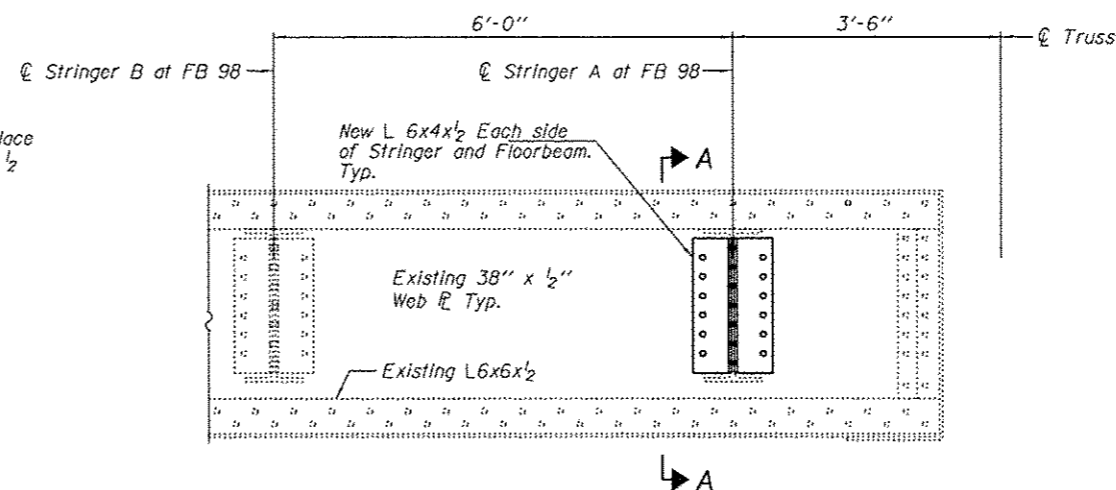
REPAIR ITEM 231

FLOOR BEAM 98

(Looking South)

- - Use holes in existing member as template
- - Use holes in new member as template

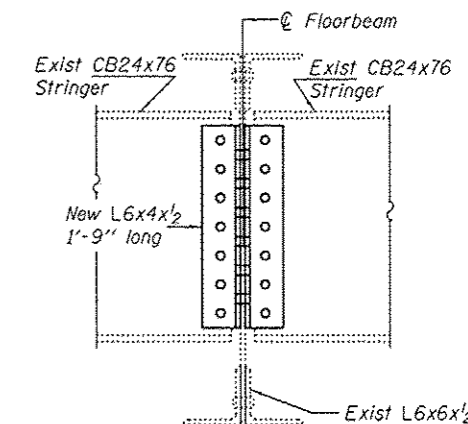
SECTION A-A

Temporary support of stringer end is required. See sheet B of 13 for details.
