STATE OF ILLINOIS  
DEPARTMENT OF TRANSPORTATION

REPAIRS 8 & 9  
SN 062-0036

SHEET NO. 9 OF 10 SHEETS

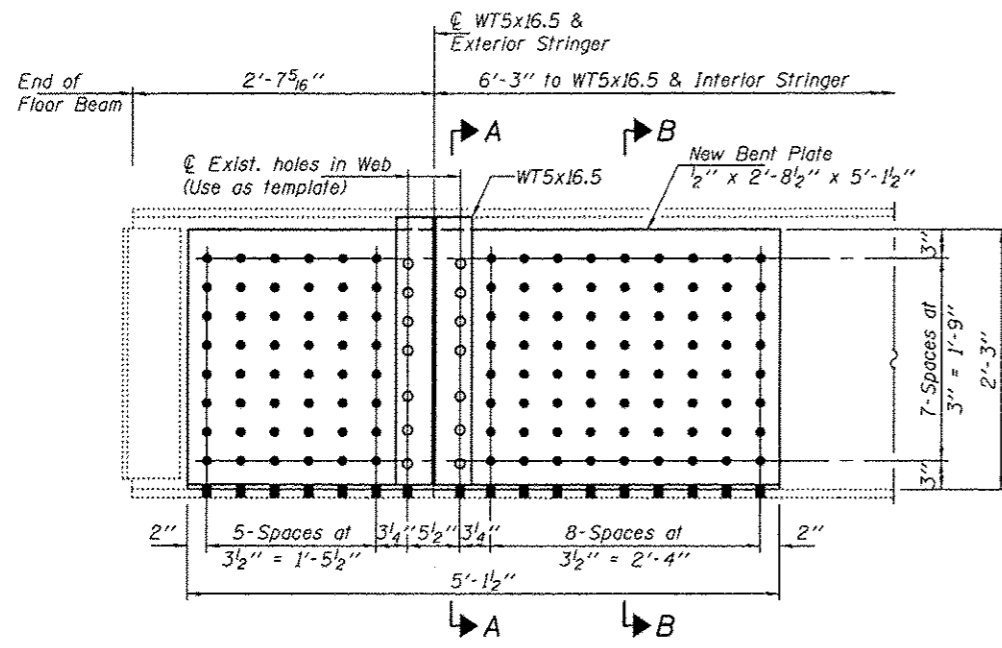
**REPAIR 8 DETAILS**

Span 8, Floor Beam 0, North Face, East End  
Span 8, Floor Beam 8, South Face, West End

**STEPS TO REPAIR THE FLOOR BEAMS**

1. Provide support to the exterior stringer at the floor beam that is to be repaired.
2. Remove the existing WT5x16.5 from the W30x116 floor beam.
3. Prepare all surfaces of the existing W30x116, from the end of the floor beam to 1 foot beyond the end of the new bent plate. The linear distance would be approximately 7 feet. Included in the surface preparation will be the angles that attach the exterior stringer to the floor beam and 2 linear feet of the exterior stringer. Refer to "Cleaning and Painting Contact Surface Areas of Existing Steel Structures"
4. Install the Bent Plate (1/2" x 2'-8 1/2" x 5'-1 1/2") on the W30x116 floor beam.
5. Install the WT5x16.5 on top of the bent plate. Reuse the existing holes in the web of the W30x116 to attach the WT and bent plate to the existing floor beam.

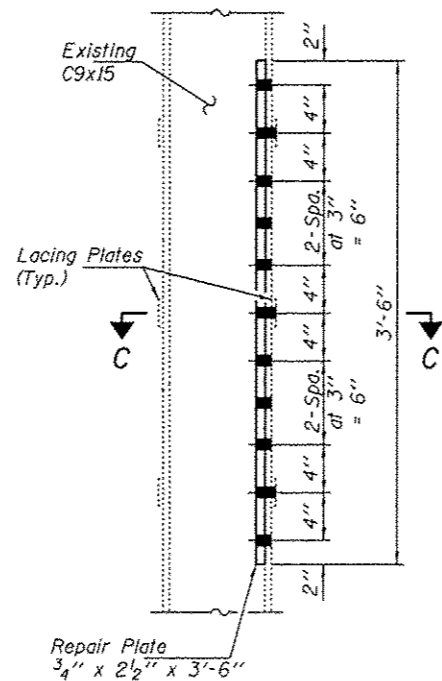
**REPAIR 9 DETAILS**

Span 7, L2W-U2W, ±3' above deck
