DETAIL G COLUMN BASE REPAIR

SN 016-1116, Pier 2

DETAIL H BRACING MEMBER REPLACEMENT

REVISIONS NAME	DATE	ILLINOIS DEPARTMENT OF TRANSPORTATION
		F.A.I. 94/90 (DAN RYAN EXPRESSWAY)
		NB DAN RYAN ELEVATED BRIDGE
		REPAIR FROM 15TH TO 28TH STREETS
		STRUCTURAL STEEL REPAIR
		DETAIL G & H
		SCALE: NTS
		DATE: 8/12/2005
		DRAWN BY: BDC
		CHECKED BY: BLU

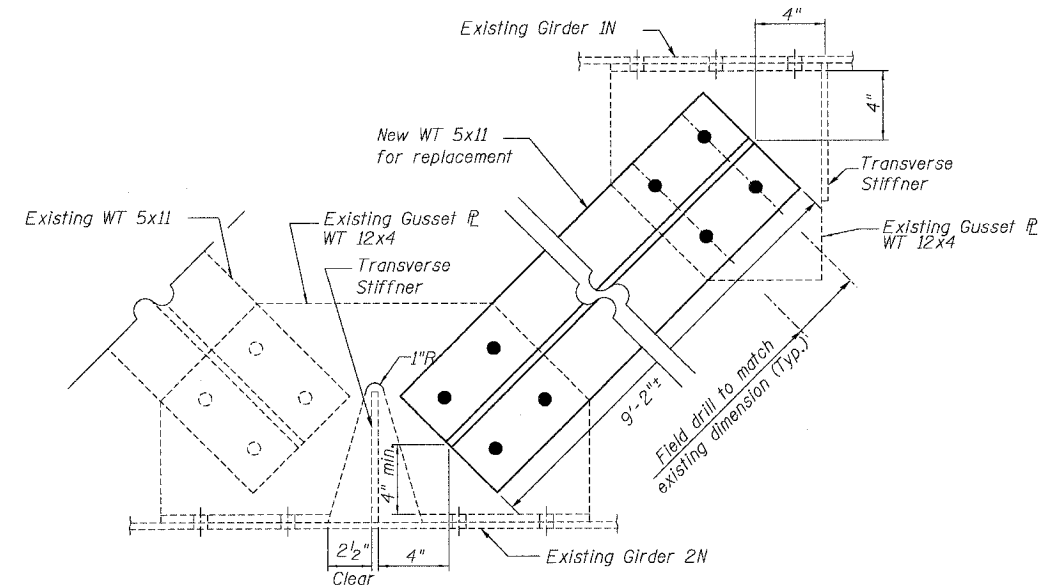
(S.N. 016-1116, Span 3)

Notes: This work shall require temporary sidewalk and lane closure of South Canal Street in accordance with Highway Standards 701801 & 701501.
