CONCRETE DECK BEAM REPAIRS

WOLF RD. OVER PALATINE RD.

STRUCTURE NO. 016-0680

SHEET NO. 5

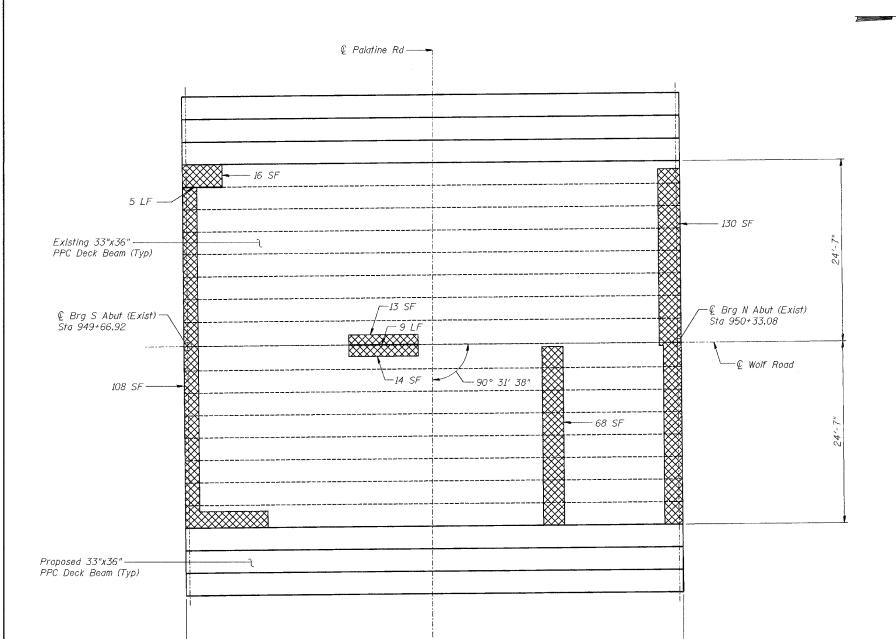
PLAN OF CONCRETE DECK BEAM REPAIRS

Length of Keyway Repair based on Infrared Survey dated 12/21/92.

- Area Showing Possible Delaminations of Top of Beam based on Infrared Survey dated 12/21/92

Repair areas shown are the surveyed areas of deterioration. The actual area to be repaired shall be as directed by the Engineer.

Surveyed areas that show possible delamination should be investigated after removal of the bituminous overlay. Any areas with delamination extending to the top mat of reinforcement on the beam shall be cleaned of any loose concrete and filled back up with the concrete overlay. Cost included with "Concrete Wearing Surface." Any area where the damage extends below the top mat of reinforcement on the beam shall be brought to the attention of the Bureau of Bridges and Structures for further disposition.
