STATE OF ILLINOIS
DEPARTMENT OF TRANSPORTATION

REPAIR DETAILS
SN 060-0046

SHEET 9A OF 9 SHEETS

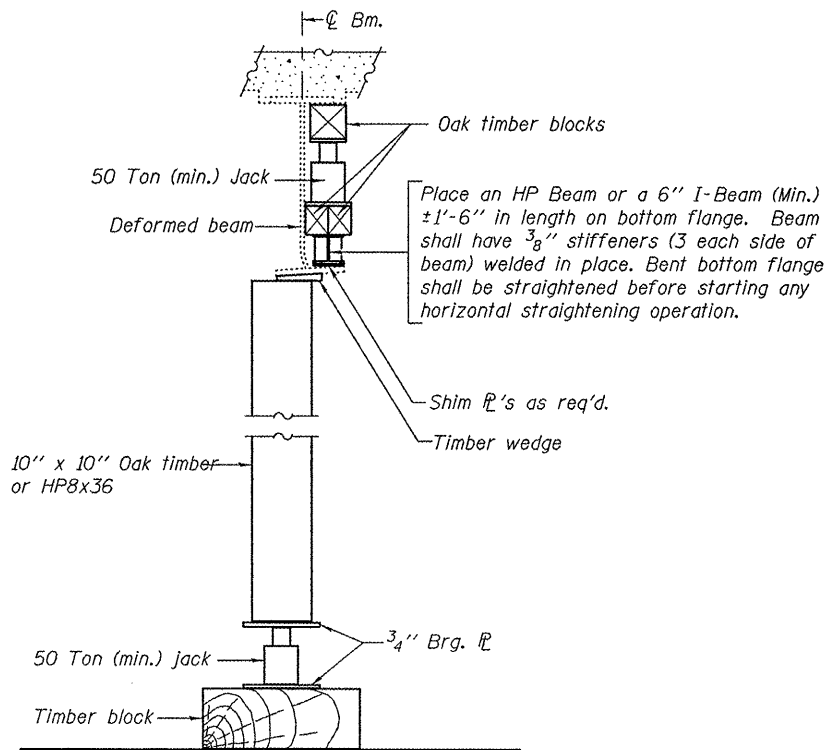
SUGGESTED VERTICAL STRAIGHTENING DETAIL

(To correct flange rotation.)

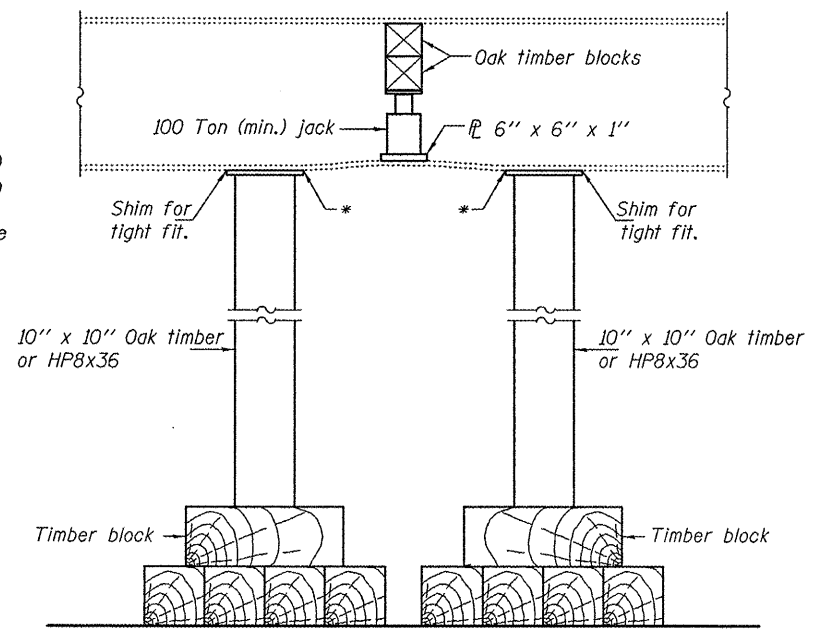
SUGGESTED VERTICAL STRAIGHTENING DETAIL

(To correct localized vertical flange deformations.)

* Edge of plate shall line up with edge of deformation.
