STATE OF ILLINOIS DEPARTMENT OF TRANSPORTATION

PIER NO. 2 REPAIR

STRUCTURE NO. 084-0078

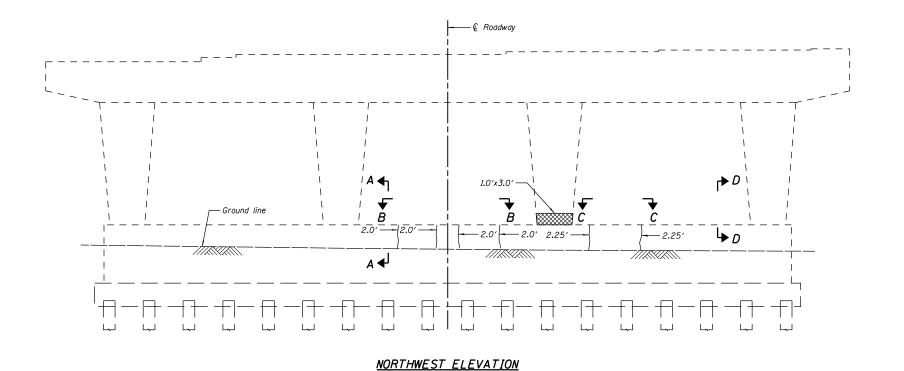
(Looking Southeast)

Crack widths are $^{l}_{8}$ " ($^{\pm}_{l6}$ ") unless otherwise noted.

Epoxy Crack Injection

Structural Repair of Concrete
