STATE OF ILLINOIS
DEPARTMENT OF TRANSPORTATION

PIER REPAIRS
STRUCTURE NO. 077-0016

ESCA
CONSULTANTS, INC.

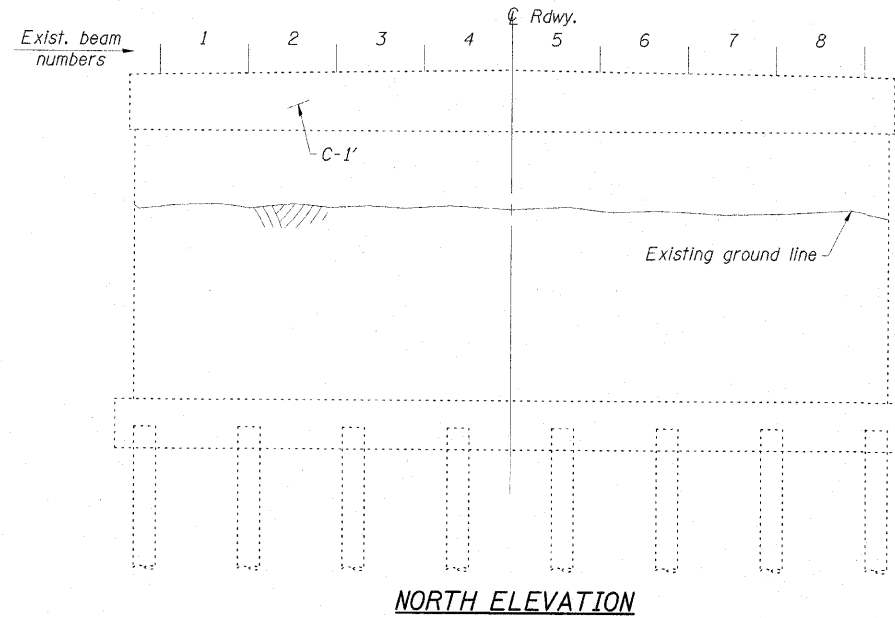
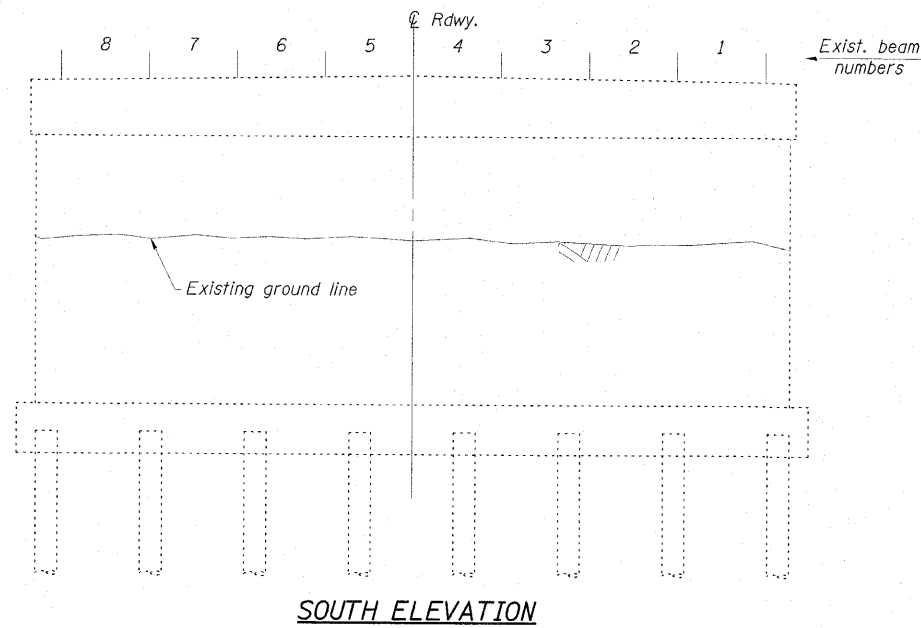
Existing bearing seat to be inspected by the Engineer after deck beam removal. Deteriorated concrete areas shall be repaired (estimated 15 sq. ft. Structural Repair of Concrete) and cracks shall be sealed (estimated 20' Epoxy Crack Injection) as required. Structural Repair of Concrete and Epoxy Crack Injection locations and dimensions are estimated from 06/24/2009 survey work. Actual locations and dimensions shall be shown by the Engineer on the as-built plans for this section.
