**STATE OF ILLINOIS**  
**DEPARTMENT OF TRANSPORTATION**

**MAIN SPANS FLOORBEAM WEB REPAIRS - 2**  
**S.N. 082-6001 MLK BRIDGE OVER MISSISSIPPI RIVER**

F.A.P. RTE. 799	SECTION 1BR. DRS-2	COUNTY ST. CLAIR	TOTAL SHEETS 156	SHEET NO. 84
CONTRACT NO. 76B03			ILLINOIS FED. AID PROJECT

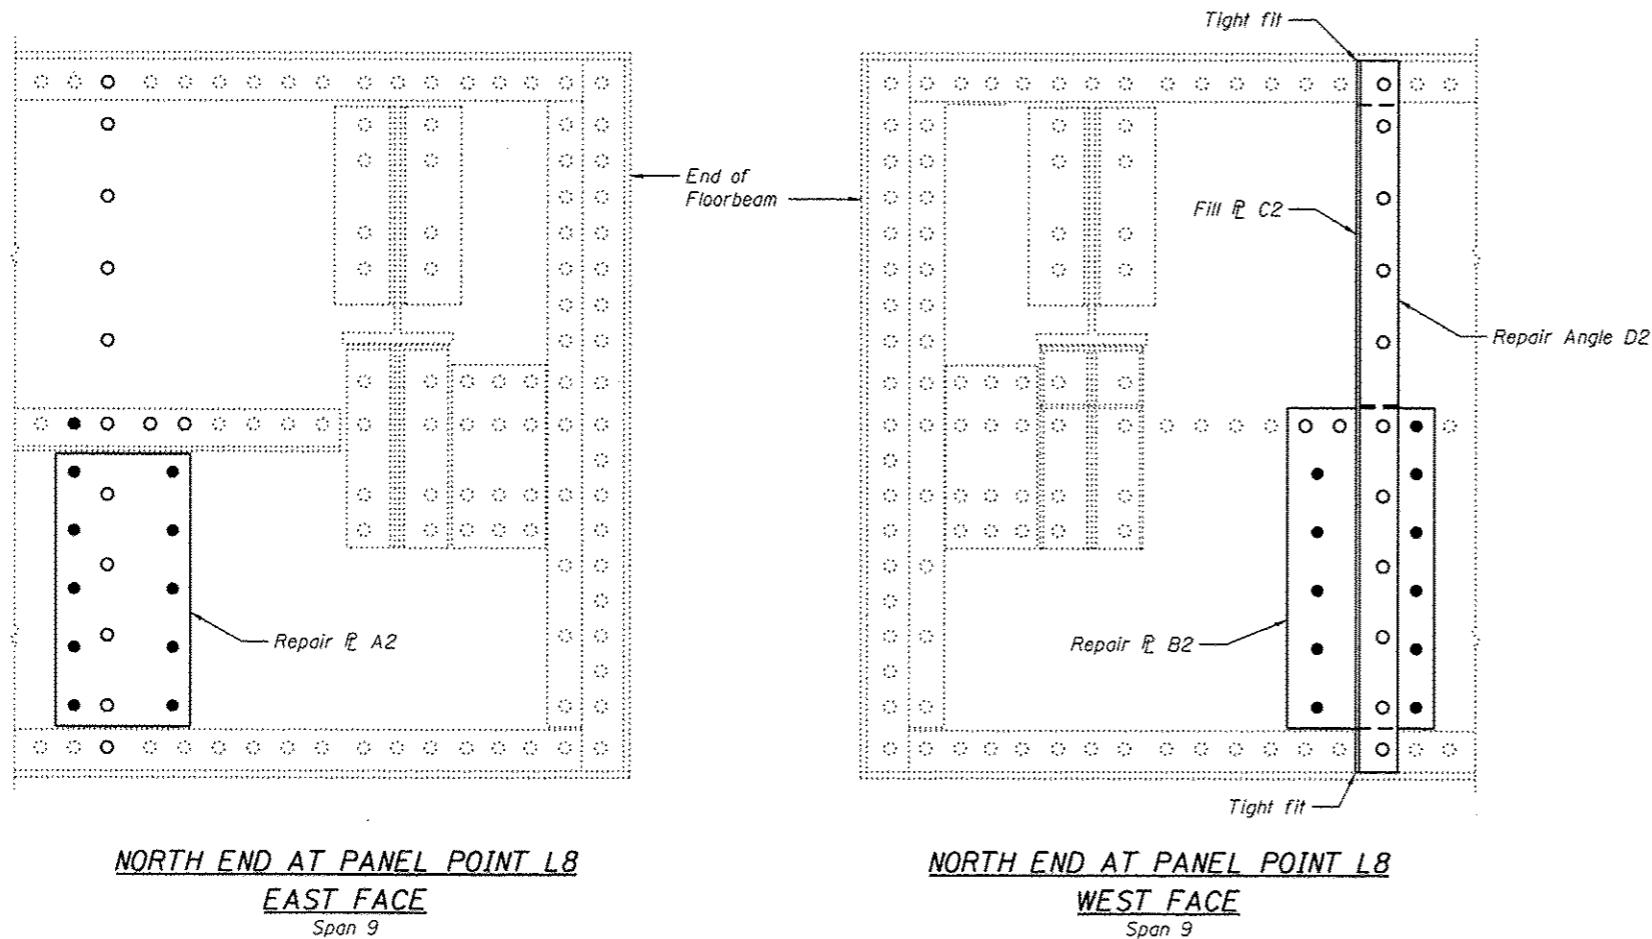
**FLOORBEAM WEB REPAIRS**

**NORTH END AT PANEL POINT L8**  
**EAST FACE**  
Span 9

**NORTH END AT PANEL POINT L8**  
**WEST FACE**  
Span 9
