FLOORBEAM WEB REPAIRS

STATE OF ILLINOIS
DEPARTMENT OF TRANSPORTATION

MAIN SPANS FLOORBEAM WEB REPAIRS - 8
S.N. 082-6001 MLK BRIDGE OVER MISSISSIPPI RIVER

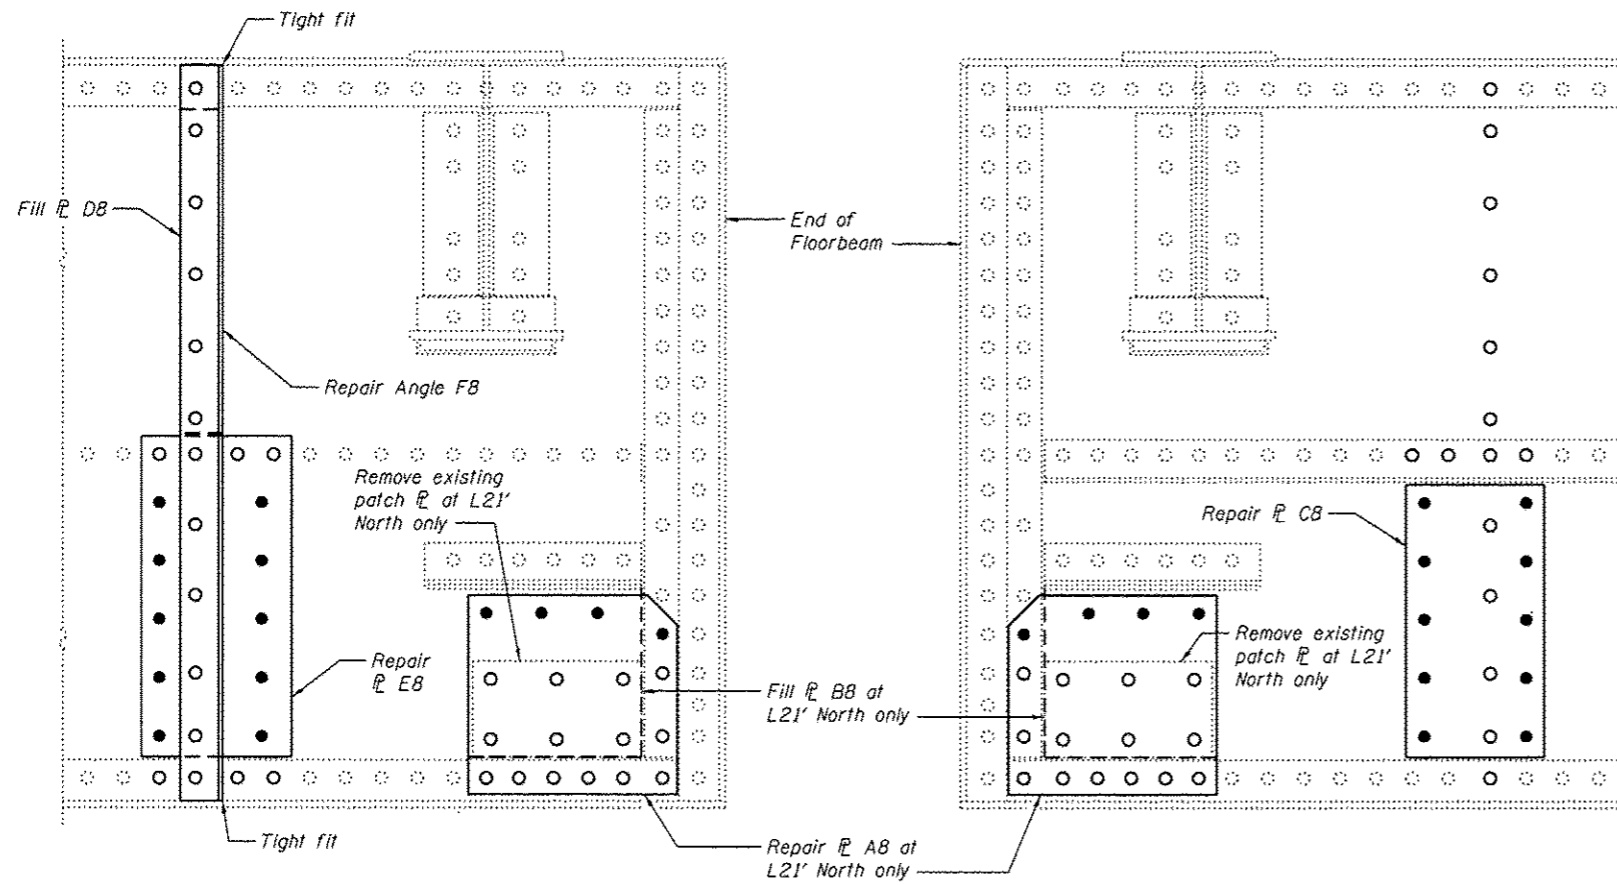
NORTH END AT PANEL POINT L21' AND L23'
EAST FACE
(Span 10)

NORTH END AT PANEL POINT L21' AND L23'
WEST FACE
(Span 10)

Note: L21' shown, L23' similar

Note A:
Field drill holes using existing holes as template.
Remainder of holes may be shop or field drilled.
