STATE OF ILLINOIS
DEPARTMENT OF TRANSPORTATION

MAIN SPANS FLOORBEAM WEB REPAIRS - 12
S.N. 082-6001 MLK BRIDGE OVER MISSISSIPPI RIVER

SHEET NO. S76 OF S138 SHEETS

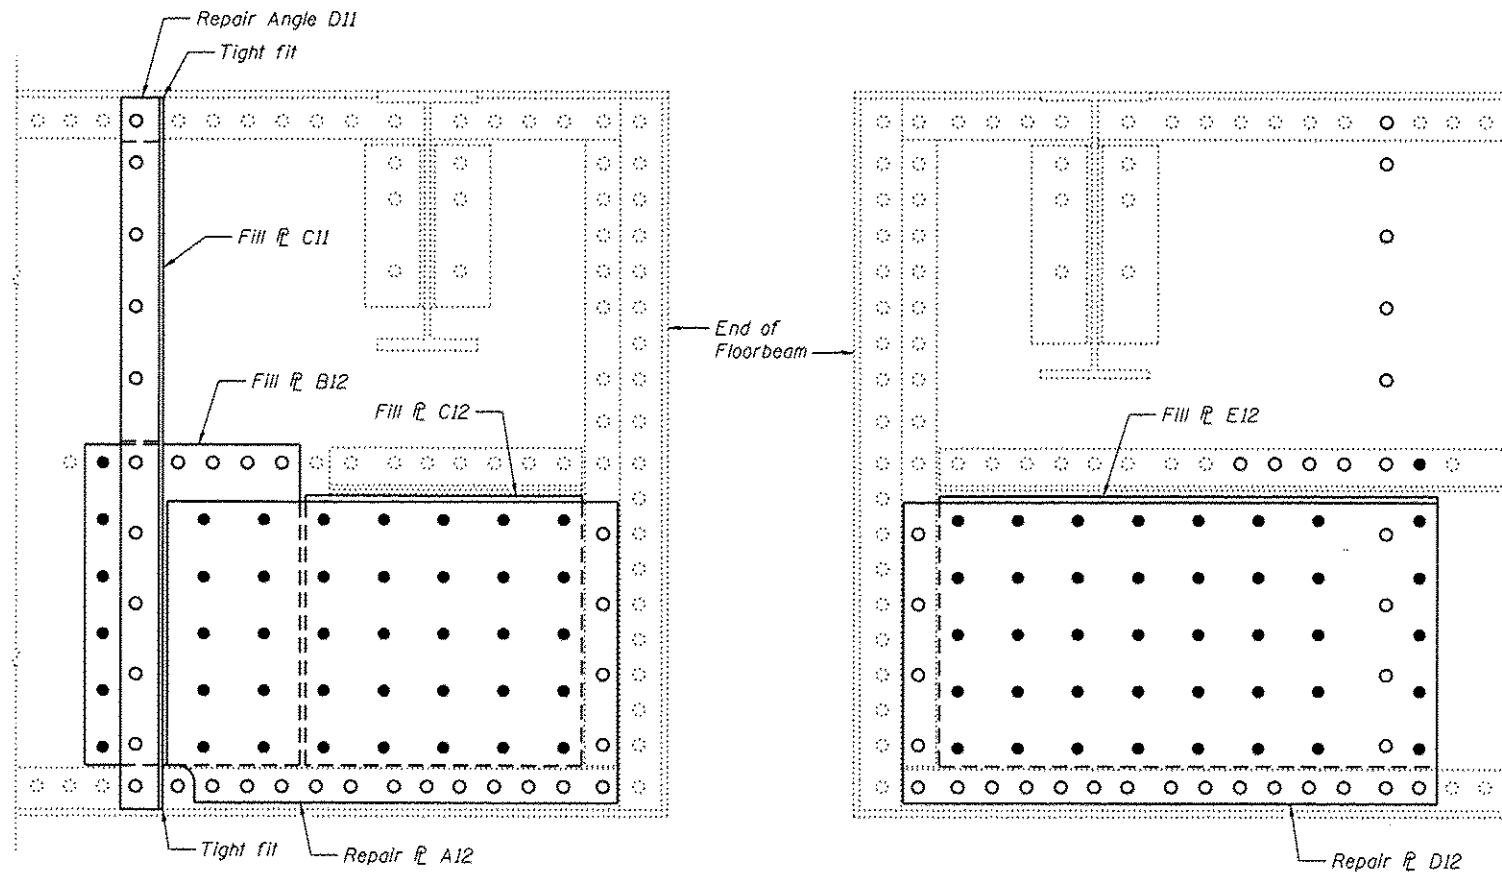
FLOORBEAM WEB REPAIRS

NORTH END AT PANEL POINT L6'
EAST FACE
(Span 11)

NORTH END AT PANEL POINT L6'
WEST FACE
(Span 11)

Note A:
Field drill holes using existing holes as template.
Remainder of holes may be shop or field drilled.
