REPLACE DEFECTIVE OR MISSING FASTENERS		
09/16/13 NBIS Inspection Deficiency Item No.	Location	No. of Bolts
103	Span X, between Stringer 1 and Stringer 2 at Midspan	1
104	Span X, between Stringer 3 and Stringer 4 at Midspan	1
106	Bent 1 at Stringer 6	2
107	Bent 1 at Stringer 4	1
108	Span 2, Stringer 7, 5' from Bent 1, 5' from Bent 2, and at Bent 2	5
109	Span 2, Stringer 1 at Bent 2	3
119	Bent 7 at Stringer 4	2
371	Bent 7 at South Column Long. Bracing	1
311	Span 9, Stringer 7, 6' East of Floorbeam 0	2
125	Span 9, Floorbeam 1 at Stringer 3	1
48	Span 10, Floorbeam 18 between Stringer 1 and Stringer 2	5
177	Span 10, Floorbeam 24' at Stringer 2	1
181	Span 10, Floorbeam 23' at Stringer 3	1
182	Span 10, Floorbeam 23' at Stringer 4	1
183	Span 10, Floorbeam 23' at Stringer 4	1
187	Span 10, Floorbeam 21' at Stringer 2	1
190	Span 10, Lower Lateral Connection at L15'N	2
192	Span 10/11, L14'N, outside Gusset Plate	3
361	Span 11, L11'N inside Gusset Plate	2

REPLACE DEFECTIVE OR MISSING TIE RODS TO CONCRETE MEDIAN BARRIER		
09/16/13 NBIS Inspection Deficiency Item No.	Location	No. of Tie Rods
349	Span X, 12' East of Bent W	-
-	Span Y, 12' West of Bent Y	1
-	Span 7, at Bent 7	1
-	Span 8, 24' West

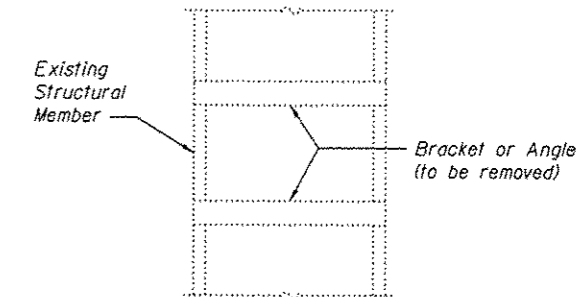
MISCELLANEOUS STEEL REMOVAL DETAIL

-	Bent 1, 4' above base of North Column	2
-	Bent 1, 4' above base of South Column	1
-	Bent 3, South Column	5
66	Bent 3, North Column	4
-	Bent 4, North Column	6

-	Bent 6, North Column	6
-	Bent 6, South Column	4
41	Span 9, L4N - U4N, 4' and 20' above Deck	2
-	Span 9, L4S - U4S, 4' above Deck	2
-	Span 9, L10S - U10S, 4' above Deck	2
75	Span 9/10, M14N - M14S, 20' above Deck	1

-	Span 10, L18S - U18S, 4' and 30' above Deck	4
50	Span 10, L23N - U23N, 4' above Deck	2
51	Span 10, L23N - U23N, 25' above Deck	1
21	Span 10, L23'S - U23'S, 30' above Deck	2

-	Span 10, L21'N - M21'N, 12' above Deck	1
-	Span 10, M19'N, outside Gusset Plate	1
-	Span 10, L18'N - U18'N, 4' and 25' above Deck	4
-	Span 11, L13'S - M13'S, 4' above Deck	2
54	Span 11, L13'S - M13'S, 40' above Deck	2

-	Span 11, L10'N - U10'N, 4' and 30' above Deck	4
-	Span 11, L4'S - U4'S, 4' above Deck	2
61	Span 11, L4'S - U4'S, 30' above Deck	1

Notes:
Remove existing brackets or angles welded to the structure and grind smooth to an ANSI 250 finish. Cost of removal is included with Structural Steel Repair. See table for specific repair locations.
