To:	Carl Puzey		From:	John Baczek/Steve Schilke			
Bureau:	Bridges and Structures		Bureau:	Programming			
Attn:	Patrik Claussen		By:	Mark Peterson			
			Subject:	Project and Environmental Studies			
Date:	July 18, 2017			BCR Submittal 016-0706 Des Plaines Ave over I-290			
Please ch	eck appropriate box below:						
	Take Necessary Action			Reply			
\boxtimes	☐ For Your Comments ☐ See I		le About the At	ached 🗌 Return			
	☐ Per Your Request ☐ Draft (For 🗌 Route

ABBREVIATED BRIDGE CONDITION REPORT

REGION:	1
DISTRICT:	1
COUNTY:	Cook
ROUTE:	Des Plaines Avenue
JOB NUMBER:	P-91-597-10
STRUCTURE NUMBER:	016-0706
LOCATION:	Des Plaines Ave. over FAI 290 (I-290)
II. Roadway/Structure Data

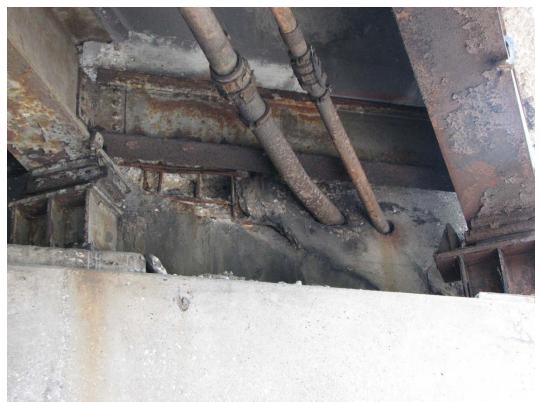
Photo 7 – Abutment Backwall Spalling and Utilities

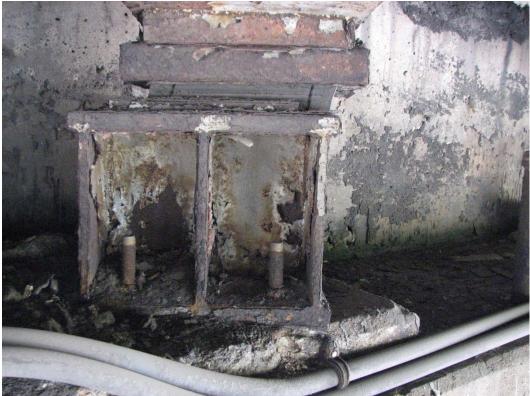
Photo 8 – Bearing Condtion with Utilities
